Service Bulletin

Bulletin No.: 09-08-57-002D

Subject: General Water Leak Diagnostic Guide

Models: 2007-2013 Chevrolet Silverado
2007-2013 GMC Sierra

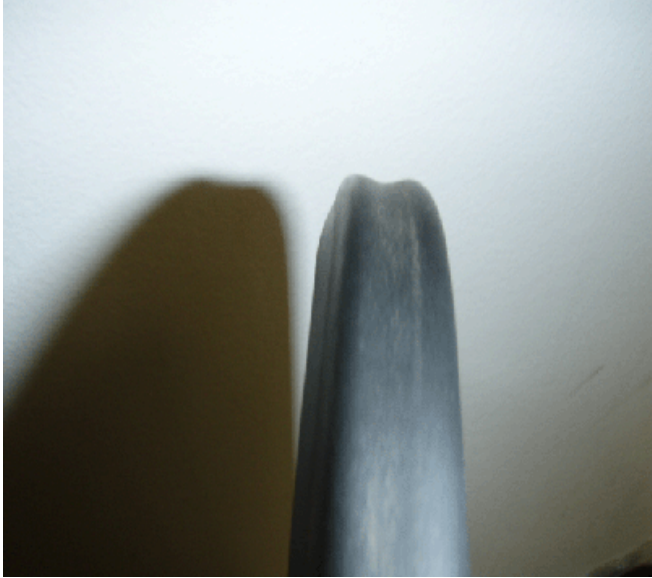
2094563

Excessive water may leak past the sunroof glass seal at the corners of the glass panel.

The corners of the sunroof glass seal surface may have taken a set into an "hourglass" shape. This condition will be visually evident if the seal looks depressed or concave in the middle as shown above.

If excessive water is leaking past the sunroof glass seal at the corners of the glass panel, inspect the condition of the seal at each corner. If the seal exhibits the depressed or concave appearance noted above, replace the sunroof glass panel seal. Refer to Corporate Bulletin Number 08-08-67-006 for additional repair information, if needed.

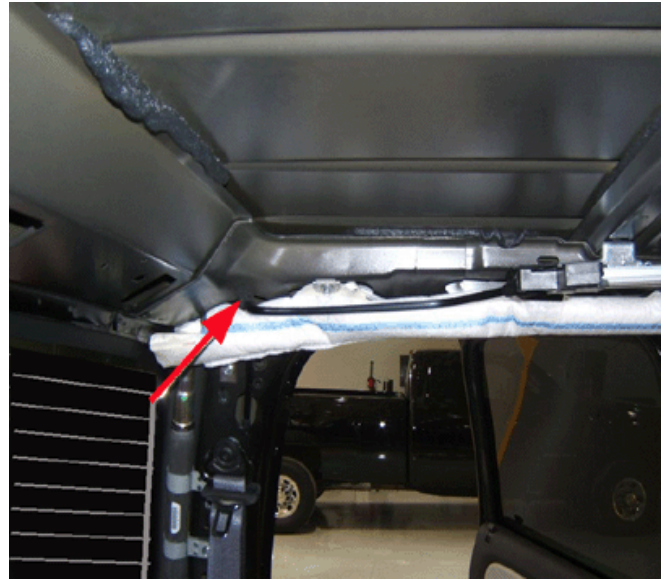
2094566

Water is backing up/collecting in the upper end of the rear sunroof drain tubes.

The rear drain tubes may not have adequate downward slope.

Inspect that the rear drain tubes have adequate downslope. If not, a foam block can be used to push the drain tube down to provide additional downward slope as shown above.

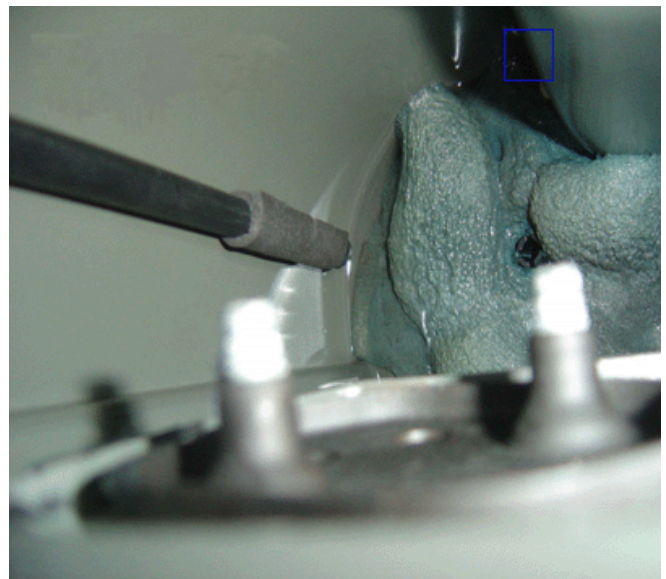
2094567

Water becomes trapped in the lower end of a rear sunroof drain tube and is not draining properly into the rear pillar cavity.

In some cases, the drain tube may be too long and the end of the tube bottoms out against the foam in the rear pillar.

Shorten the drain tube by cutting the end of the drain tube off to provide additional clearance as shown above.

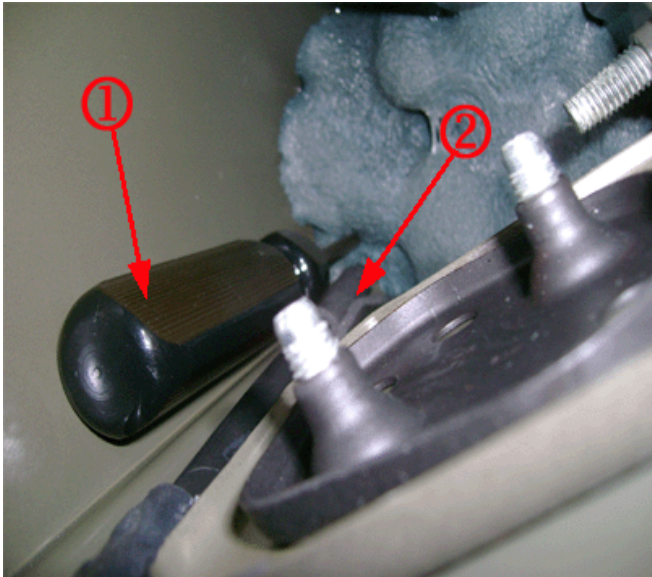
2094570

Water is not exiting the rear pillar cavity drain hole properly. If the water cannot drain from the pillar cavity, the water may leak onto the floor and dampen the carpet.

The rear pillar cavity drain hole may be plugged/ blocked with foam as shown above. This may have been the result of the foam expanding too much during vehicle assembly.

Important: The reason for staying within one inch of the perimeter of the pillar is that there is a plastic block located under the foam and it is very difficult to pierce through it with a screwdriver.

Create a drain hole in the foam block using a long screwdriver (1). The hole can be made anywhere within a one inch perimeter of the pillar cavity (EXCEPT for the inboard side of the pillar), and would be more effective if made in a low spot where the drain tube (2) empties into the cavity as shown above.

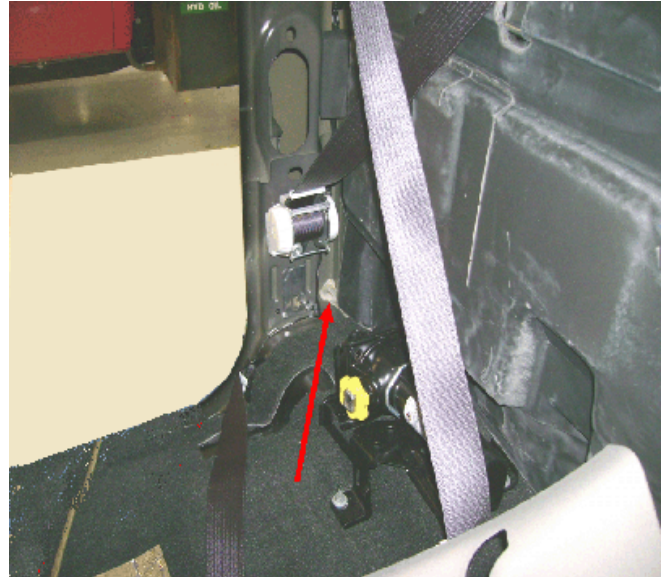
2094574

Water may be found in the lower rear pillar and floor area. Water may be entering at the corner where the rear pillar and floor meet, and/or the two bottom holes in the pillar that align and secure the pillar trim panel.

Insufficient body sealer may be the cause.

1. Inspect the corner where the rear pillar and floor meet for any voids in the seam sealer as shown above. If a void is found, fill it with seam sealer Kent Automotive High-Tech Clear Sealer Part Number P10200 (5 oz. tube) or equivalent.

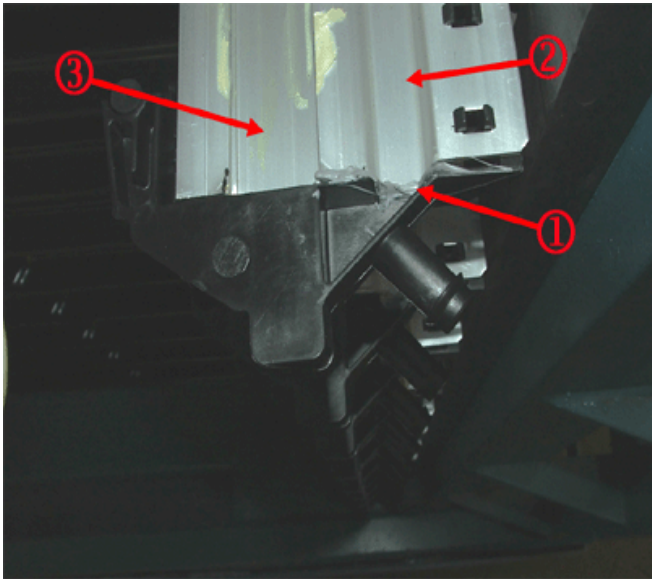
2094580

Note: The area marked (2) in the above graphic is the sunroof drain channel. Any water that gets past the glass seal is routed through the drain tubes. The area marked (3) is the sunroof mechanism track and no water should be in this area. If there is water in area (3) it will leak out between the end cap and side rail because the end cap is not sealed in this area. If water is in area (3) this could be caused by one or more of the conditions previously listed in this document.

Water may be collecting in the rear of the sunroof drain channel (2).

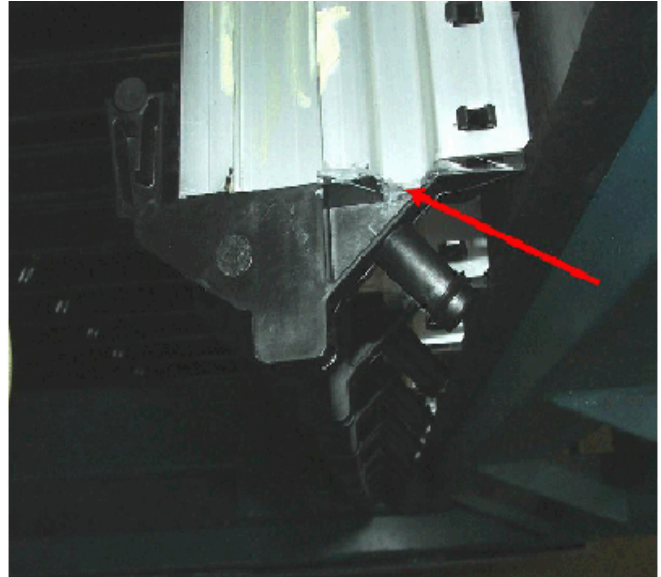
2094578

During the manufacturing process, excess sealer may have squeezed out between the black plastic end cap (gutter) and the sunroof rail. Any excess sealer may create a dam, or block the nipple, and prevent the water from draining freely, as shown above.

To correct the concern, simply remove any excess sealer.

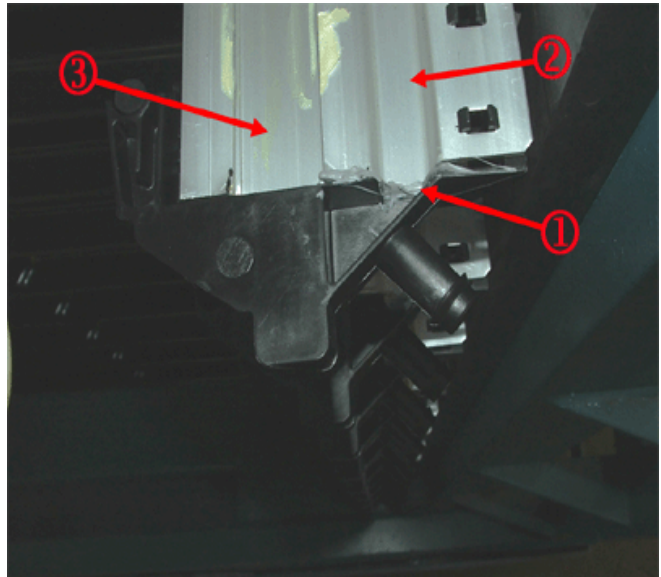
2094580

Water may be leaking between the sunroof side rail and the black plastic rear end cap (gutter) where it attaches to the side rail as shown above (1).

Insufficient sealer or an improper sealant path may be the cause.

If water is NOT getting into area (3) noted above, but IS leaking between the rear end cap and side rails, then remove and re-install the end cap using the following steps.

1. Remove the sunroof frame from the vehicle. Refer to Sunroof Frame Replacement in SI.
2. Disengaging the retaining tabs on the outboard side, remove the end cap from the sunroof frame side rail.
3. Clean any old sealer from the end cap and rail using Kent Automotive Acrysol™, or equivalent.

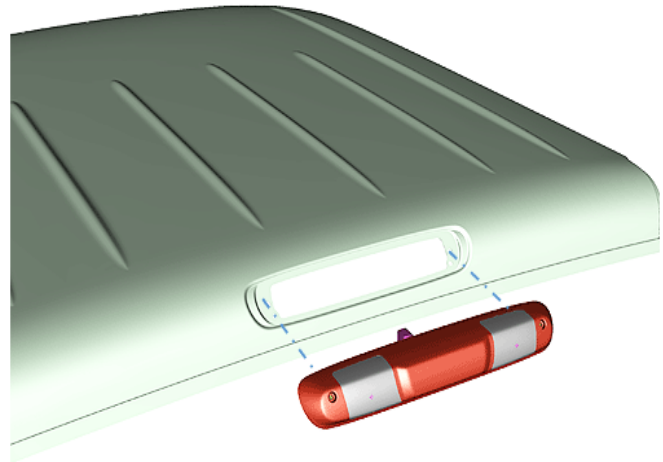
2407759

Water may be found on the rear floor of the vehicle and/or the rear carpet may be wet. In extreme circumstances, this condition may sometimes lead to a possible no start, due to remote control door lock receiver (RCDLR) connector corrosion.

Water may be entering the vehicle through the center high mounted stop lamp (CHSML) opening, and may leak down the B and/or C-pillars.

Lower the headliner and water test by running water onto the outer CHSML area while looking to verify any leak path down the B or C pillars. Seal by removing and cleaning the CHMSL, then applying a bead of Kent Automotive High-Tech Clear Sealer (Part Number P10200 5 oz. tube), or equivalent, along the outer edge of lamp surface so that it provides an adequate seal between the body and the lamp housing. Reinstall the CHMSL, remove any excess sealant and reinstall the headliner.

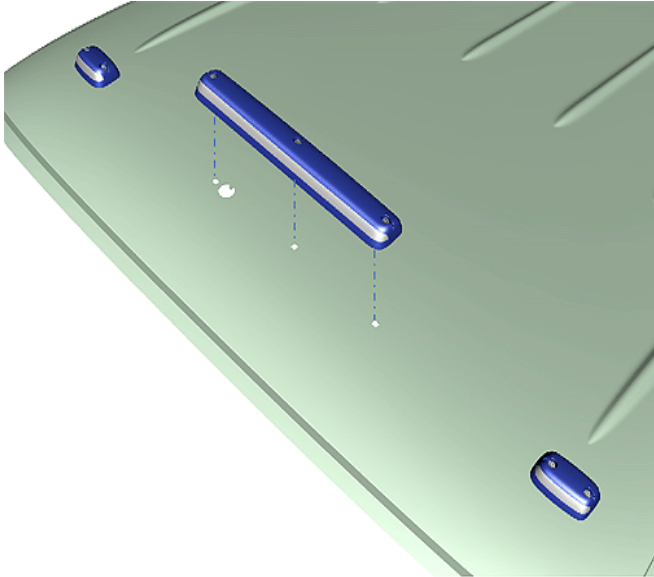
2407762

The headliner may be wet, or water may collect on the headliner at the overhead console. In some instances, water may possibly be seen dripping from the overhead map lights.

Water may be entering the vehicle through the one of the roof marker lamp openings. A water leak at the larger center lamp is most prevalent.

Lower the headliner and water test the roof lamps area to verify the leak path. Remove and clean the affected lamp, then apply a bead of Kent Automotive High-Tech Clear Sealer (Part Number P10200 5 oz. tube), or equivalent, along the outer edge of lamp surface so that it provides an adequate seal between the body and the lamp housing. Reinstall the lamp assembly, remove any excess sealant and reinstall the headliner.

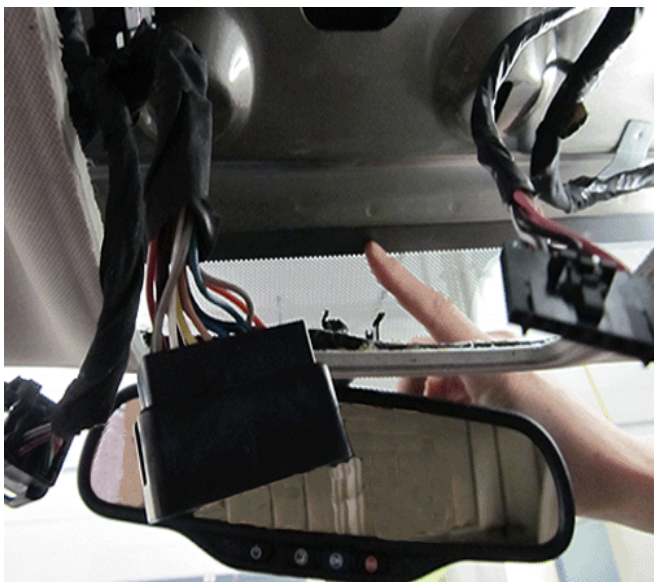
3273575

Water may be entering the vehicle through a burn hole in the forward seam above the windshield, where the roof panels are welded together.

Lower the headliner and water test the roof/windshield area at the rearview mirror or the front right side. Once the leak path is verified, apply a bead of Kent Automotive High-Tech Clear Sealer (Part Number P10200 5 oz. tube), or equivalent, to the outside of the roof panel seam and reinstall the headliner.

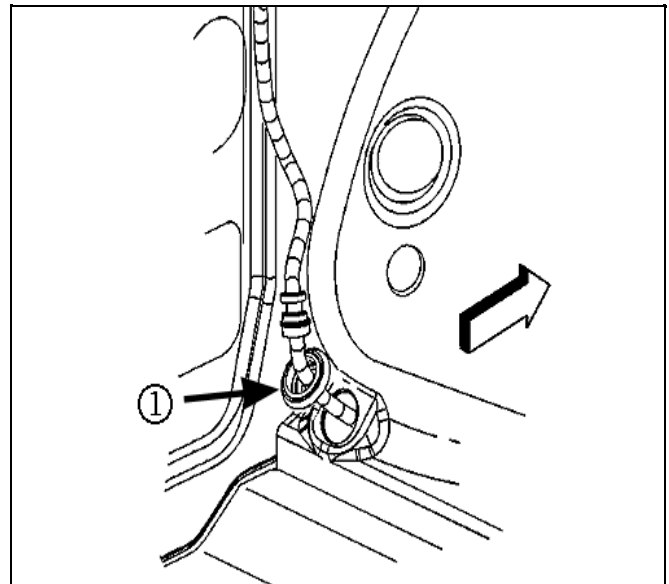
2407753

Carpet may be wet or water may be found on the driver side floor area, which only occurs after the vehicle is driven in the rain or in wet road conditions.

This condition may be the result of an improperly seated parking brake cable grommet.

Remove the left side hinge pillar trim panel and position the carpet to expose the park brake cable pass-through grommet (1).

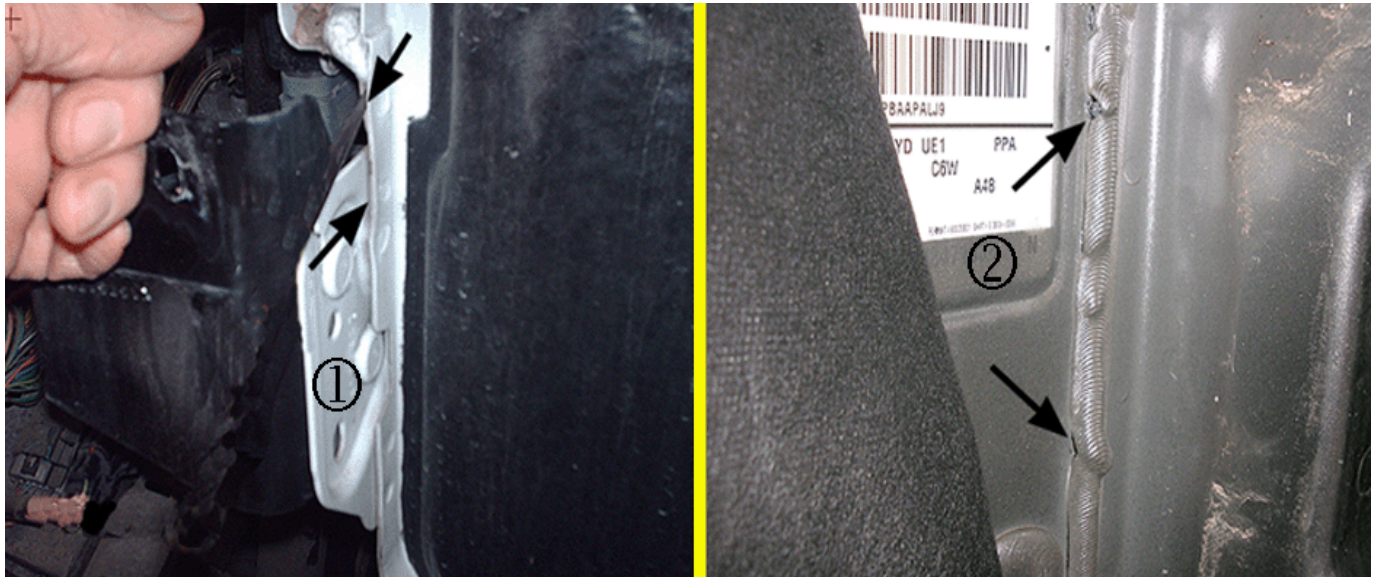
2413849

Carpet may be wet or water may be found on the driver side floor area.

The water leak may be due to a lack of sealer (or voids in the sealer) at the seams of the front cowl area and front of dash (FOD), behind the left front fender. The above graphic shows two examples of seams missing sealer. (The position of seams 1 and 2, in relationship to each other, is shown clearer in the graphic below).

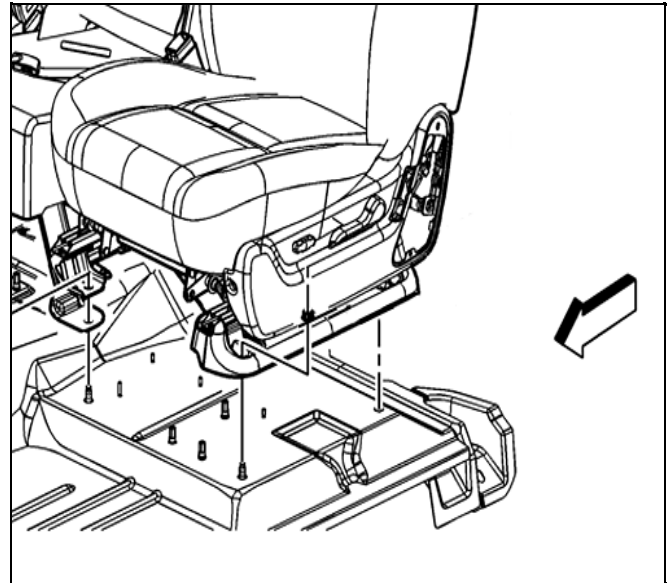
2407756

Water dampness noted on driver's carpet area, only occurring after the vehicle is driven in the rain or in wet road conditions.

Water may be traveling/wicking up the drivers front seat studs due to a poor seal at the stud locations.

Remove the seat assembly and water test by spraying the underside of vehicle at the seat studs and watching for water to wick up the studs. Seal the studs from inside vehicle by applying Kent Automotive High-Tech Clear Sealer (Part Number P10200 5 oz. tube), or equivalent, around the stud base/floor interface. Reposition the carpet/trim and reinstall the seat.
