Service Bulletin

Bulletin No.: 10-06-01-008G

Date: January, 2013

Subject: Engine Oil Consumption on Aluminum Block/Iron Block Engines with Active Fuel Management (AFM) (Install AFM Oil Deflector and Clean Carbon from Cylinder and/or Install Updated Valve Cover)

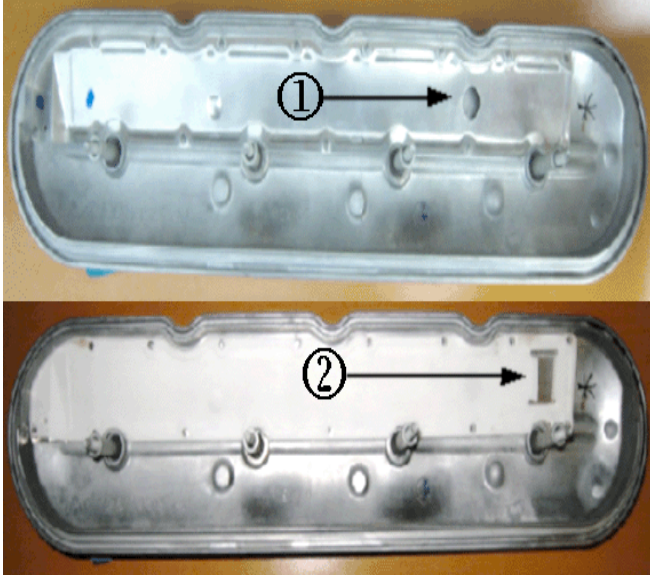
2740641

- 1) Old Design
- 2) New Design

PCV pullover or an overactive lifter can cause oil to be pulled through the PCV system even at low vehicle mileage. A correctly functioning PCV system will only leave a film of oil in the intake manifold. Inspect the intake manifold to see if there is any oil puddling in the bottom. If there is you will need to replace the left valve cover. Two new left rocker arm covers have been released for trucks and vans. Technicians should replace the left rocker arm cover with GM P/N 12570427 for 2007-2008 or GM P/N 12642655 for 2009-2011. Refer to the Parts Information below for the Camaro. This rocker arm cover has a relocated PCV drain hole that prevents oil from entering the intake manifold. Refer to Valve Rocker Arm Cover Replacement - Left Side in SI.

Aluminum or Cast Iron Block - Oil in Intake Manifold - Install Updated Valve Cover on All Models Built Prior to February 1, 2011

Note: These rocker covers are for specific years. The PCV orifice is different for each. The correct cover must be used or an SES light may set.
