# Service Bulletin

Bulletin No.: 10-06-01-008I

Date: February, 2013

**Subject:** Engine Oil Consumption on Aluminum Block/Iron Block Engines with Active Fuel Management (AFM) (Install AFM Oil Deflector and Clean Carbon from Cylinder and/or Install Updated Valve Cover)

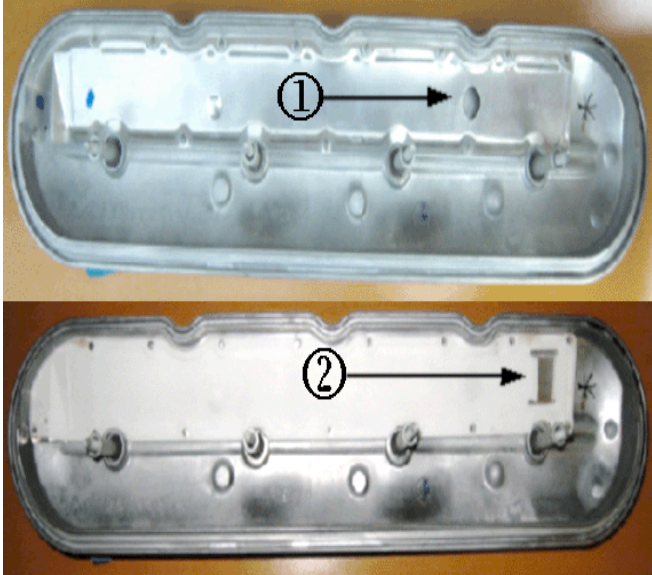
2740641

- 1) Old Design
- 2) New Design

PCV pullover or an overactive lifter can cause oil to be pulled through the PCV system even at low vehicle mileage. A correctly functioning PCV system will only leave a film of oil in the intake manifold. Inspect the intake manifold to see if there is any oil puddling in the bottom. If there is you will need to replace the left valve cover. Two new left rocker arm covers have been released for trucks and vans. Technicians should replace the left rocker arm cover with GM P/N 12570427 for 2007-2008 or GM P/N 12642655 for 2009-2011. Refer to the Parts Information below for the Camaro. This rocker arm cover has a relocated PCV drain hole that prevents oil from entering the intake manifold. Refer to Valve Rocker Arm Cover Replacement - Left Side in SI.

**Note:** These rocker covers are for specific years. The PCV orifice is different for each. The correct cover must be used or an SES light may set.
