Service Bulletin

Bulletin No.: 10-07-30-001D

Subject: Fluid/Oil Leak During Cold Weather from Transmission Vent

Models: 2001-2013 Chevrolet Silverado 2500HD-3500HD Series

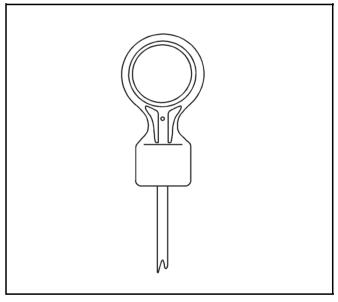
1377427

Note: The fluid level on the indicator may be higher on one side than the other. The lower reading should be considered the actual fluid level. The higher fluid level on the indicator should be considered splash.

Important: Ensure that the fluid level is at the top of the HOT band when the transmission fluid temperature is 79°C (175°F). Refer to SI Document ID# 2408059 for the proper fluid level checking procedure.
