Service Bulletin

Bulletin No.: 12-02-32-001A

Subject: Hydraulic Power Steering Leak at Hose Connection to Steering Rack

Models: 2007-2013 Cadillac Escalade Models
2007-2013 Chevrolet Avalanche, Silverado, Suburban, Tahoe
2007-2013 GMC Sierra, Yukon Models

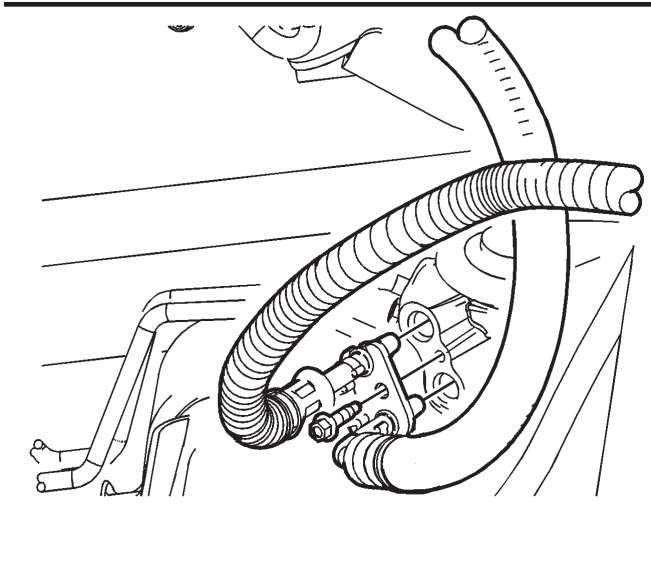
2760840

Some customers may comment on a fluid leak under the front of the vehicle. Upon further investigation, the technician may find fluid leaking from the power steering hose connection at the rack.

Based on parts returned to the Warranty Parts Center (WPC), replacement of both hose-to-rack “duckbill type” seals has corrected the condition. Replacement of the rack is not necessary for this issue.

8. Verify the source of the leak is actually the hose connection to the power steer rack.
9. If the source of the leak is from the hose to power steering rack connection, remove the bolt securing the hoses and replace the seals to correct the leak. Replacement of the power steering rack is not necessary to correct the condition.
