Bulletin No.: PI0339C

PRELIMINARY INFORMATION

Subject: Instrument Panel Cluster (IPC) Warning Lamps and/or MIL are Illuminated. Diesel

Models: 2011-2014 Chevrolet Silverado 2500HD. 3500HD

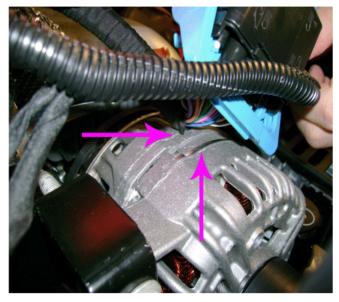
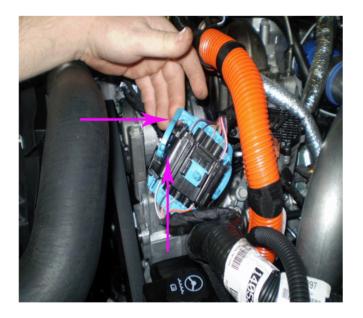
2552508

The wiring harness of connector X107 is chafing on one of the generators on trucks equipped with dual generators and/or the assist lever for connector X107 is not fully or properly seated or has backed out or damaged terminals.

Typical View of Wiring Harness Chafing and of an Improperly Seated Connector Assist Lever

- 1. Inspect connector X107 and its wiring harness for the following conditions:
 - 1.1. Chafing of the wiring harness insulation from contact on the generator as shown.
 - 1.2. A connector assist lever that is not fully or properly seated as shown.
 - 1.3. Backed out or damaged connector terminals.
 - 1.4. Poor terminal contact or tension. Refer to Testing for Intermittent Conditions and Poor Connections in SI.
- ⇒ If any of the above conditions exist, repair as needed. Refer to > Power and Signal Distribution > Wiring Systems and Power Management > Diagnostic Information and Procedures > Wiring Repairs and Repairing Connector Terminals in SI.

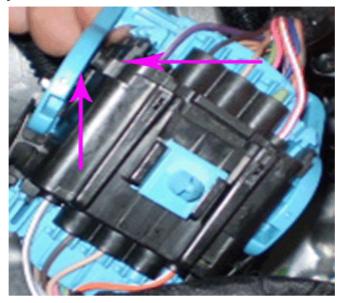
2553066

The assist lever for connector X300 is not fully or properly seated or has backed out or damaged terminals.

Typical View of an Improperly Seated Connector Assist Lever

- 1. Inspect wiring harness connector X300 for the following:
 - 1.1. A connector assist lever that is not fully or properly seated as shown.
 - 1.2. Backed out or damaged connector terminals.
 - 1.3. Poor terminal contact or tension. Refer to Testing for Intermittent Conditions and Poor Connections in SI.
 - ⇒ If any of the above conditions exist, repair as needed. Refer to > Power and Signal Distribution > Wiring Systems and Power Management > Diagnostic Information and Procedures > Wiring Repairs and Repairing Connector Terminals in SI.
- 2. Clear the DTCs with a scan tool.

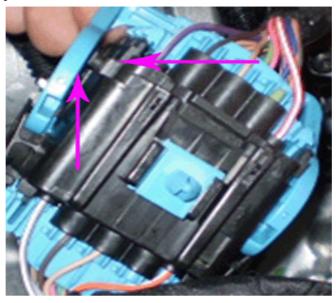
2553066

The assist lever for connector X395 is not fully or properly seated or has backed out or damaged terminals.

Typical View of an Improperly Seated Connector Assist Lever

- 1. Inspect wiring harness connector X395 for the following:
 - 1.1. A connector assist lever that is not fully or properly seated as shown.
 - 1.2. Backed out or damaged connector terminals.
 - 1.3. Poor terminal contact or tension. Refer to Testing for Intermittent Conditions and Poor Connections in SI.
 - ⇒ If any of the above conditions exist, repair as needed. Refer to > Power and Signal Distribution > Wiring Systems and Power Management > Diagnostic Information and Procedures > Wiring Repairs and Repairing Connector Terminals in SI.
- 2. Clear the DTCs with a scan tool.

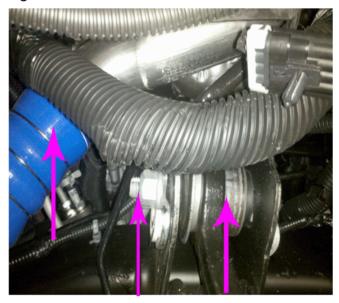
2552582

Chafing of the insulation of the wiring harness that is routed by the left front control arm.

Typical View of Improper Wiring Harness Contact Points in the Control Arm Area

- 1. Inspect the wiring harness insulation for chafing from contact on the left front control arm and from contact on the charge air cooler (CAC) pipe, in the areas as shown by the arrows.
 - ⇒ If chafing of the wiring harness insulation is observed, repair as needed. Refer to > Power and Signal Distribution > Wiring Systems and Power Management > Diagnostic Information and Procedures > Wiring Repairs in SI.
- 2. Clear the DTCs with a scan tool.

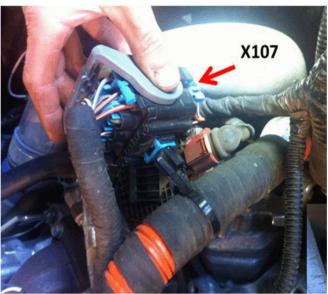
2967329

Chafing of the insulation of the wiring harness immediately adjacent to harness connector X107 on the EGR valve.

Typical View of Wiring Harness Chafing From Contact With the EGR Valve

- 1. Inspect the wiring harness insulation in the area immediately adjacent to wiring harness connector X107 for chafing from contact on the EGR valve as shown.
 - ⇒ If chafing of the wiring harness insulation is observed, repair as needed. Refer to > Power and Signal Distribution > Wiring Systems and Power Management > Diagnostic Information and Procedures > Wiring Repairs in SI.
- 2. Clear the DTCs with a scan tool.
