# **M-TIPS**

**UNIQUE REPAIR INFORMATION FOR  
MAZDA TECHNICIANS**

***JANUARY / FEBRUARY 2014***

## MULTI-MODEL REAR COMBINATION LAMP/FINISHER POOR APPEARANCE

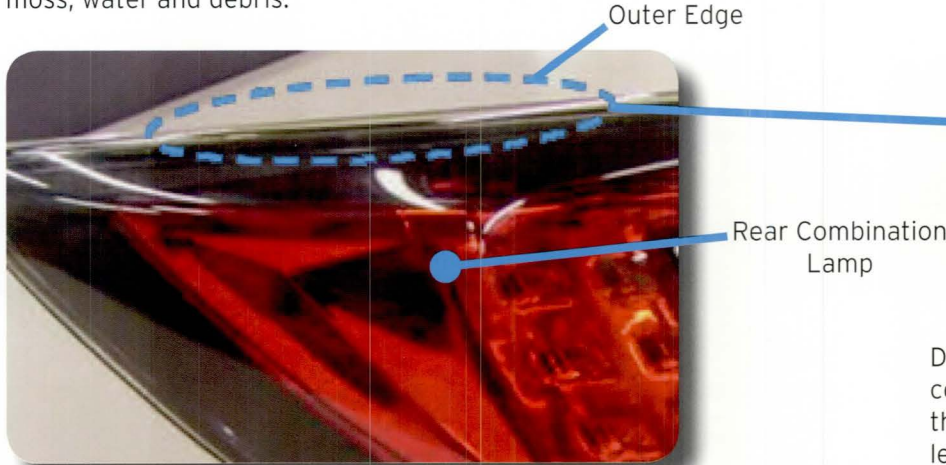
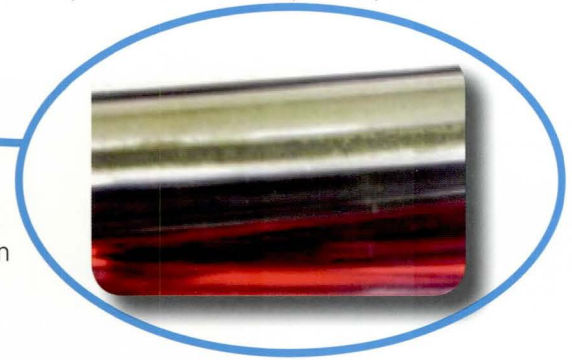
Some customers may complain about the poor appearance of the rear combination lamp and/or finisher. This may be caused by normal environmental conditions, such as dirt, moss, foreign particle adhesion, and/or water to the back side of the outer edge. Part replacement will not correct this concern. Refer below for the procedures to temporarily remove dirt/moss, water and debris.

Dirt/moss can stick to the back side of the combination lamp outer edge (not inside the lamp) and can be seen through the lens, causing poor appearance.

This is a normal condition. Remove dirt/moss using a soft tooth brush soaked in water. Brush out the dirt/moss between the back side of the rear combination lamp and outer edge of the vehicle body.

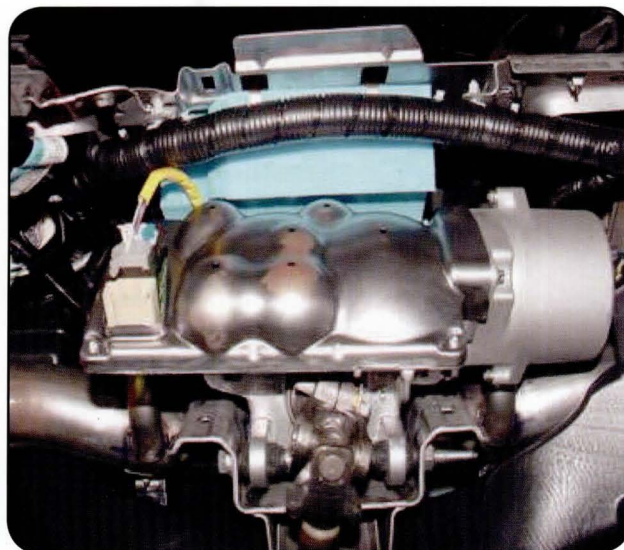
Some vehicles may exhibit a lack of power steering assist with DTC B1342, B2277, and/or B227B.

Clear codes and replace steering column (EPAS unit).

**Note:** It is not necessary to wait for the code to reset before replacing the steering column.

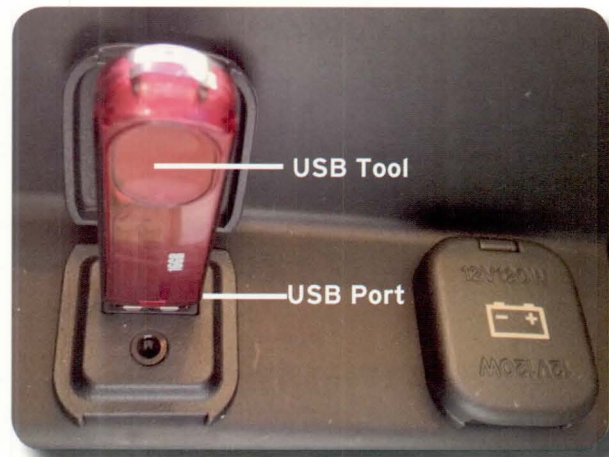
Some customers may complain about their portable USB connected device (e.g., iPod, iPhone, smart phone) being inoperative. This may be caused by a compatibility issue between the vehicle's audio unit and the USB device. Create a test tool to check the vehicle's USB connection.

1. Turn on the vehicle audio system.
2. Connect the USB tool into the vehicle's USB port.

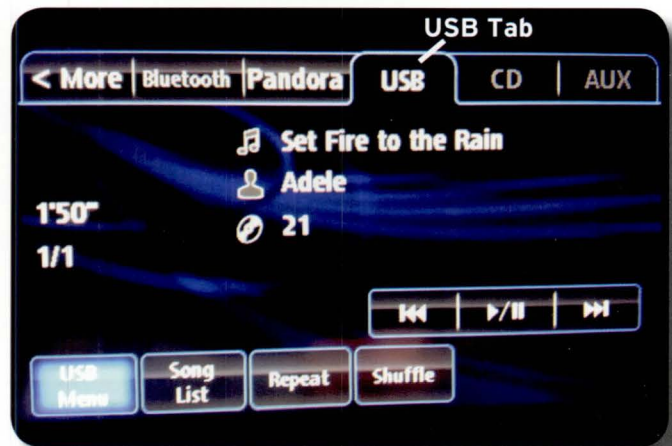
- Audio playback is successful - The connection between the audio unit and the USB port is good. Customer's concern may be caused by a compatibility issue between the vehicle's audio unit and their USB device.
- Audio playback was not successful - Further diagnosis is needed. Refer to MS3 AUXILIARY JACK/USB PORT INSPECTION.
- Save the USB tool in your toolbox for future vehicle testing.

3. The audio USB tab should switch from gray to white text.
4. Select the USB tab.
5. Music should begin to play from the USB flash drive.
