# Service Bulletin

Bulletin No.: PIP3423K

**Subject:** DTC P0016 P0017 P0018 P0019 P0008 P0009

**Models:** 2013-2014 Cadillac ATS XTS  
2004-2014 Cadillac CTS SRX  
2004-2011 Cadillac STS  
2005-2009 Buick Allure (Canada Only)  
2005-2014 Buick Lacrosse  
2008-2014 Buick Enclave  
2007-2014 GMC Acadia  
2010-2014 Chevrolet Camaro  
2008-2014 Chevrolet Equinox  
2012-2014 Chevrolet Impala  
2008-2012 Chevrolet Malibu  
2009-2014 Chevrolet Traverse  
2007-2009 Pontiac G6  
2008-2009 Pontiac G8, Torrent  
2007-2010 Saturn Aura, Outlook  
2008-2010 Saturn Vue  
with 2.8L LP1, 2.8 LAU, 3.0 LF1, LFW 3.6L LY7, LLT, LFX engines

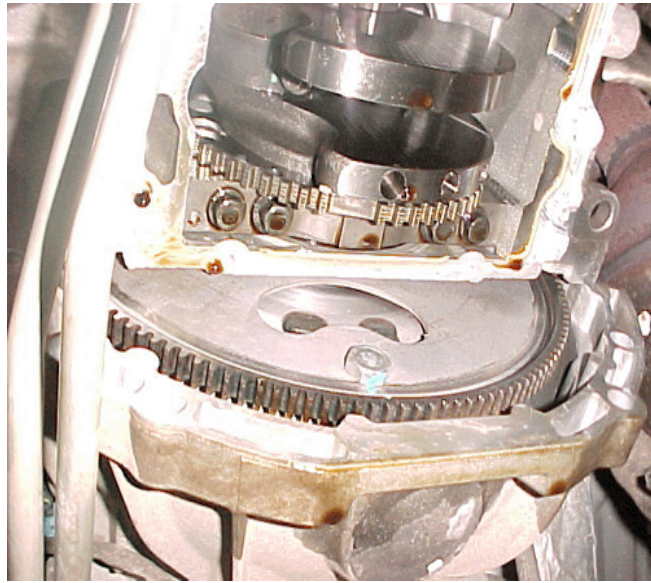
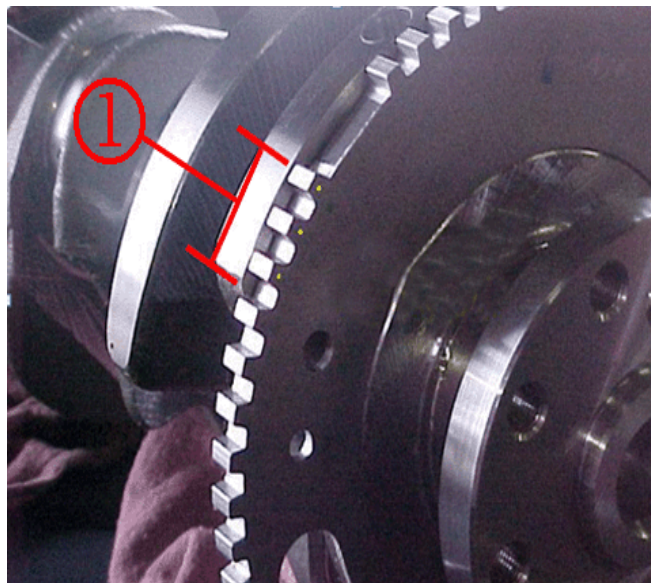
1= The actual measurement of a good Reluctor wheel.

25 to 26 mm This measurement is from the end of the machined surface of the crankshaft throw to the edge of the open space in the reluctor. (approximately 3 1/2 teeth)

If the reluctor has moved then replace crankshaft.

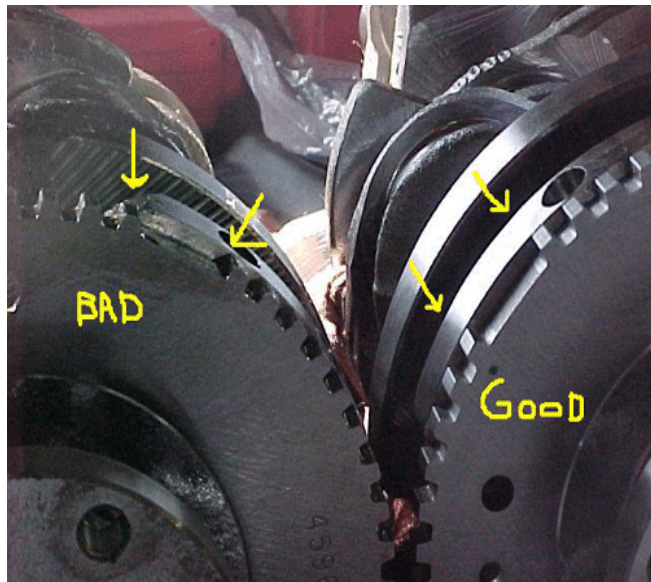
1873654

2 and 3 = Show a good reluctor next to a bad reluctor.

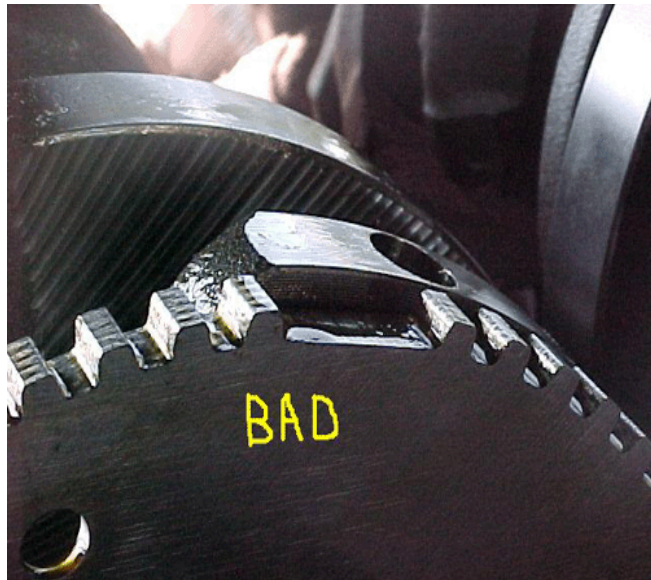
1873655

The reluctor for the crankshaft sensor pressed on the crankshaft may have moved.

Crankshaft with bad reluctor wheel.

**Note:** The distance can be offset either clockwise or counter clockwise. Both will result in these codes.
