UPDATE Technical Bulletin

December 03, 2014

37J2 UPDATE – AQ250 TCM Software (FED_EMS)

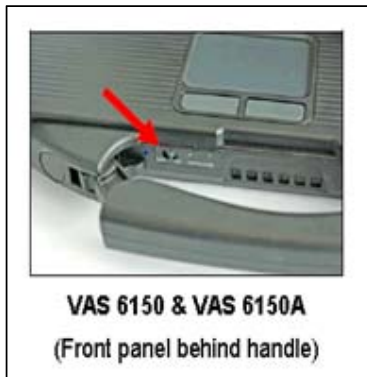
- Connect the tester to the on-line network using an Ethernet cable.
- Connect the VAS 5054A transmitter head to the VAS tester using the USB cable.
- Disable Bluetooth by physically turning the switch to the off position.

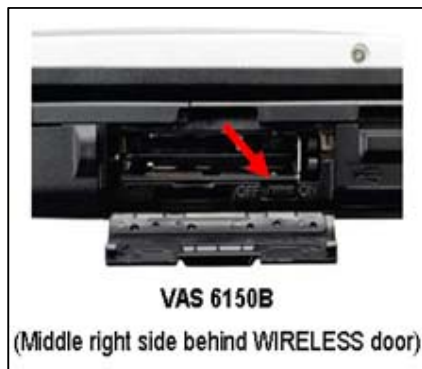
Note: If the Bluetooth wireless VAS 5054A transmitter head is used in conjunction with a VAS tester, the transmitter head **MUST BE** connected with a USB cable to the tester.

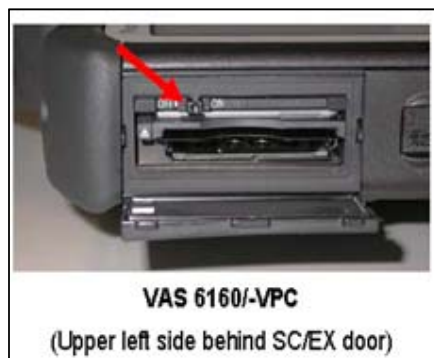
Warning: The Bluetooth function of the scan tool **MUST BE PHYSICALLY SWITCHED OFF** prior to performing this update.
<See pictures>
