Technical Bulletin

01 13 08 March 5, 2013 2030688

MIL ON DTC P0108 Manifold Absolute Pressure Sensor Circuit High Stored in ECM Fault Memory

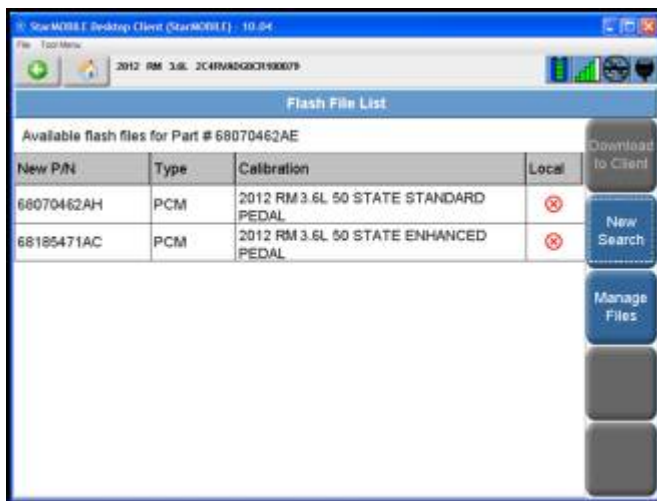
Note:

On some vehicles there are two updates available.

If there are two updates available, as shown on this screen (left), **ONLY** the **68070462AH** software should be selected and installed.

Installing the wrong software update into the PCM will change the driving characteristics of the vehicle and can result in a customer complaint.

Selecting the wrong installation of the software is irreversible and will not be covered under warranty.
