SERVICE BULLETIN

APPLICABILITY: 2013MY Legacy and Outback Models with 2.5L FB Engines
 2011-14MY Forester Models with 2.5L FB Engines
 2012-13MY Impreza and 2013MY XV Crosstrek Models with 2.0L FB Engine

NUMBER: 02-157-14R
DATE: 08/28/14
REVISED: 09/08/14

SUBJECT: Surface Treatment Change To Oil Control Piston Rings

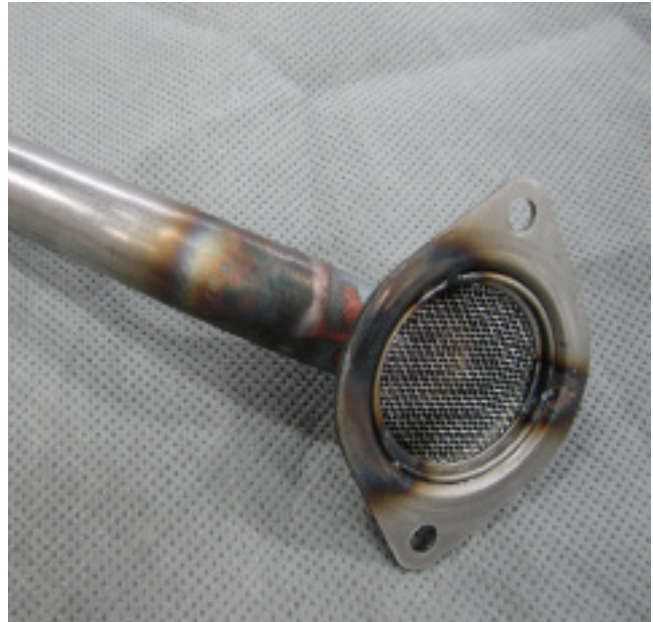
Oil Pick Up Tube/Filter Screen Assembly

- Before installing the upper and lower oil pans, **always thoroughly clean and inspect the pick-up tube and screen.** Always use new o-rings on the pick-up tube and both oil pans during reassembly.
- Once the basic “long block” has been reassembled (valve cover to valve cover), proceed with installation of the timing components as outlined below.

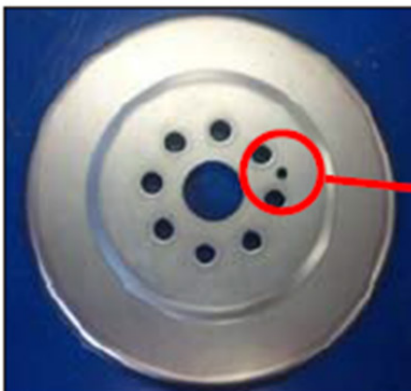
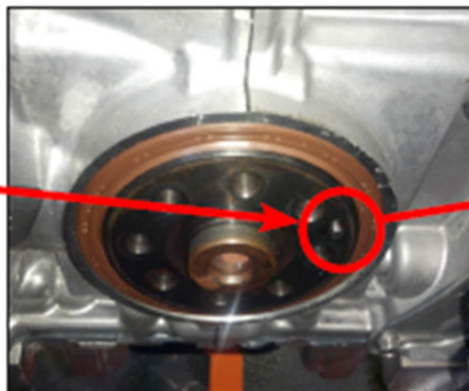
- **REMINDER:** When replacing the short block, in addition to transferring the crankshaft position sensor, be sure to index the reluctor properly onto the crankshaft as shown in the photos below. The reluctor is indexed by a dowel pin in the rear crankshaft flange which aligns with a corresponding hole in the reluctor. It is possible to install the reluctor without indexing it correctly. Failure to index the reluctor correctly will result in a no-start condition due to an out of time crank position signal to the ECM.
