Service Bulletin

Bulletin No.: 13-06-01-003B

Subject: Excessive Oil Consumption – Perform Oil Consumption Test and/or Install Piston and Piston Ring Kit

Models: 2010-2013 Buick LaCrosse
2011-2013 Buick Regal
2010-2013 Chevrolet Equinox
2010-2013 GMC Terrain
Equipped with 2.4L Engine (RPOs LAF, LEA)

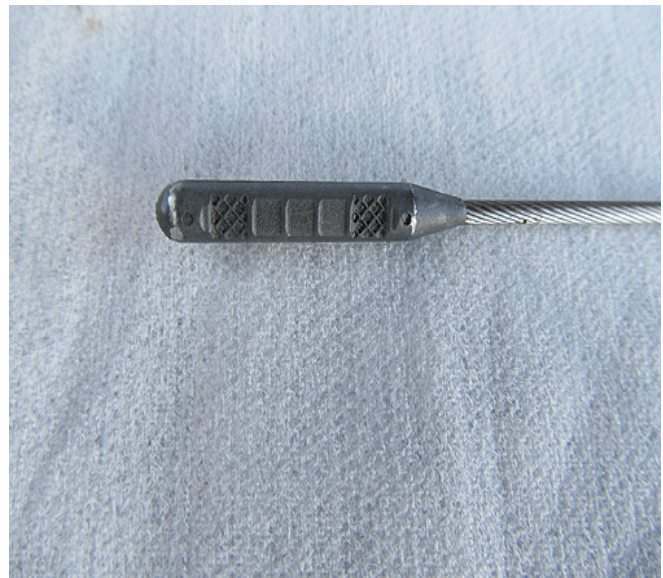
3339530

Important: When checking the oil level with the oil dipstick design shown below, please note that the oil volume per notch is not linear due to the shape of the block. The upper notches (relative to the top of the handle) equal 0.24 quart (0.227 L) between each notch while the lower notches only equal 0.14 quart (0.132 L) between each notch. As a result, no oil will appear on the dipstick if it is low on oil by approximately 1.25 quarts (1.18 L) or more. When determining the oil consumption rate, the oil volume added to return it to the starting location is the total amount of oil consumed. The consumption rate must be documented on a repair order.

Notice: Do not add too much oil. An overfill can lead to burn off of the excess oil. Advise the customer to wait until the oil is below the cross-hatched area at the tip of the dipstick before adding oil.

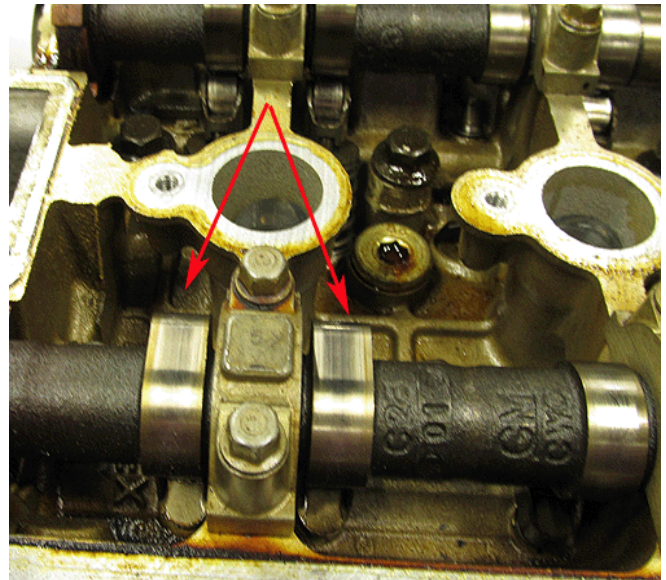
3409678

- Camshafts and roller follower will have wear markings. This is normal and do not need to be replaced (refer to picture above).

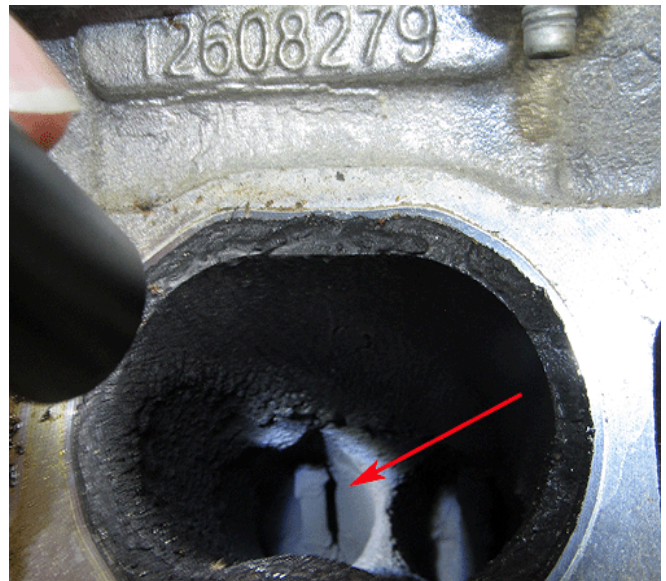
3409680

- Valves stems may have deposits build up on them. These deposits are characteristic of a direct inject engine. The valves stems do not need to be cleaned as they are not affecting engine performance (Refer to picture above).
- The oil pump does not need to be replaced as the low oil level operation did not damage the pump.
- The camshaft actuators do not need to be replaced at this time. The vehicle may have arrived with the engine knocking. If the oil level was 1 1/2 - 2 quarts low, it was the lack of oil causing the actuator noise.
- Rod bearings can be reused if there is not any excessive scoring, some light wear marks are acceptable
