Service Bulletin

Bulletin No.: 13-06-01-003C

Subject: Excessive Oil Consumption – Perform Oil Consumption Test and/or Install Piston and Piston Ring Kit

Models: 2010-2013 Buick LaCrosse
2011-2013 Buick Regal
2010-2013 Chevrolet Equinox
2010-2013 GMC Terrain
Equipped with 2.4L Engine (RPOs LAF, LEA)

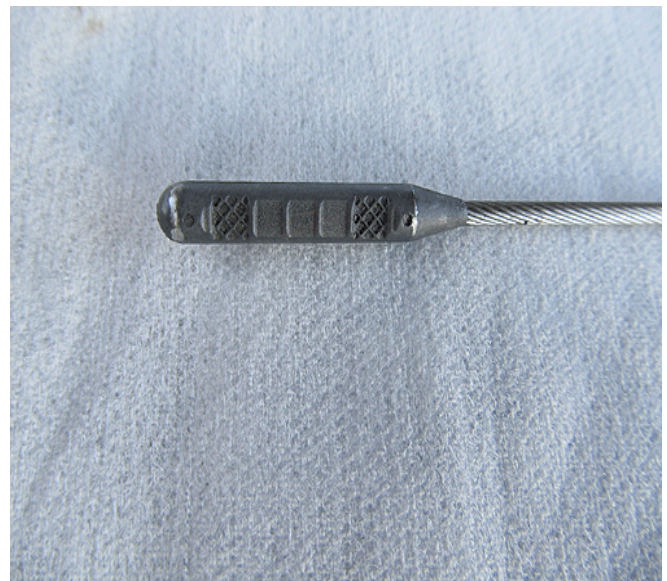
3339530

Important: When checking the oil level with the oil dipstick design shown below, please note that the oil volume per notch is not linear due to the shape of the block. The upper notches (relative to the top of the handle) equal 0.24 quart (0.227 L) between each notch while the lower notches only equal 0.14 quart (0.132 L) between each notch. As a result, no oil will appear on the dipstick if it is low on oil by approximately 1.25 quarts (1.18 L) or more. When determining the oil consumption rate, the oil volume added to return it to the starting location is the total amount of oil consumed. The consumption rate must be documented on a repair order.

Notice: Do not add too much oil. An overfill can lead to burn off of the excess oil. Advise the customer to wait until the oil is below the cross-hatched area at the tip of the dipstick before adding oil.

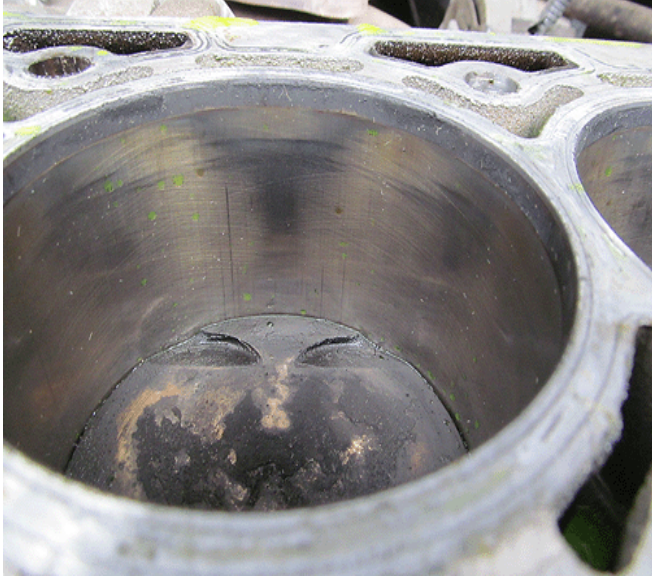
3339531

The repair is to replace the pistons and rings. In some cases the bore surface may not have a uniform look to the finish (zebra stripes) as shown below. As a result, some technicians may question whether the engine should be repaired or replaced. After careful evaluation, GM Powertrain has determined that the new pistons and rings will perform correctly in bores that have this appearance so engine replacement should not be necessary. The cylinder bores do not need any machine or honing work performed on them. Refer to the picture below for acceptable surface finishes.

Acceptable Cylinder that Does Not Appear Uniform (Zebra Stripes)

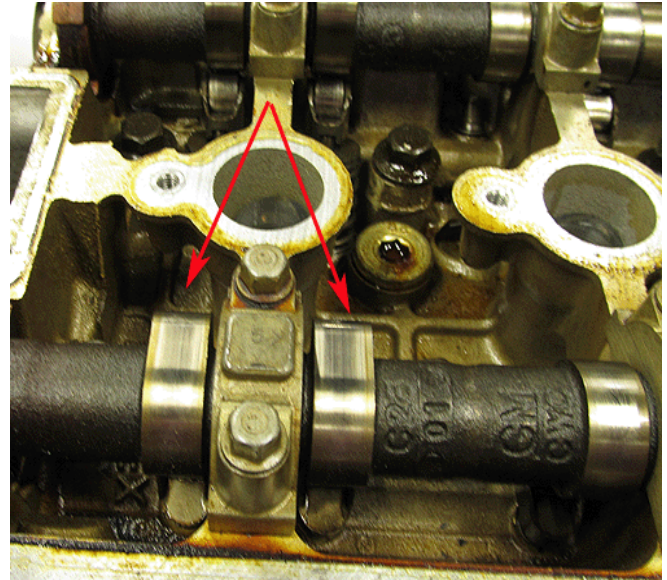
3409678

- Camshafts and roller follower will have wear markings. This is normal and do not need to be replaced (refer to picture above).

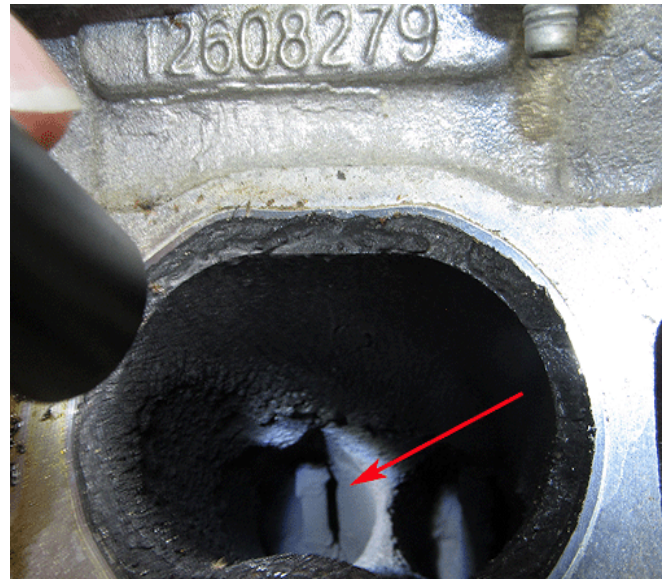
3409680

- Valves stems may have deposits build up on them. These deposits are characteristic of a direct inject engine. The valves stems do not need to be cleaned as they are not affecting engine performance (Refer to picture above).
- The oil pump does not need to be replaced as the low oil level operation did not damage the pump.
