Service Bulletin

Bulletin No.: 13-06-01-003D

Subject: Excessive Oil Consumption – Perform Oil Consumption Test and/or Install Piston and Piston Ring Kit

Models: 2010-2013 Buick LaCrosse
2011-2013 Buick Regal
2010-2013 Chevrolet Equinox
2012-2013 Chevrolet Orlando (Canada Only)
2010-2013 GMC Terrain
Equipped with 2.4L Engine (RPOs LAF, LEA)

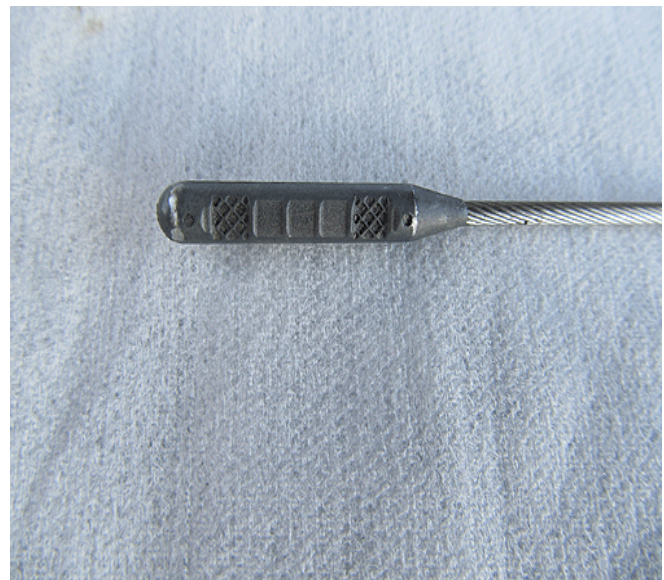
3339530

Important: When checking the oil level with the oil dipstick design shown below, please note that the oil volume per notch is not linear due to the shape of the block. The upper notches (relative to the top of the handle) equal 0.24 quart (0.227 L) between each notch while the lower notches only equal 0.14 quart (0.132 L) between each notch. As a result, no oil will appear on the dipstick if it is low on oil by approximately 1.25 quarts (1.18 L) or more. When determining the oil consumption rate, the oil volume added to return it to the starting location is the total amount of oil consumed. The consumption rate must be documented on a repair order.

Notice: Do not add too much oil. An overfill can lead to burn off of the excess oil. Advise the customer to wait until the oil is below the cross-hatched area at the tip of the dipstick before adding oil.

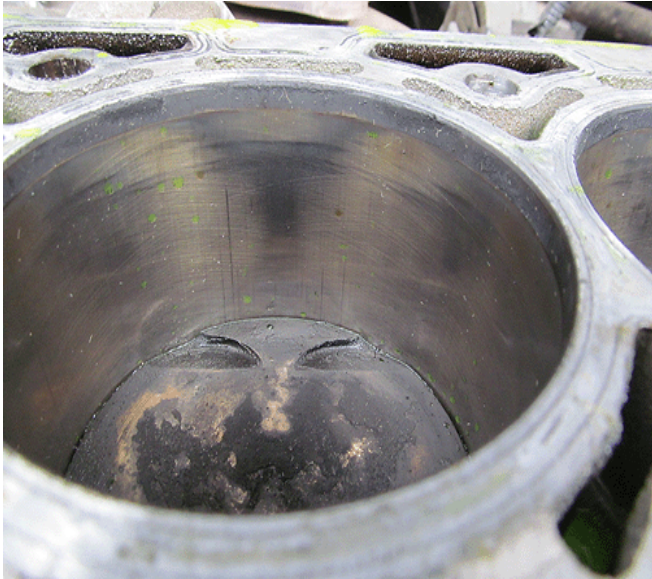
3339531

The repair is to replace the pistons and rings. In some cases the bore surface may not have a uniform look to the finish (zebra stripes) as shown below. As a result, some technicians may question whether the engine should be repaired or replaced. After careful evaluation, GM Powertrain has determined that the new pistons and rings will perform correctly in bores that have this appearance so engine replacement should not be

necessary. The cylinder bores do not need any machine or honing work performed on them. Refer to the picture below for acceptable surface finishes.

Acceptable Cylinder that Does Not Appear Uniform (Zebra Stripes)

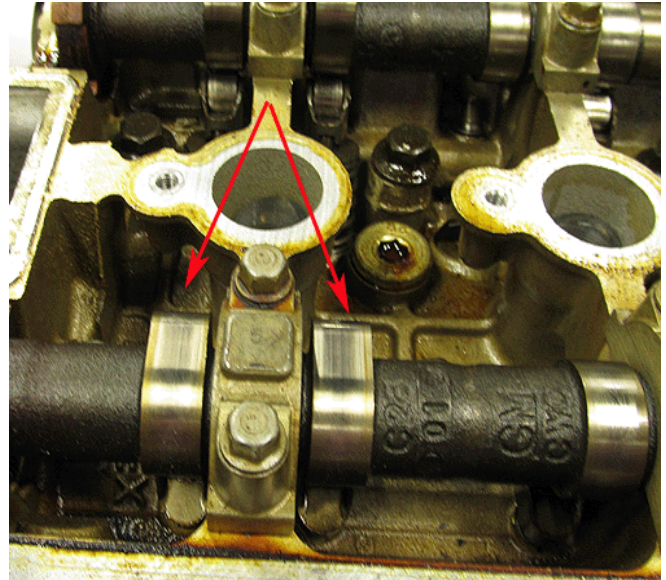
3409678

- Camshafts and roller follower will have wear markings. This is normal and do not need to be replaced (refer to picture above).

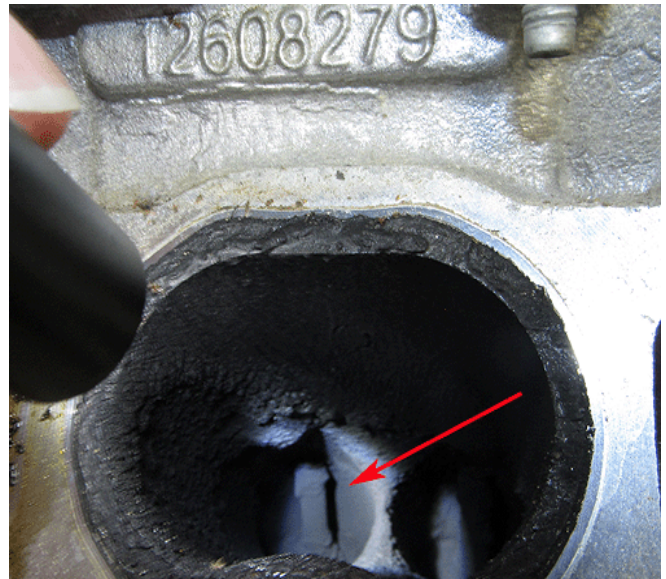
3409680

- Valves stems may have deposits build up on them. These deposits are characteristic of a direct inject engine. The valves stems do not need to be cleaned as they are not affecting engine performance (Refer to picture above).
- The oil pump does not need to be replaced as the low oil level operation did not damage the pump.
