Service Bulletin

Bulletin No.: 13-06-01-003

Subject: Excessive Oil Consumption – Perform Oil Consumption Test and/or Install Piston and Piston Ring Kit

Models: 2010-2013 Buick LaCrosse
2011-2013 Buick Regal
2010-2013 Chevrolet Equinox
2010-2013 GMC Terrain
Equipped with 2.4L Engine (RPOs LAF, LEA)

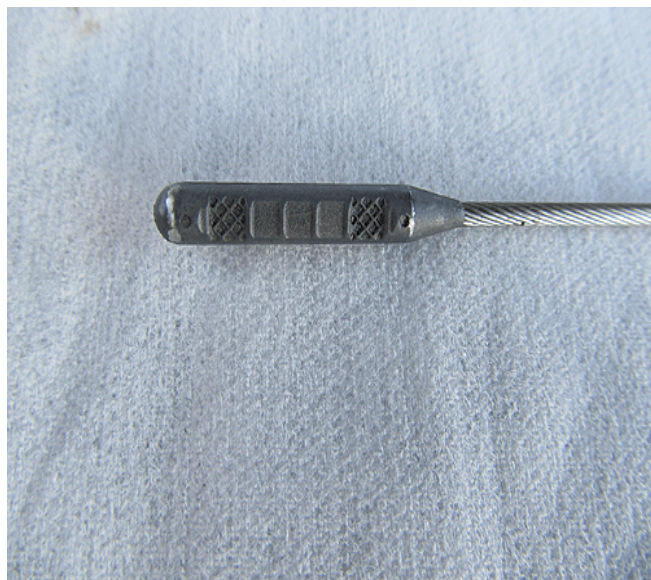
3339530

Important: When checking the oil level with the oil dipstick design shown below, please note that the oil volume per notch is not linear due to the shape of the block. The upper notches (relative to the top of the handle) equal 0.24 quart (0.227 L) between each notch while the lower notches only equal 0.14 quart (0.132 L) between each notch. As a result, no oil will appear on the dipstick if it is low on oil by approximately 1.25 quarts (1.18 L) or more. When determining the oil consumption rate, the oil volume added to return it to the starting location is the total amount of oil consumed. The consumption rate must be documented on a repair order.

Notice: Do not add too much oil. An overfill can lead to burn off of the excess oil. Advise the customer to wait until the oil is below the cross-hatched area at the tip of the dipstick before adding oil.

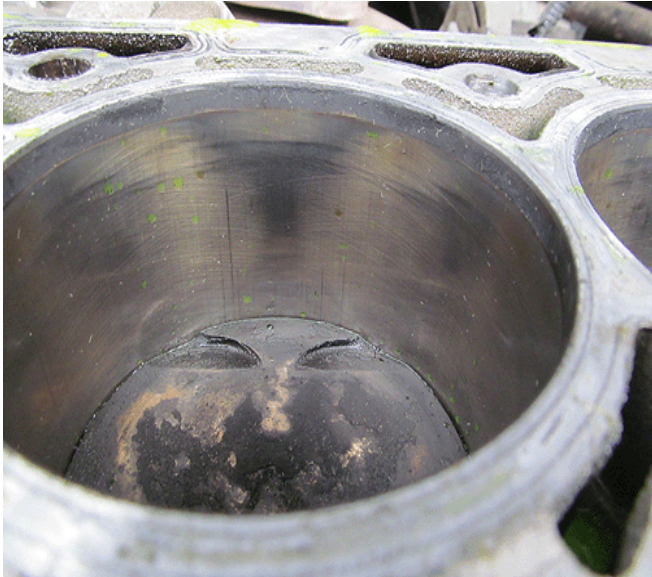
3339531

The repair is to replace the pistons and rings. In some cases the bore surface may not have a uniform look to the finish (zebra stripes) as shown below. As a result, some technicians may question whether the engine should be repaired or replaced. After careful evaluation, GM Powertrain has determined that the new pistons and rings will perform correctly in bores that have this appearance so engine replacement should not be

necessary. The cylinder bores do not need any machine or honing work performed on them. Refer to the picture below for acceptable surface finishes.

Acceptable Cylinder that Does Not Appear Uniform (Zebra Stripes)

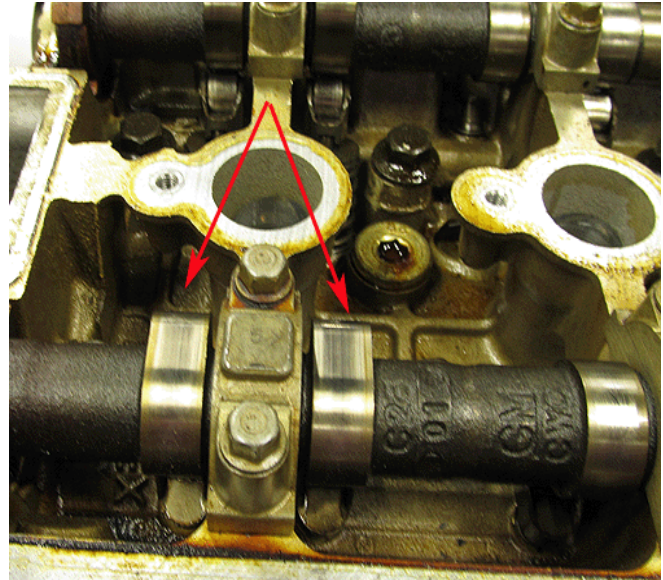
3409678

- Camshafts and roller follower will have wear markings. This is normal and do not need to be replaced (refer to picture above).

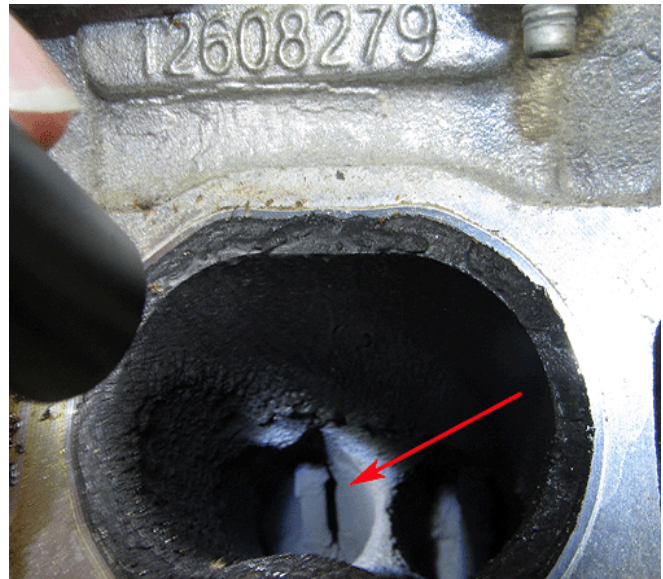
3409680

- Valves stems may have deposits build up on them. These deposits are characteristic of a direct inject engine. The valves stems do not need to be cleaned as they are not affecting engine performance (Refer to picture above).
- The oil pump does not need to be replaced as the low oil level operation did not damage the pump.
- The camshaft actuators do not need to be replaced at this time. The vehicle may have arrived with the engine knocking. If the oil level was 1 1/2 - 2 quarts low, it was the lack of oil causing the actuator noise.
