Service Bulletin

Bulletin No.: 13-08-116-001

Subject: Aftermarket ALDL or DLC Interface Devices Causing Multiple Issues

Models: 2006-2013 GM Passenger Cars and Trucks

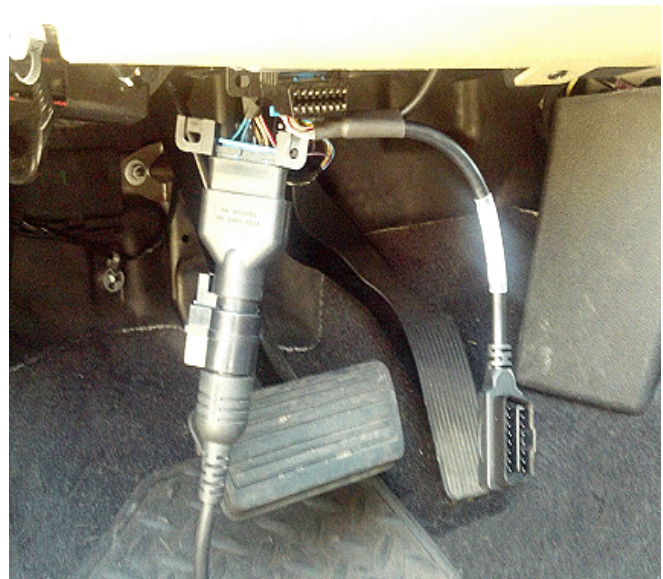
Device W/Secondary DLC Connector

This device has another DLC connector on it. The rest of the harness along with the device can be placed out of sight hidden from the technician, who may not notice the diagnostic connector is not in the factory location.

If the device is available, attempt to duplicate the condition, then remove the device to determine if the condition is eliminated. If confirmed, inform the customer of the issue and that they need to work with the supplier of the device for further resolution.
