Service Bulletin

Bulletin No.: 13-08-116-001A

Subject: Aftermarket ALDL or DLC Interface Devices Causing Multiple Issues

Models: 2006-2014 GM Passenger Cars and Trucks

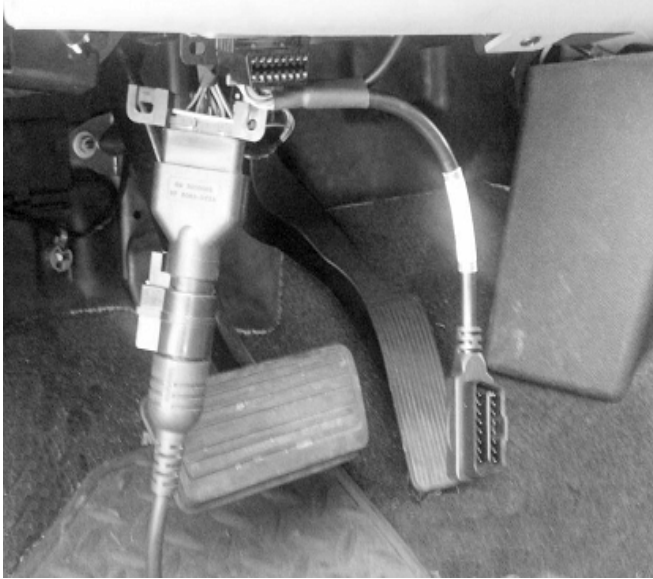
Device W/Secondary DLC Connector

This device has another DLC connector on it. The rest of the harness along with the device can be placed out of sight hidden from the technician, who may not notice the diagnostic connector is not in the factory location.
