Service Bulletin

SPECIAL COVERAGE

SUBJECT: Special Coverage Adjustment – Throttle Position Sensor Replacement

MODELS: 2008-2011 Cadillac Escalade, Escalade ESV, Escalade EXT
2008-2009 Chevrolet TrailBlazer
2008-2011 Chevrolet Avalanche, Express, Silverado, Suburban, Tahoe
2009-2011 Chevrolet Colorado
2008-2009 GMC Envoy
2008-2011 GMC Savana, Sierra, Yukon, Yukon XL
2009-2011 GMC Canyon
2008-2009 HUMMER H2
2008-2010 HUMMER H3
2009-2010 HUMMER H3T
Equipped with V8 Engine (LFA, LY2, L20, LMG, LC9, LH6, LMF, LH8, LH9, L76, LS2, LY5, LY6, L92, L96, LZ1, L94, L9H)

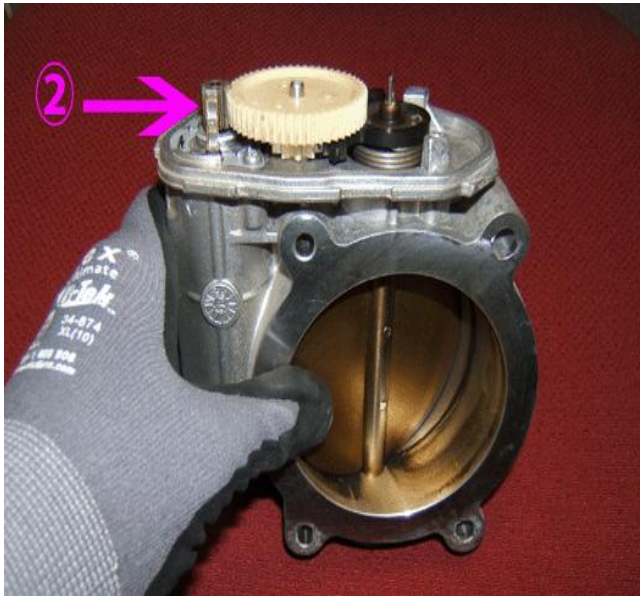
2698017

Note: If one or both of the TP sensor cover female throttle actuator motor terminals HAVE BEEN retained on the throttle actuator motor male terminals (2), remove and discard those female terminals.

14. Observe the TP sensor cover for missing female throttle actuator motor terminals (1). Verify that the female throttle actuator motor terminals HAVE REMAINED in the TP sensor cover and HAVE NOT been retained on the throttle actuator motor male terminals (2). Discard the old TP sensor cover, gasket and terminals.
15. Remove the new TP sensor cover from the protective shipping wrapper.

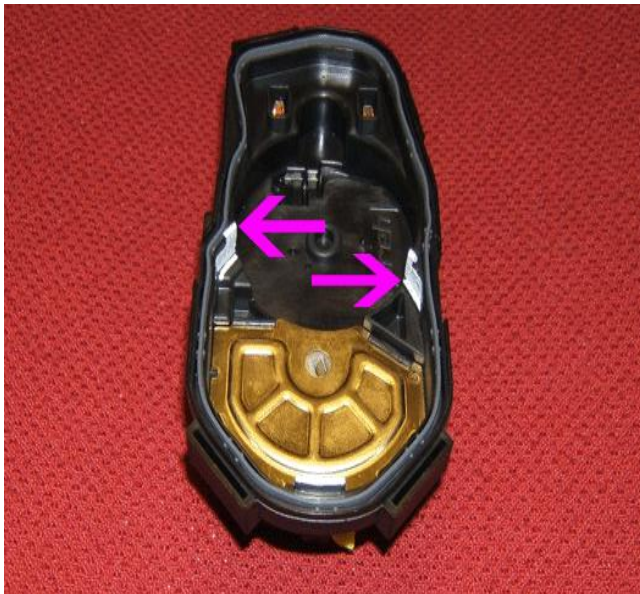
2699007

Note: The three TP sensor cover alignment tabs are highlighted in white for identification purposes only.

18. Verify that all three of the TP sensor cover alignment tabs are present and are not damaged.
19. Grasp and hold the throttle body in the previously hand held upward position. Lightly depress the intermediate gear to verify that it is fully seated and the gears are engaged.
