Recall Bulletin

PRODUCT SAFETY RECALL

SUBJECT: Shift Lever Indicator May Not Display Correct Gear

MODELS: 2008-2010 Chevrolet Malibu
2008-2010 Pontiac G6
2007-2010 Saturn AURA
Equipped with 4-Speed Automatic Transmission (ME7/MN5)

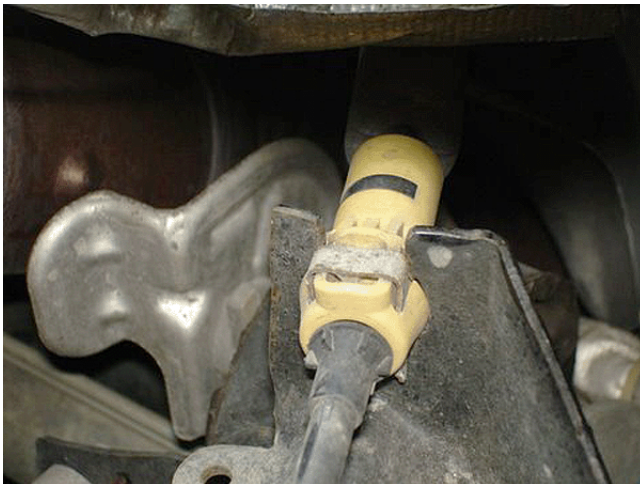
3256032

Note: Perform the service repair procedure in this bulletin on second design transmission shift cables only. First design transmission shift cables do NOT require a repair. Refer to the illustration to view a first design shift cable. Refer to *Transmission Shift Cable Kit Installation Procedure* in this bulletin to view the second design transmission shift cable.

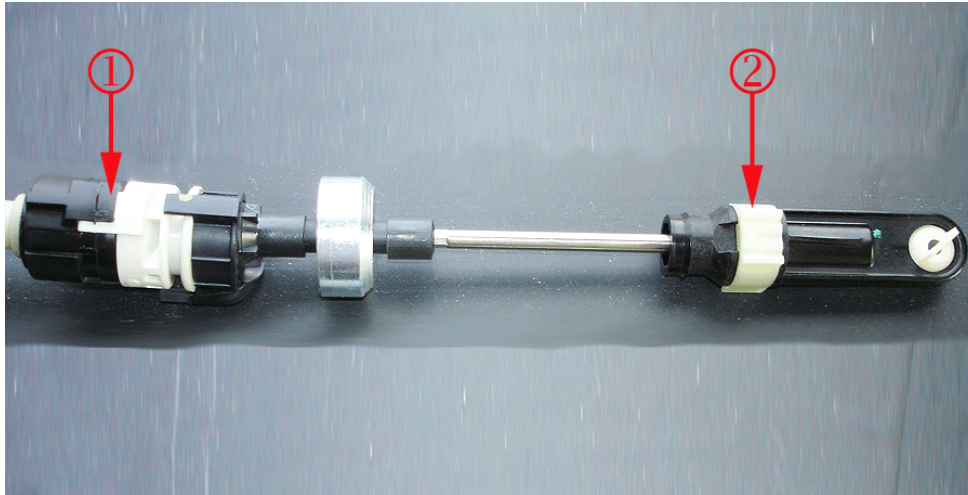
2269489

- (1) Shift Cable Locking Tabs
 (2) Shift Cable Adjuster Locking Clip

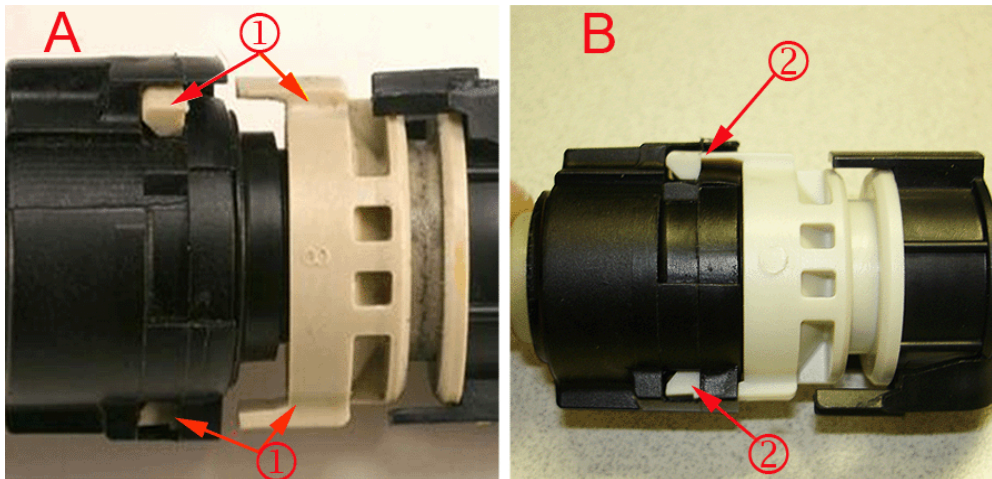
2269486

1. Open the hood and locate the transmission shift cable.
2. Determine if the transmission shift cable locking tabs are fractured and separated.

- If the transmission shift cable locking tabs (1) are fractured and separated (A), remove the transmission shift cable and replace it with a new one. Refer to *Floor Shift Control Cable Replacement* or *Range Selector Lever Cable Replacement* in SI. **Also install a transmission shift cable kit with the new shift cable.**
- If the transmission shift-cable locking tabs (2) are NOT fractured and separated (B), install the transmission shift cable kit. Proceed to Step 3.

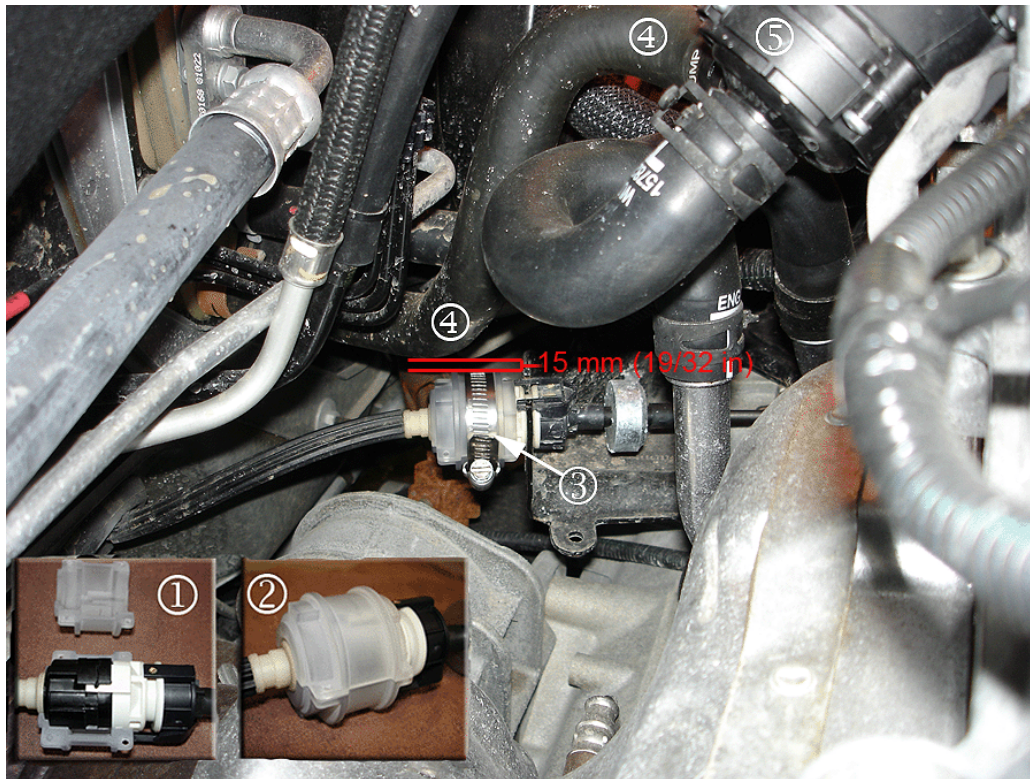
2269484

- (1) Clam Shell in Two Pieces
- (2) Clam Shell Around Shift Cable Locking Tabs
- (3) Clamp on Clam Shell
- (4) Inlet Coolant Hose and
- (5) Heater Cooler Pump.

3. Install the clam shell (1) (2) over the shifter cable locking tabs.
4. Install the service clamp over the clam shell (3). Position the clamp fastener head away from the inlet coolant hose (4). **Tighten the clamp to 4 N·m (35 lb-in).**
5. Ensure that there is 15 mm (19/32 in) of clearance between the inlet coolant hose (4) and the clam shell (3). On hybrid equipped vehicles, it may be necessary to reposition the inlet coolant hose (4) to achieve the required 15 mm (19/32 in) of clearance. **To reposition the inlet coolant hose (4) on hybrid equipped vehicles, locate the heater cooler pump (5) and perform Steps 5.1-5.4.**

Caution: Do not kink or damage the inlet coolant hose (4) when repositioning the hose to obtain the 15 mm (19/32 in) clearance. To avoid damaging the hose clamp, use J-38185 or equivalent hose clamp pliers to loosen the hose clamp.

- 5.1. Using J-38185 or equivalent hose clamp pliers, loosen the inlet coolant hose (4) connected to the heater cooler pump (5). Note the location of the clamp on the inlet coolant hose (4).
- 5.2. Rotate the inlet coolant hose (4) clockwise until 15 mm (19/32 in) of clearance between the inlet coolant hose (4) and clam shell (3) is achieved.
- 5.3. Ensure that the inlet coolant hose clamp is secure on the inlet coolant hose (4) in the production location.

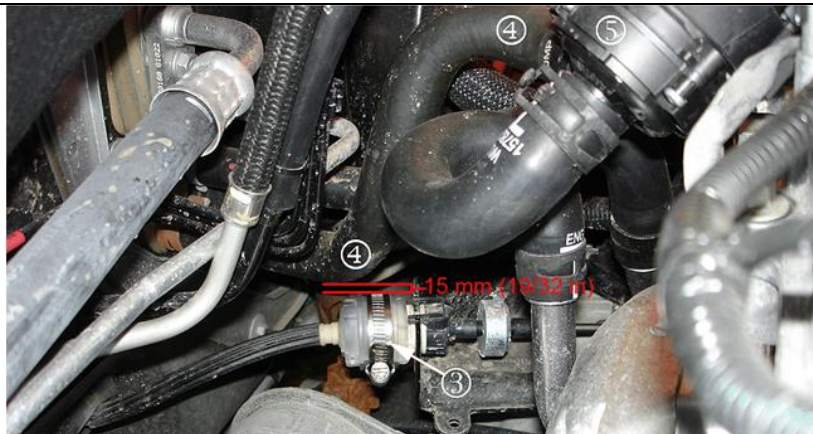
- (1) Clam Shell in Two Pieces
- (2) Clam Shell Around Shift Cable Locking Tabs
- (3) Clamp on Clam Shell
- (4) Inlet Coolant Hose and
- (5) Heater Cooler Pump.

This bulletin requires the use of a reinforcement kit on some transmission shift cables. The affected cables are “second design” cables, as defined in the bulletin. These cables were sold prior to February 8, 2013 and may have been sold without the reinforcement kit.
