Service Bulletin

Bulletin No.: PI0746E

Date: April, 2014

Subject: Malfunction Indicator Lamp (MIL) On, Poor Acceleration, Throttle Body Freezing, Multiple DTCs Set, Ice Deposits and/or Oil Deposits Present in Air inlet Duct

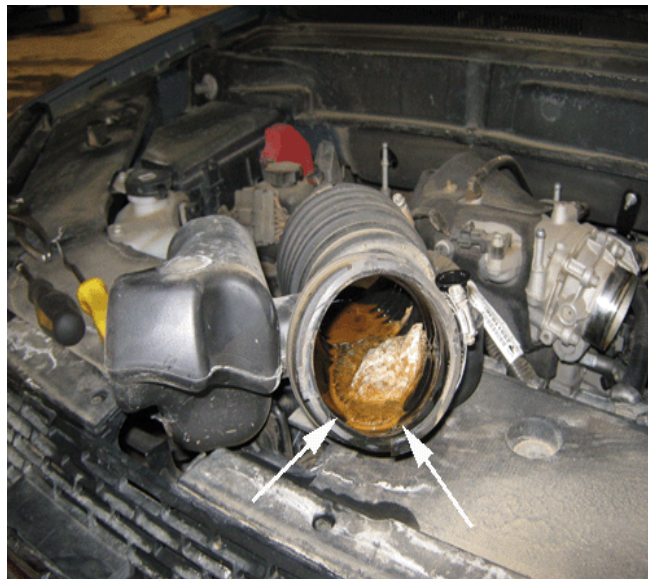
2837688

Technicians may find DTCs P0101, P0171, P0172, P0174, P0175, P1516, P2177, P2178, P2179, P2180, P2187, P2188, P2189 and/or P2190 along with either ice or oil deposits in the air inlet duct.

Ice formation is caused by condensation freezing at the base of the throttle body with additional collection of ice formation deposits in the air inlet duct. Freezing condensation forms after the vehicle has been driven and then parked in low ambient temperatures.

Oil deposits are the collection of the engine vapors, fuel dilution and oil mist at the base of the throttle body with additional formation collecting in the duct.
