Service Bulletin

Bulletin No.: PI0896A

Subject: Broken or Separated Auxiliary Floor Mat Retainers, Floor Mat Retainer Won't Seat on Carpet

Models: 2010-2014 Buick LaCrosse
2011-2014 Buick Regal
2012-2014 Buick Verano
2008-2014 Cadillac CTS All Models including V-Series
2010-2014 Cadillac SRX
2013-2014 Cadillac ATS, XTS
2014 Cadillac ELR
2011-2014 Chevrolet Cruze, Equinox, Volt
2012-2014 Chevrolet Sonic
2013-2014 Chevrolet Malibu
2011-2014 GMC Terrain

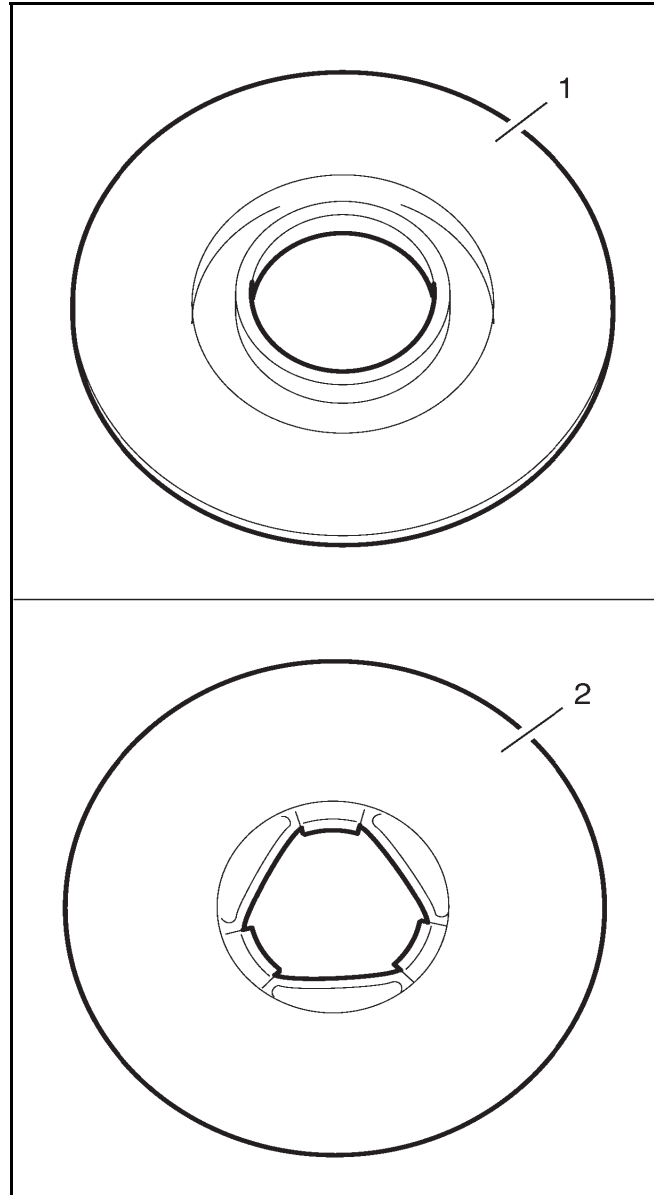
2652399

There are two different suppliers of auxiliary floor mat retainers for these vehicles, Saxonía and ITW, and the mat retainers and carpet retainers are NOT interchangeable between the two suppliers. Additionally, the ITW style have a first (V1.x) and second (V2.0) design. Look at the backside of the retainer on the auxiliary mat. If the center of the lower section is round, the retainer was made by Saxonía (1). If the center of the lower section has a triangle, the retainer was made by ITW (2). Furthermore, ITW V2.0 retainers can be identified by a "V2.0" embossed on the back side of the floor mat retainer.
