Recall Bulletin

PRODUCT SAFETY RECALL

SUBJECT: Supplemental Restraint System (SRS) Electronic Control Module (ECM)

MODELS: 2003-2004 Pontiac Vibe

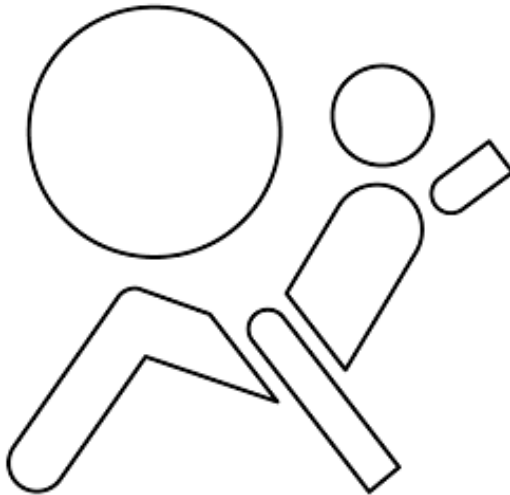
33527671

- **After the 6 second illumination of the warning indicator, if the indicator goes off then back on or remains on, check for DTCs.**
- **Consult with the customer to determine if they would like to diagnose/repair any remaining concerns.**

- a) Confirm that the warning indicator illuminates when the ignition is switched on.
- b) Confirm that the warning light will go off after about 6 seconds have elapsed after IG on.
