PRODUCT SAFETY RECALL

SUBJECT: Supplemental Restraint System (SRS) Electronic Control Module (ECM)

MODELS: 2003-2004 Pontiac Vibe

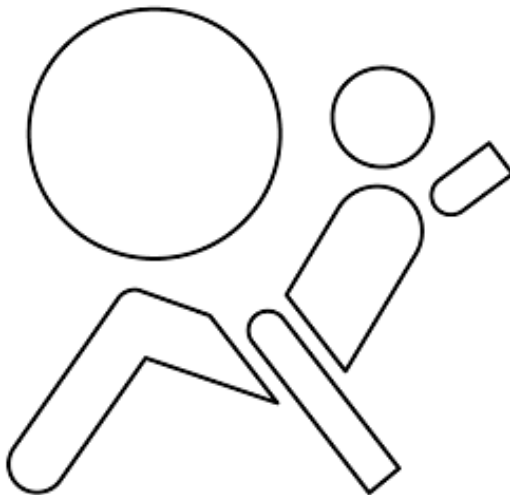
3352671

- b) After the ignition has been on for approximately 6 seconds check the behavior of the warning indicator.

Condition #1: Light Remains On, **OR** Light Blinking, **OR** Light Does Not Come On.

Condition #2: Light Goes Off.

Corrective Action: Replace the Sensing and Diagnostic Module (SDM) and install the sub harness. Proceed to **STEP 2. CHECK FOR DTCs**.

Corrective Action: Install the sub harness. Proceed to **STEP 2. CHECK FOR DTCs**

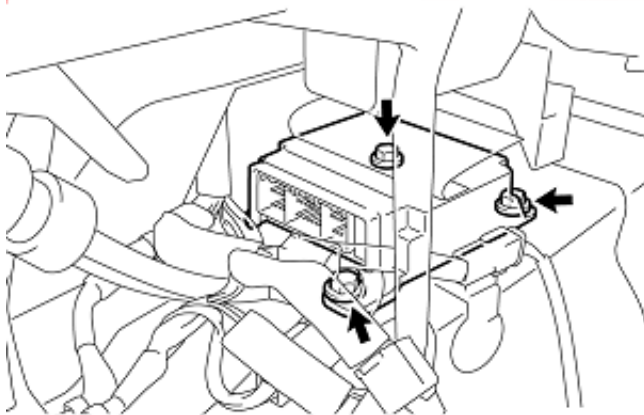
(Required IF Vehicle Exhibited Condition #1 Above)

- Remove the 3 bolts and the SDM.
- Install a NEW SDM, then continue to STEP 12.

TIGHTEN to 13ft. lb (17.5 N·m)

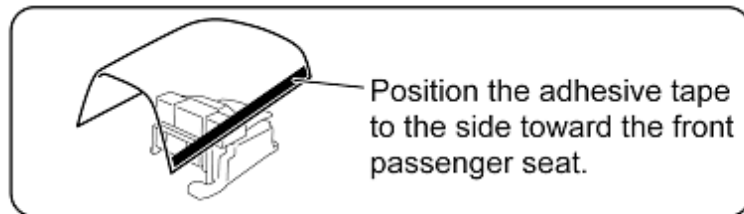
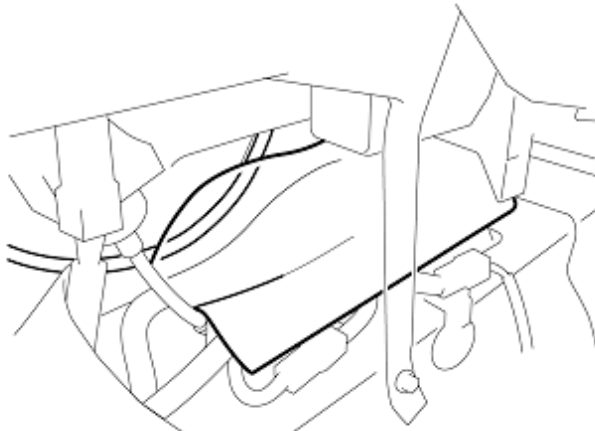
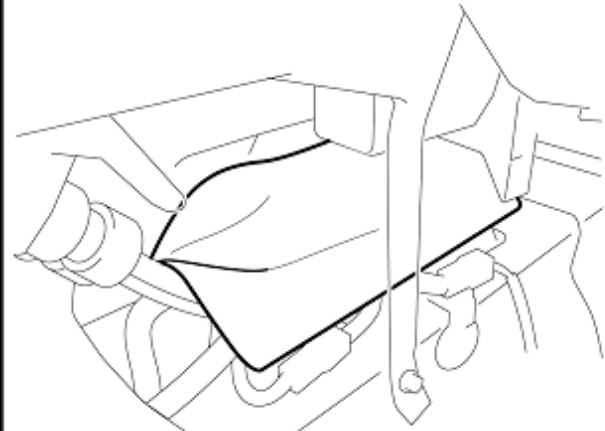
3352700

- **The water guard sheet is critical to prevent water from the air conditioner from dripping on the SDM, confirm it is positioned and adhered correctly.**

- a) Position the water guard sheet over the SDM and sub harness.
