BOSCH MASTER CYLINDER SAFETY RECALL

Bulletin No: 13082

SUBJECT: Recall of Master Cylinders (used with Hydro-Max® Booster)

**MODELS: 2003-2009 Chevrolet Kodiak and GMC TopKick C4/C5 Series
Serviced with a Suspect Master Cylinder**

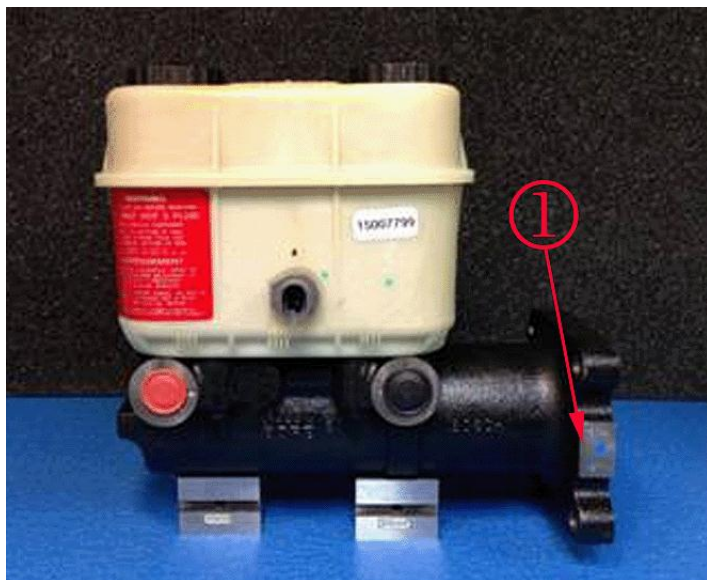
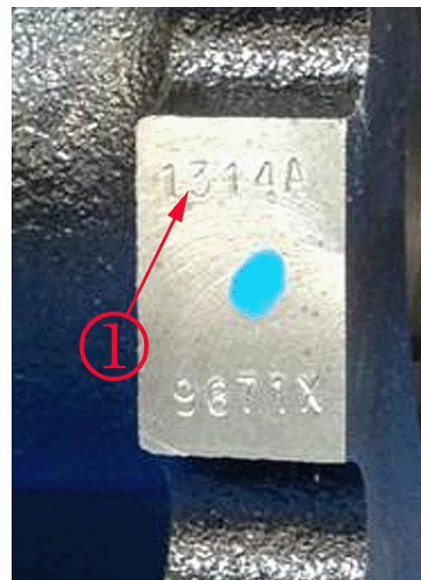
3405417

1. Locate the master cylinder manufacturing date code (1). The manufacturing date code (1) is marked on the upper left side of the master cylinder mounting flange. Refer to the photograph.

Note: For purposes of identification, the letter that follows the four numbers is ignored.

- If the manufacturing date code (1) is 1182 through 2103, replace the brake fluid level switch. Proceed to the next step.
- If the manufacturing date code (1) is less than 1182 or greater than 2103, no further action is required.

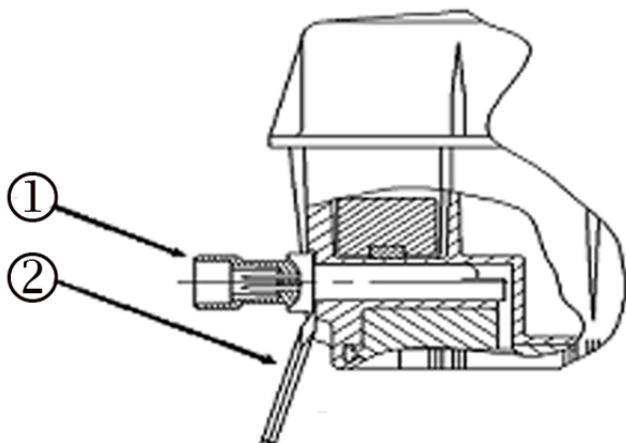
3415395

Sectioned view of reservoir. (1) Fluid Level Indicator Switch (2) Flat Blade Screwdriver

2. Remove the brake fluid level switch from the master cylinder reservoir. Using a flat #2 screwdriver, position the screwdriver tip between the switch face and the reservoir body as shown. Rotate the screwdriver blade tip until the switch breaks free; remove the switch.
3. Install the new brown color brake fluid level switch into the master cylinder reservoir until the tabs click.
4. Install the connector onto the new brake fluid level switch.
