Service Bulletin

Bulletin No.: PI0040C

Subject: Poor Fit/Gap at Interface of Side Door Trim Panel and Lower Door and/or Rattle Noise Upon Opening/Closing Door

Models: 2007-2013 Cadillac Escalade Models
2007-2013 Chevrolet Avalanche, Silverado, Suburban, Tahoe
2007-2013 GMC Sierra, Sierra Denali, Yukon Models

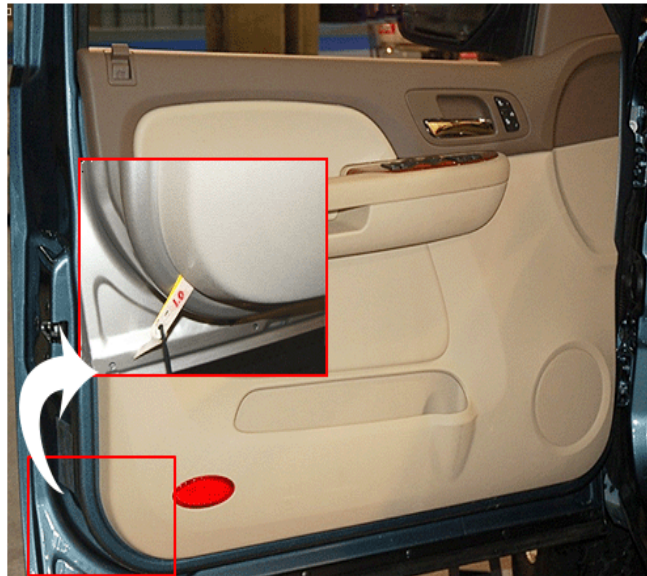
2395421

Note: The gap is generally 1-2 mm (0.04-0.08 in) as shown by the gauges in the above graphic.

Some customers may comment on seeing a poor fit/gap of the side door lower trim panel to the lower door inner structure. This condition could also be associated with a rattle noise upon opening or closing the side door.

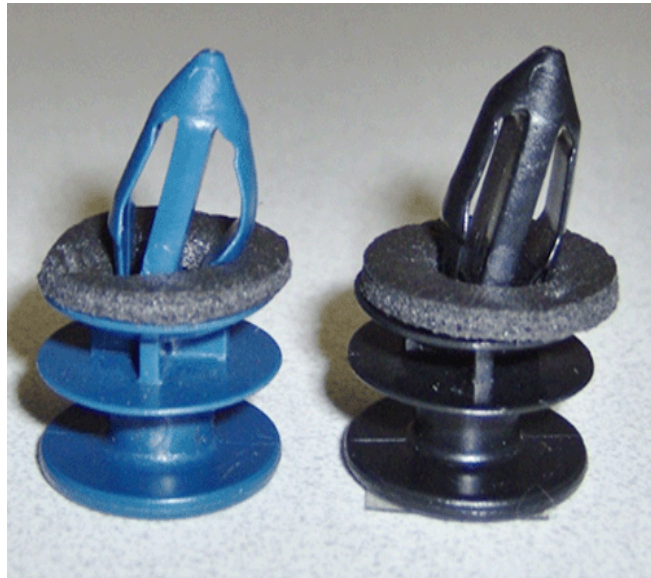
2395422

The cause of this condition is most commonly found to be the rear and lower door trim panel retainers, which have been damaged or not properly engaged during installation or R&R of the door trim panel.

Do This	Don't Do This
Replace the door trim panel lower retainers.	Do not replace the door trim panel assembly.

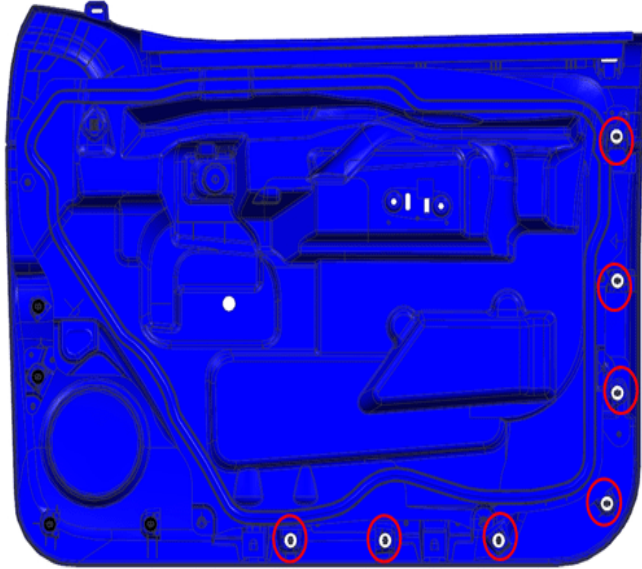
3351925

2. Inspect the rear and lower door trim retainers (circled in the graphic above) for damage or improper engagement.

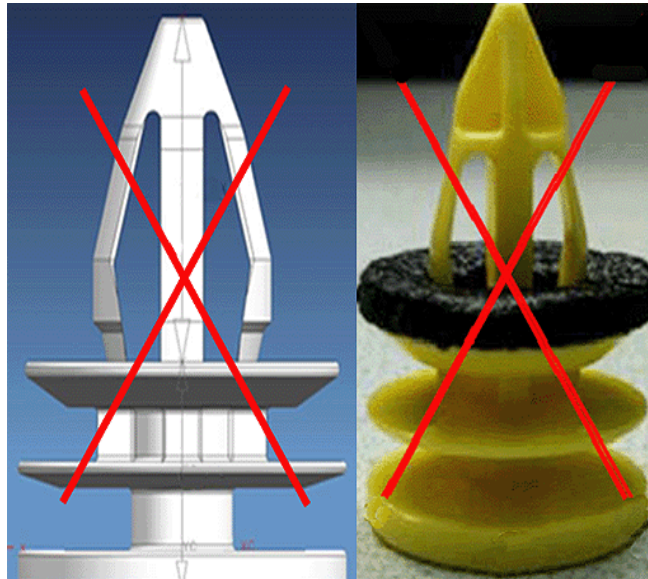
3351927

3. Also inspect these locations for any white first design (1) retainers or yellow (2) retainers. These retainers should not be used and should be replaced with the white, second design retainer, referenced previously.

Important: When replacing any retainer in the locations noted in the following steps, only use the second design white retainer, GM P/N 11611339, which has a more robust tip.
