Technical Bulletin

51 14 01 July 25, 2014 2037787

Rattle, Tick or Squeak from the Instrument Panel Area

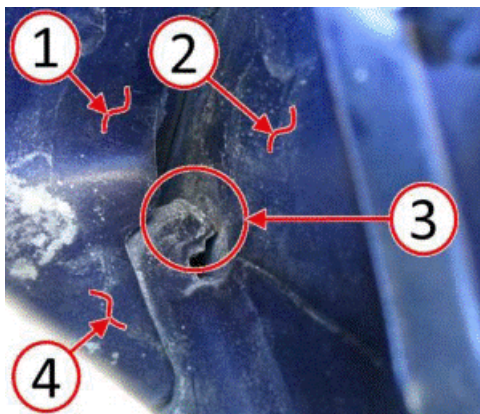
Fig. 2 Close Up Of Contact Area Under The Cowl Panel Cover

A sheet metal contact or touch condition under the cowl panel cover in either right or left corner of the plenum below the hood hinge may cause the rattle, tick, or squeak noise.

- With a flashlight, look for a touch condition (metal to metal contact) of a sheet metal tab (3) contacting the body inner panel (2) at the outboard ends (rear corners) of the plenum (1, 4). The contact area will be under the hood hinge on the side of the vehicle where the noise was most noticeable (Fig. 2).
