Technical Bulletin

Model(s)	Year	Eng. Code	Trans. Code	VIN Range From	VIN Range To
Passat	2001-2005	All	All	All	All

55 14 06 December 12, 2014 2038996

Corrosion on Rear Lid around License Plate Light / Release Handle Assembly

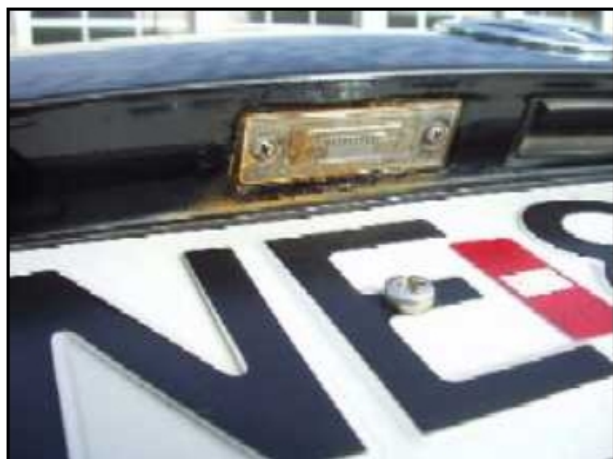
Figure 1 – Corrosion around License Plate Light

Rear lid - edge corrosion in the cut-out sections for the license plate light / handle assembly.

Water ingress through the seal of the license plate light.

1. Replace the rear lid.

2. Repair the rear lid. Only perform this operation if the total repair cost is 80% or less of the total replacement cost.

If the license plate light / handle assembly area in the rear lid exhibits through-corrosion (perforation), DO NOT repair, install a new rear lid.

Before the repair, check the license plate light / handle assembly area in the rear lid. If the license plate light / handle assembly area exhibits through-corrosion (perforation), DO NOT repair, install a new rear lid.

- Remove all necessary parts / trim parts from the rear lid. See Repair Group 70 and Repair Group 55 in Elsa.
- Remove the rear lid. See Repair Group 55 in Elsa.
- Remove the corrosion with a pneumatic brush grinder. Make sure that the edges of the rear lid do not get damaged.

- Apply a VOC compliant epoxy primer as an anti-corrosion treatment and primer (locally sourced).
- Re-paint the rear lid according to the Volkswagen guidelines.
- Install the rear lid. See Repair Group 55 in Elsa.
- Replace the lock cylinder carrier (license plate light / release handle assembly). See Repair Group 55 in Elsa.
- Install all remaining parts / trim pieces previously removed. See Repair Group 70 and Repair Group 55 in Elsa.
- Adjust the rear lid fit according to the repair manual. See Repair Group 55 in Elsa.

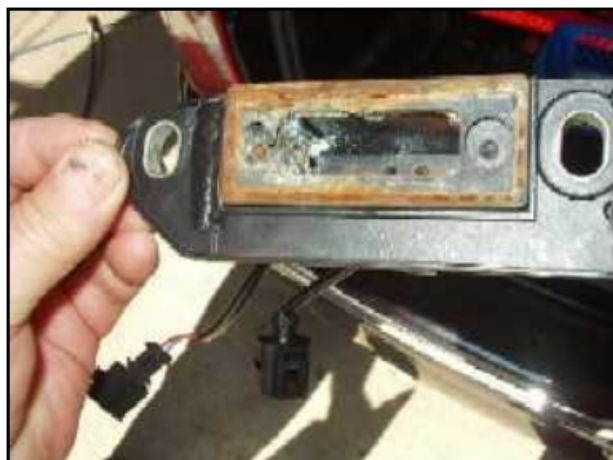
Figure 2 – Corrosion around License Plate Light

Rear lid – corrosion in the contact area (inside and outside) of the license plate light / handle assembly.
