Technical Bulletin

Model(s)	Year	Eng. Code	Trans. Code	VIN Range From	VIN Range To
Passat	1998-2001	All	All	All	All
Passat Wagon	1998-2001	All	All	All	All

55 14 10 December 16, 2014 2038999

Corrosion Around Handle On Rear Lid

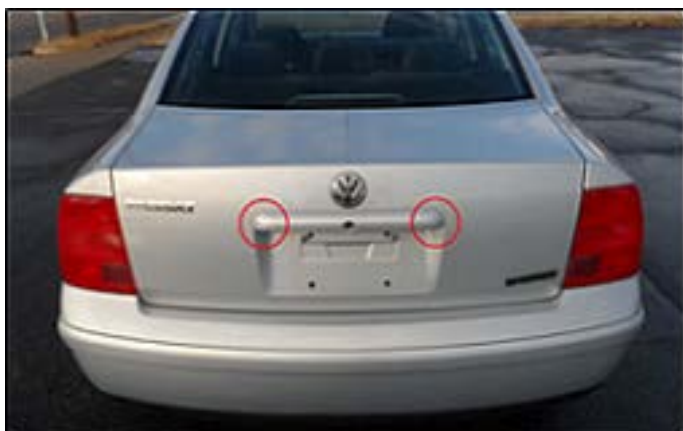
Figure 1 (rear lid handle)

Corrosion where handle contacts rear lid (Figure 1).

Paint abrasion from sharp edge on the contact area on the handle.

- Install the rear window in the new rear lid. See Repair Group 64 in Elsa (Wagon Only).
- Trim protective foil (part number: AKL 448 030 05), or similar clear vinyl tape (locally sourced), to fit in the left and right handle contact surface areas (Figure 1). Attach to rear lid before installing the handle.

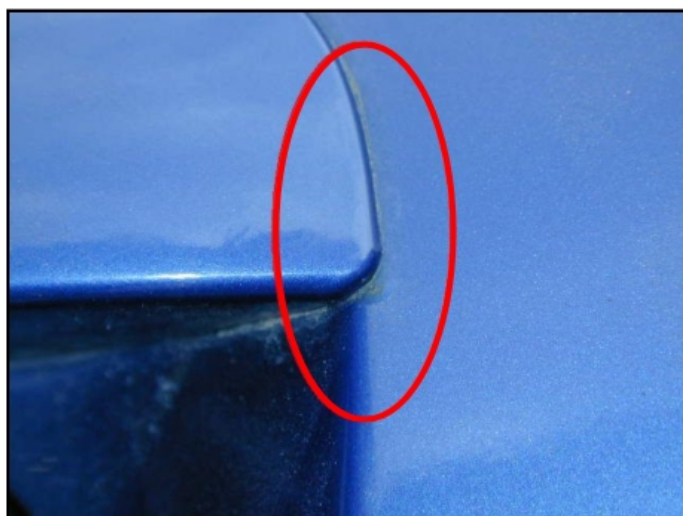
Figure 2 (corrosion on right side of the rear lid / handle)

Corrosion on the contact area of the left and right sides of the rear lid / handle (Figure 2).

- Remove all necessary parts / trim pieces from the rear lid. See Repair Group 70 and Repair Group 55 in Elsa.
- Remove the rear lid. See Repair Group 55 in Elsa.
- Remove the corrosion with a pneumatic brush grinder. Make sure that the rear lid does not get damaged.

- Apply a VOC compliant epoxy primer as an anti-corrosion treatment and primer (locally sourced).
- Re-paint the rear lid according to Volkswagen guidelines.
- Install the rear lid. See Repair Group 55 in Elsa.
- Trim protective foil (part number: AKL 448 030 05), or similar clear vinyl tape (locally sourced), to fit in the left and right handle contact surface areas (Figure 1). Attach to rear lid before installing the handle.
- Install all remaining parts / trim pieces previously removed. See Repair Group 70 and Repair Group 55 in Elsa.
- Adjust the rear lid fit according to the repair manual. See Repair Group 55 in Elsa.
