Technical Bulletin

55 14 12 December 19, 2014 2038996 Supersedes Technical Bulletin V551406 dated December 12, 2014 to update attachments.

Corrosion on Rear Lid around License Plate Light / Release Handle Assembly

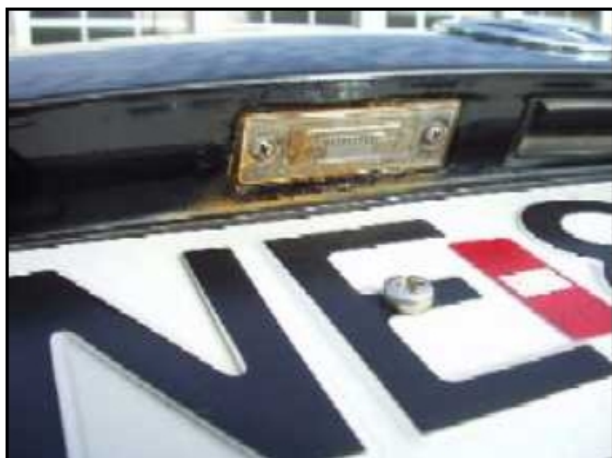
Figure 1 – Corrosion around License Plate Light

Corrosion on the rear lid in the cut-out sections for the license plate light / handle assembly (Figures 1 and 2).

Rear lid - edge corrosion in the cut-out sections for the license plate light / handle assembly.

Water ingress through the seal of the license plate light.

1. Replace the rear lid.

2. Repair the rear lid. Only perform this operation if the total repair cost is 80% or less of the total replacement cost.

If the license plate light / handle assembly area in the rear lid exhibits through-corrosion (perforation), DO NOT repair, install a new rear lid.

Before the repair, check the license plate light / handle assembly area in the rear lid. If the license plate light / handle assembly area exhibits through-corrosion (perforation), DO NOT repair, install a new rear lid.

- Remove all necessary parts / trim parts from the rear lid. See Repair Group 70 and Repair Group 55 in Elsa.
- Remove the rear lid. See Repair Group 55 in Elsa.
- Remove the corrosion with a pneumatic brush grinder. Make sure that the edges of the rear lid do not get damaged.

- Apply a VOC compliant epoxy primer as an anti-corrosion treatment and primer (locally sourced).
- Re-paint the rear lid according to the Volkswagen guidelines.

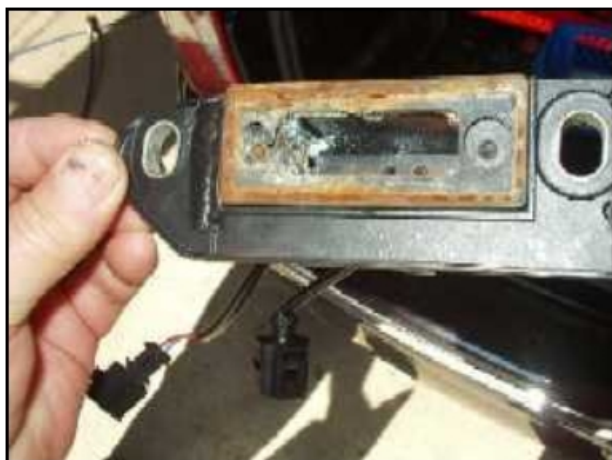
Figure 2 – Corrosion around License Plate Light

Rear lid – corrosion in the contact area (inside and outside) of the license plate light / handle assembly.
