Technical Bulletin

Model(s)	Year	Eng. Code	Trans. Code	VIN Range From	VIN Range To
Phaeton	2004 –2006	All	All	All	All

57 14 07 December 18, 2014 2039003

Corrosion on Front Doors (Multiple Locations)

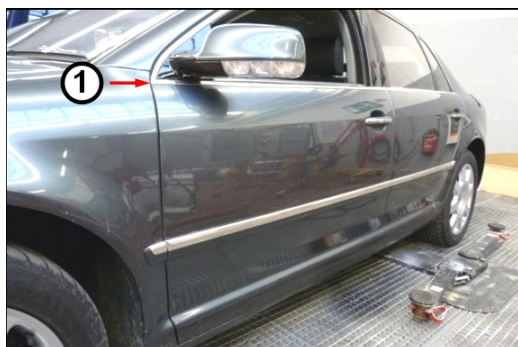
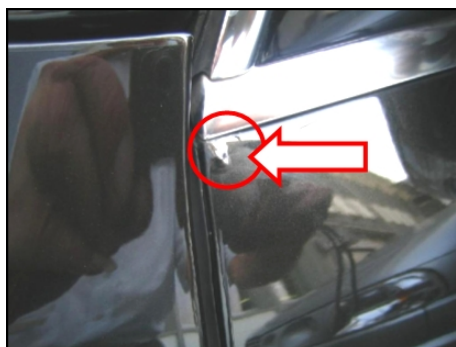
Figure 1 – Upper window channel strip

Figure 1.1

Alignments in production can lead to hairline cracks in the top coat and paint damage (edges on holes) on the already painted door. Humidity then penetrates paint and causes blistering and/or white corrosion.

- Inspect the inner edge area of the doors for cracks, particularly the fine seam sealing.
- Completely remove the corrosion in the damaged area.
- Apply a VOC compliant epoxy primer as an anti-corrosion treatment and primer to both sides of the door (locally sourced).
- Seal the edges/metal sheathings with adhesive (part number: AKD 476 KD505) before painting.
- Repaint door according to Volkswagen guidelines

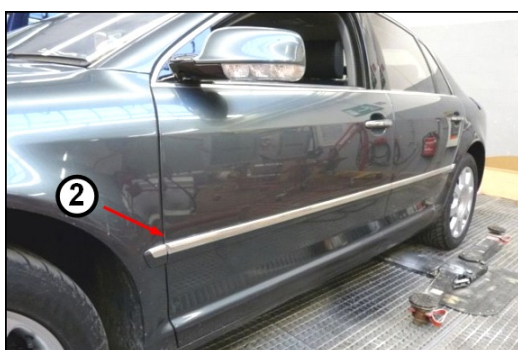
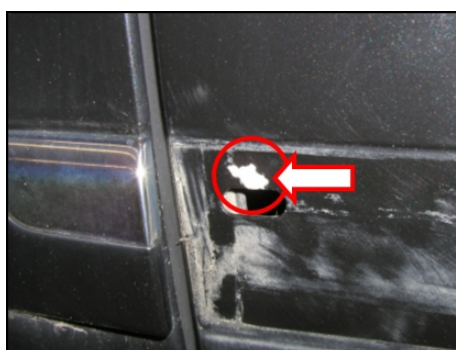
Figure 2 – Central protective strip

Figure 2.1

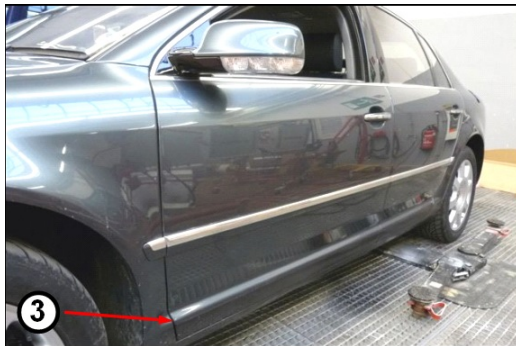
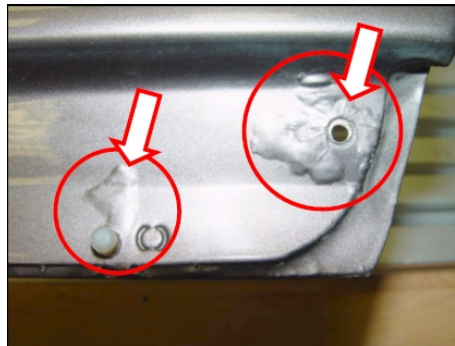
Figure 3 – Lower protective strip

Figure 3.1

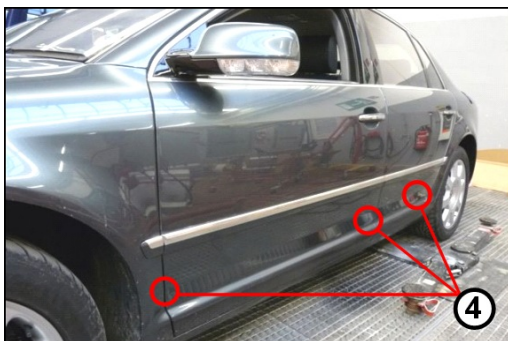
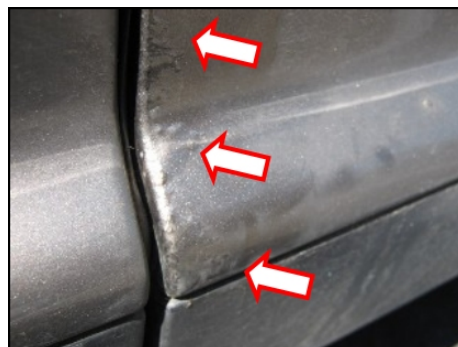
Figure 4 – Surface/edge corrosion

Figure 4.1

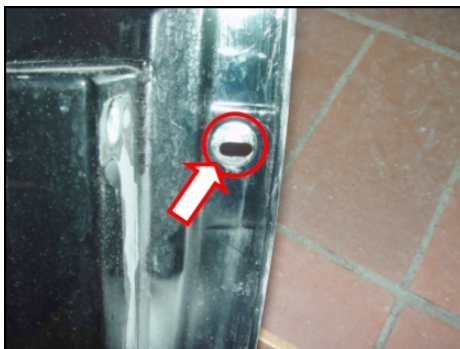
Figure 5

Inner door area (Figure 5 and 6).

Holes and edges in the flange area.
