# Service Bulletin

Bulletin No.: PI0235E

**Subject:** Exhaust Leak or Vibration/Rattle Noise at Approximately 900 RPM, Fuel Smell, White Smoke, Oily Substance on Exhaust Downpipe

**Models:** 2011-2013 Chevrolet Express 2500/3500/4500, Silverado 2500HD/3500HD  
2011-2013 GMC Savana 2500/3500/4500, Sierra 2500HD/3500HD  
Equipped with 6.6L Duramax™ Diesel Engine (RPOs LML or LGH)

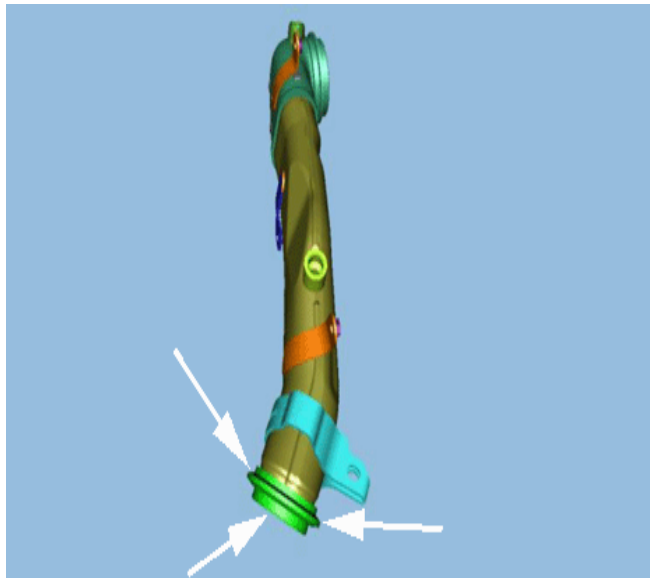
2749618

**Note:** The illustration above is the updated turbocharger exhaust pipe with a pilot flange.

If the above alignment procedure does not correct the condition, the turbocharger exhaust pipe may need to be replaced on trucks built prior to the breakpoints listed below with an updated turbocharger exhaust pipe with a pilot flange. If the turbocharger exhaust pipe has the new flange, you should not need to replace it. Refer to the Turbocharger Exhaust Pipe Replacement procedure in SI.

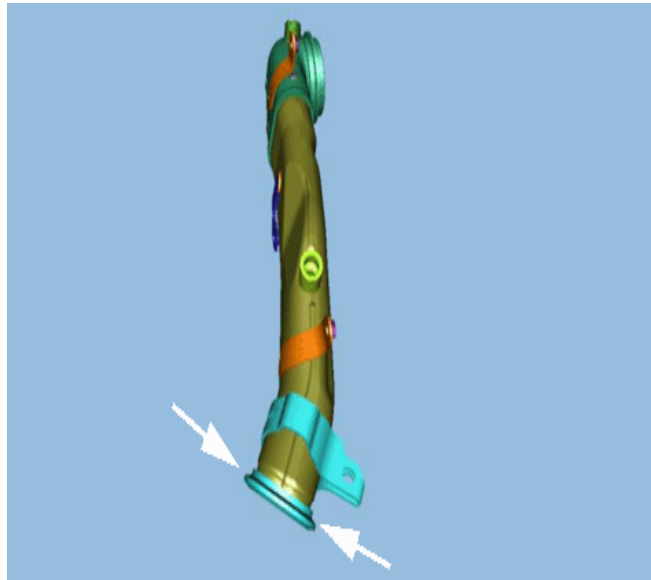
2749630

**Note:** The illustration above is the turbocharger exhaust pipe without a pilot flange.

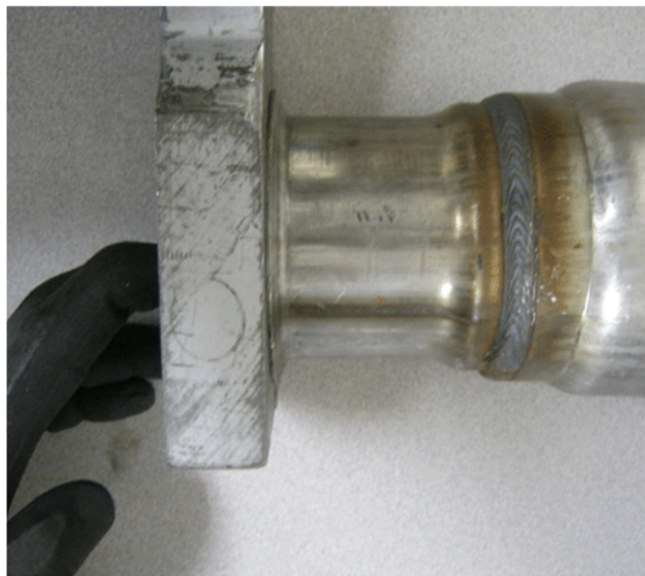
2748856

**In most cases it will not be necessary to replace the exhaust downpipe/catalytic converter assembly for this condition.** However if the mating flange on the exhaust downpipe/catalytic converter assembly is not true, it is possible a leak may occur.

This can be inspected easily by placing a gauge block flush against the flange and inspect for excessive gaps or damage to the flange.

If there are gaps, the converter may need replacing, but the new gasket should compensate for minor surface variation. It is preferred that the alignment process is attempted prior to replacing the converter. There have been very few cases that required the converter to correct this condition.
