# Service Bulletin

Bulletin No.: PI0235F

**Subject:** Exhaust Leak or Vibration/Rattle Noise at Approximately 900 RPM, Fuel Smell, White Smoke, Oily Substance on Exhaust Downpipe

**Models:** 2011-2013 Chevrolet Express 2500/3500/4500, Silverado 2500HD/3500HD  
2011-2013 GMC Savana 2500/3500/4500, Sierra 2500HD/3500HD  
Equipped with 6.6L Duramax™ Diesel Engine (RPOs LML or LGH)

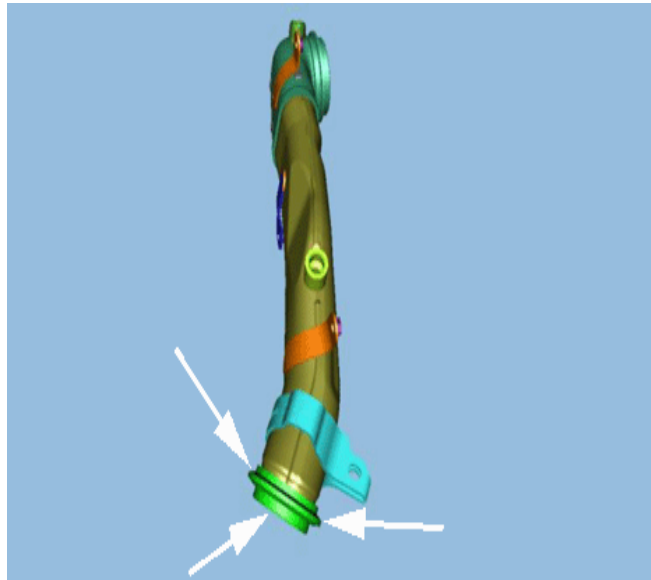
2749618

**Note:** The illustration above is the updated turbocharger exhaust pipe with a pilot flange.

If the above alignment procedure does not correct the condition, the turbocharger exhaust pipe may need to be replaced on trucks built prior to the breakpoints listed below with an updated turbocharger exhaust pipe with a pilot flange. If the turbocharger exhaust pipe has the new flange, you should not need to replace it. Refer to the Turbocharger Exhaust Pipe Replacement procedure in SI.

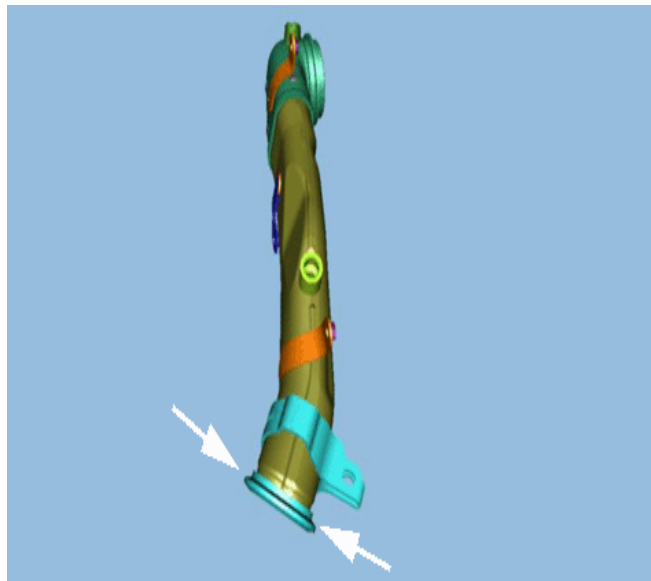
2749630

**Note:** The illustration above is the turbocharger exhaust pipe without a pilot flange.

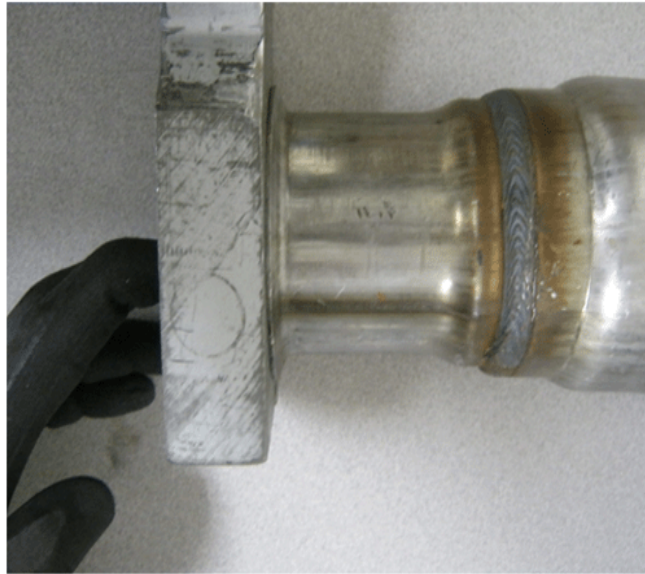
2748856

**In most cases it will not be necessary to replace the exhaust downpipe/catalytic converter assembly for this condition.** However if the mating flange on the exhaust downpipe/catalytic converter assembly is not true, it is possible a leak may occur.

This can be inspected easily by placing a gauge block flush against the flange and inspect for excessive gaps or damage to the flange.

If there are gaps, the converter may need replacing, but the new gasket should compensate for minor surface variation. It is preferred that the alignment process is attempted prior to replacing the converter. There have been very few cases that required the converter to correct this condition.
