Bulletin No.: PI0310C

Service Bulletin

Subject: Loss of Communication with Allison Transmission Control Module (TCM), Intermittent Transmission Hesitation, Reduced Torque, Range Inhibit, Clunk, Stuck in Gear or in Neutral, Won't Shift, DTC P0880 and/or U0101 Set (Inspect for Electrostatic Discharge (ESD) from Aftermarket Serpentine Belts and/or Added Equipment, Install OEM Belt, Relocate TCM)

Models: 2007-2011 Chevrolet Silverado
2007-2011 GMC Sierra
Equipped with Allison® A1000 Automatic Transmission (RPO MW7)

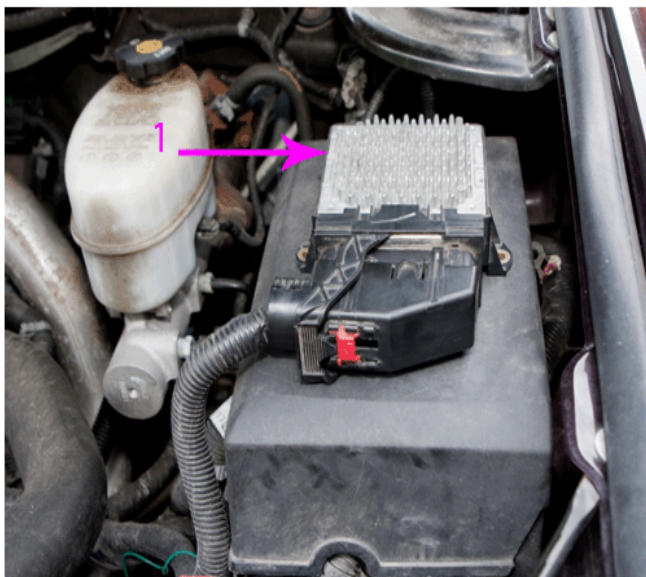
2544173

Relocate the TCM ONLY if an additional or longer accessory drive belt has been installed on the engine, resulting in the drive belt being closer to the TCM.

Relocating the TCM on a vehicle that has not been modified, WILL NOT correct the DTCs and may result in a comeback.

6. Relocate the TCM (1) to the top of the UBEC cover and secure it using a heavy duty adhesive or Velcro® “hook and loop fastener”. DO NOT use push pins as fasteners, they will compromise the water resistance of the UBEC cover.
