Service Bulletin

Bulletin No.: PI0341D

Subject: Front Sunroof Sunshade Will Not Latch or is Difficult to Latch in the Closed Position

Models: 2010-2014 Buick Enclave
2010-2014 Chevrolet Traverse
2010-2014 GMC Acadia
2010 Saturn OUTLOOK
Equipped with Sunroof RPO C3U
and Built After August 1, 2009

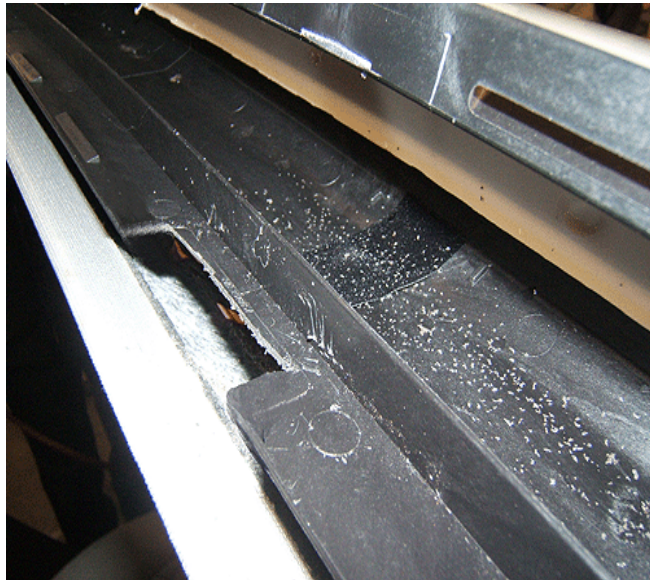
2552962

Some customers may comment that the front sunroof sunshade is difficult to latch in the closed position.

The front rail of the sunroof module may sag due to high ambient temperatures causing the sunshade striker to sit lower. This is more prevalent on dark colored vehicles when parked in direct sunlight for an extended period of time.

Important: When removing the striker, be careful not to cut/damage the headliner.

1. Remove the existing sunshade striker using a Dremel or similar tool.
2. Place the sunroof sunshade striker on the top surface of the front rail to locate the holes. Mark the hole locations.
