# Service Bulletin

Bulletin No.: PI0345C

**Subject:** Inspect XM/Cellular Mobile Phone/OnStar® Antenna for Looseness or Damage, XM/Cellular/OnStar® Reception Performance Degraded, Rattle/Flutter/Squeak Noise, Wind Noise/Whistle at Highway Speeds, Water Leak on Headliner at Sunvisor

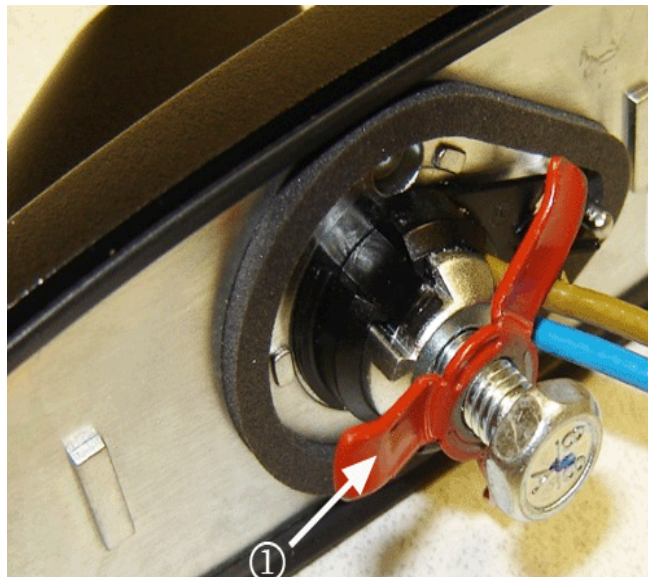
The cause of this condition may be looseness and/or damage of the XM/cellular mobile phone/OnStar® antenna, which may affect the grounding of the antenna and may allow a rattle/wind noise at highway speeds and/or a water leak.

Though difficult to detect evidence of impact damage, upon inspection of the antennas returned in warranty, there is a likelihood this damage occurred during vehicle transportation to dealerships. The result of impact damage is most often to the underside retainer (1), which is found to be bent backward or otherwise damaged and no longer provides proper retention.
