Bulletin No.: PI0522D

PRELIMINARY INFORMATION

Subject: Tick, Buzz or Rattle Noise from Front of Dash, Transmission Filler Tube Cracked or

Models: 2007-2013 Cadillac Escalade Models (excluding Hybrids)

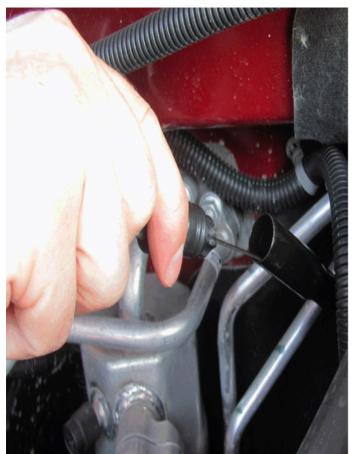
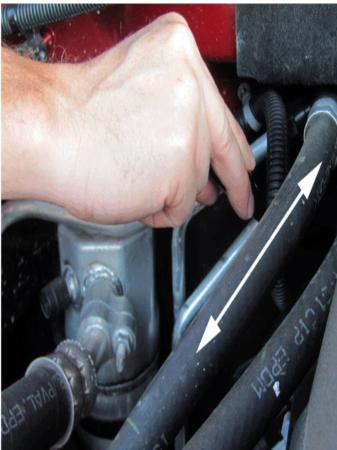
2906255

- 3. Grasp the transmission filler tube with your thumb and first two fingers of your right hand. Your thumb should be on the passenger side of the transmission filler tube and parallel to the filler tube.

- 4. Using only your thumb and the first two fingers of your right hand, force the transmission filler tube toward the driver's seating position and then back to the passenger's front wheel two times.

- 5. Determine if the transmission filler tube is damaged. An undamaged transmission filler tube will move less than two inches and spring back to its original position, while a damaged transmission filler tube will move greater than two inches and will not spring back to its original position. A damaged transmission filler tube will likely crack during this inspection.

- If the transmission filler tube is not damaged, proceed to Step 6.
 - If the transmission filler tube is damaged, replace the transmission filler tube. Refer to Transmission Fluid Filler Tube and Seal Replacement in SI.

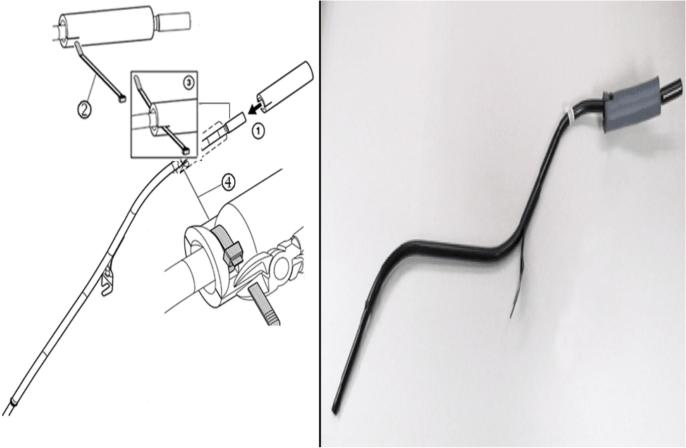
2906258

Note: The tie strap threads between the fill tube and half the foam damper using the slot in the sleeve. This is secured to the top half of the tube, leaving the lower half of the damper free.

- 6. Install a foam damper (sleeve) on the upper end of the transmission filler tube using a tie strap. Refer to the illustration.
- 7. Install the transmission dipstick.
- 8. Close the hood.

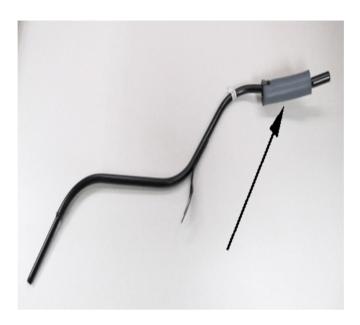
2688999

Important: The foam attached to the upper end of the tube is the damper. Do not mistake this foam for packaging material. Do not remove this foam from the tube.
