# Service Bulletin

Bulletin No.: PI0602A

**Subject:** Normal Propeller Shaft Conditions on All-Wheel Drive Vehicles (AWD)

**Models:** 2008-2014 Buick Enclave  
2007-2014 Chevrolet Equinox  
2009-2014 Chevrolet Traverse  
2012-2014 Chevrolet Captiva Sport  
2007-2014 GMC Acadia  
2010-2014 GMC Terrain  
2007-2010 Saturn OUTLOOK, VUE  
Equipped with All-Wheel Drive (AWD) (RPO F46)

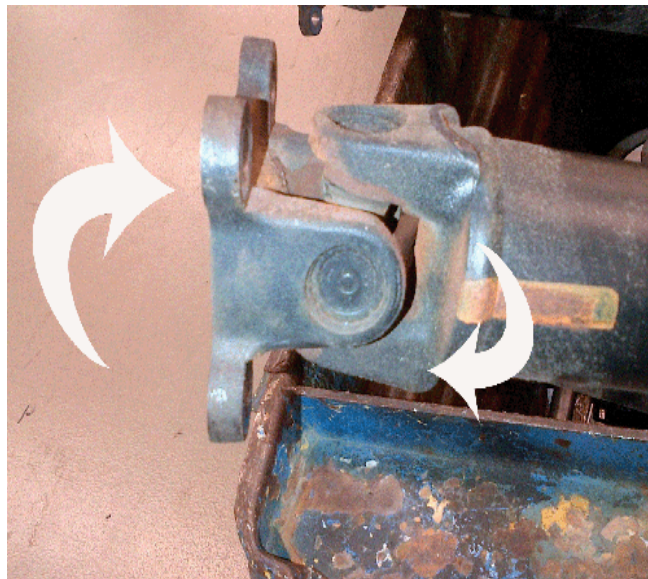
2731758

1. The rear flange yoke on the propeller shaft may exhibit a “notchy” feeling in the U-joint as it is actuated. The technician should look for obvious looseness in the joint or seizure of the joint beyond the “notchy” feeling during joint actuation. This can be wrongly diagnosed as a brinelled bearing. These propeller shaft conditions that may appear to be product defects or issues with durability are actually normal conditions.

Do not replace the propeller shaft for any of these conditions as they are normal.

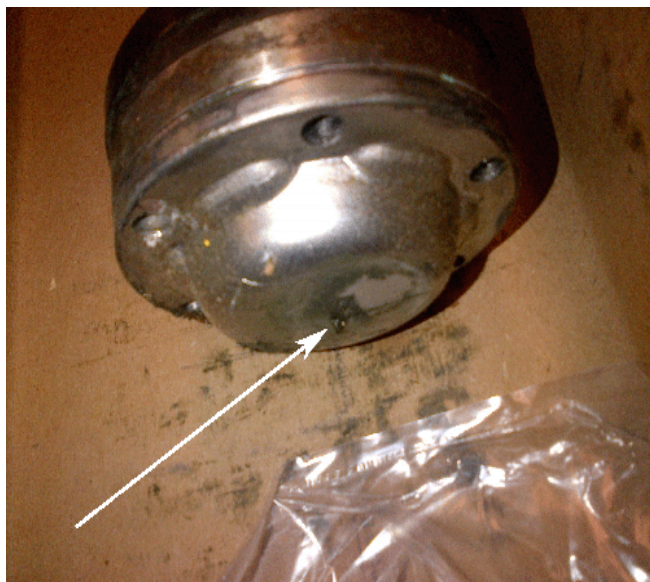
2729780

2. The front CV joint has a vent in the center of the cap that may expel grease if the propeller shaft is heavily compressed at the front CV joint during service. This grease expulsion under these conditions is normal and does not cause any significant loss to the joint.
