Service Bulletin

Bulletin No.: PI0689B

Date: August, 2013

Subject: Aftermarket Installed Service, Tool or Utility Box Sagging, Mis-aligned, Forward Box Mount Bracket Fractured on Trucks Equipped with Aftermarket Bodies

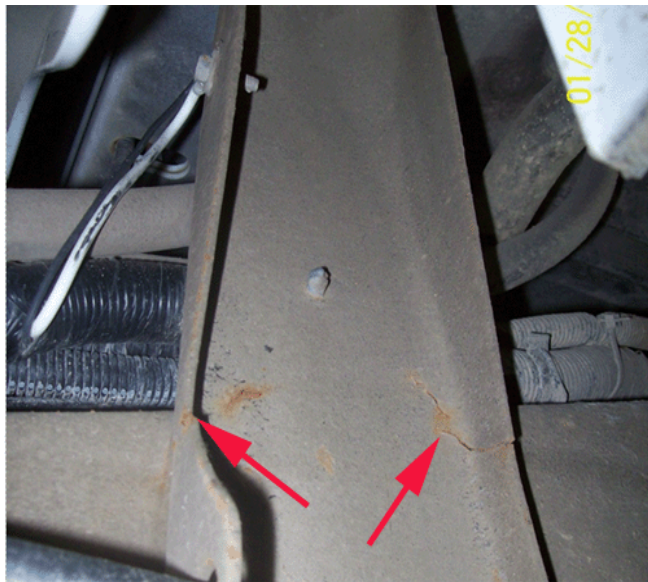
2779515

Example of mounting bracket with cracks developing (not all mounting points used).

Some customers may comment that the utility box is sagging, not level or misaligned. Upon inspection, the technician may find cracked or fractured front bed mount bracket(s).

Use the following steps to replace the affected front bed mount brackets.

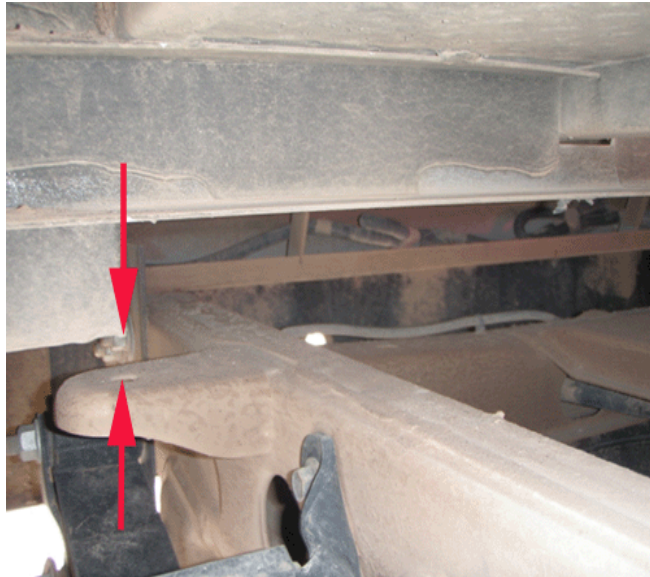
2779516

In rare occasions, situations have been identified where the incomplete pickup trucks have had an aftermarket body (typically a service body or utility type body) installed. Upon inspection it was noted that the aftermarket bed was not using all the recommended/available mounting points provided in Upfitter Integration UI Bulletin # 98 (available at www.gmupfitter.com). Every case identified so far involved an aftermarket body that only used four mounting points; one in each corner, with no additional load bearing points as described in the UI Bulletin.

Example of available body mounting locations not used by the upfitter under the service body.

Important: If the existing body is going to be re-installed after the repair, then the mounting set up of the body that contributed to this condition must be corrected to utilize the attachment scheme outlined in the UI Bulletin prior to performing the re-installation of the body. This repair only replaces the same style of bracket, which requires the correct mounting of the aftermarket body. If the body is not mounted properly, the condition may repeat. Refer to GM Upfitter Bulletin #98' for 2011 & beyond 'C/K HD Cab Chassis Mounting Guidelines' and "GM UI Body Builder's Manual Best Practices welding safety & procedures and body mounting information."

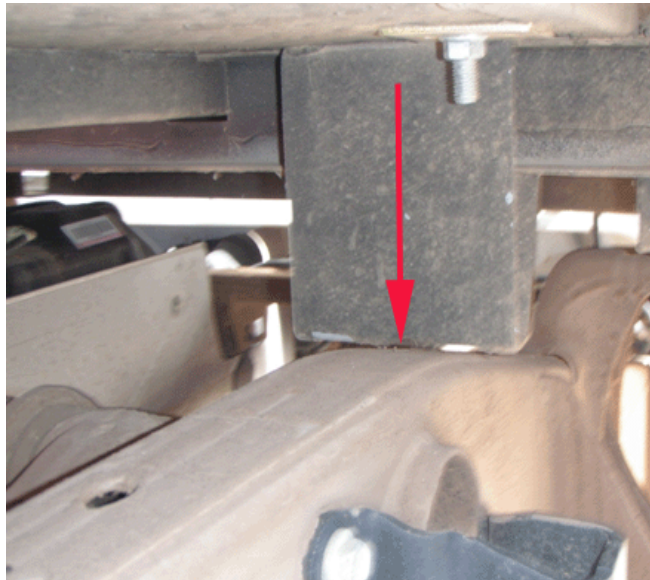
2779517

Example of support bracket not carrying any load of the body.
