Bulletin No.: PI0716A

# PRELIMINARY INFORMATION

Subject: Road Debris (Mud) on Rocker Panel at Front Door Area

Models: 2010-2013 GMC Terrain

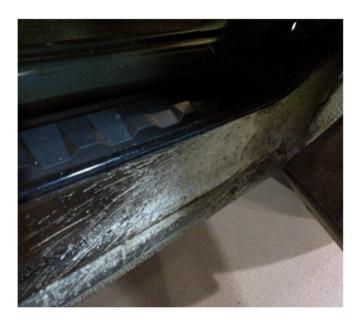
2813065

Some customers may comment that road debris (mud) is traveling up between the front doors and the rocker panels. This condition may be caused by debris working around the front of the door seal.

The installation of GM accessory splash guards will direct the debris away from the door seal and prevent mud from working into the rocker panel area.

Splash guards are available as P/N 19170501 for front splash guards only, or P/N 19170503 for all four splash guards.
