# Service Bulletin

Bulletin No.: PI0785B

**Subject:** DTC C027B, Low Brake Pedal Feel After Master Cylinder Repairs

**Models:** 2009-2014 Buick Enclave  
2010-2012 Buick LaCrosse  
2011-2014 Buick Regal  
2012-2014 Buick Verano  
2013-2014 Buick Encore  
2009-2014 Cadillac CTS, SRX  
2013-2014 Cadillac ATS, XTS  
2009-2012 Chevrolet Colorado  
2009-2014 Chevrolet Corvette, Impala, Malibu, Traverse  
2010-2014 Chevrolet Camaro, Equinox  
2011-2014 Chevrolet Cruze  
2012 Chevrolet Captiva Sport  
2012-2014 Chevrolet Sonic  
2013-2014 Chevrolet Spark  
2009-2012 GMC Canyon  
2009-2014 GMC Acadia  
2010-2014 GMC Terrain

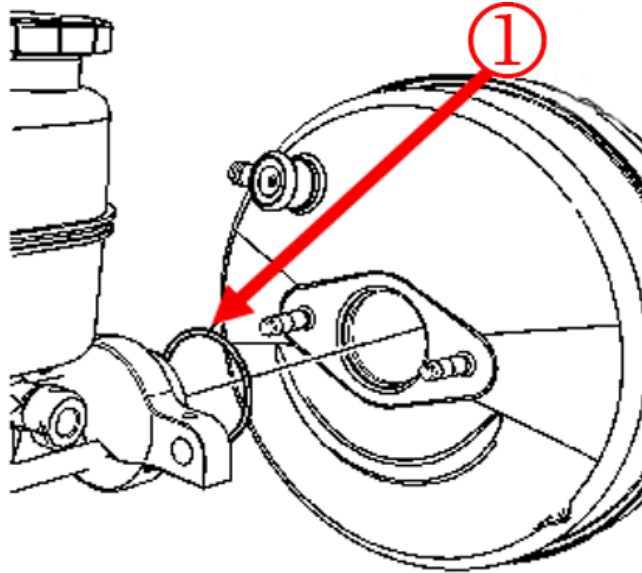
2515865

Some customers may comment on a low brake pedal during brake pedal apply. During diagnosis, a DTC C027B may be found stored in the EBCM. This concern may have started after the master cylinder was unbolted from the brake booster for any reason.

This may be caused by a small vacuum leak between the master cylinder and the brake booster. There is an O-ring between the master cylinder and the brake booster that may have fallen off during the prior repairs.

Inspect for the O-ring (1) between the master cylinder and the brake booster before performing any other diagnostics for the low brake pedal or the DTC C027B. Replace the O-ring if missing or damaged.

**Tip:** Exhaust the booster vacuum by either pumping the brake pedal or pulling the check valve out prior to removing the master cylinder. The suction may be helping to dislodge the O-ring when pulling the master cylinder out.
