Service Bulletin

Bulletin No.: PI1237

Subject: Diagnostic Tip for Intermittent Crank/No Start After Removal of Cam Shaft Sprockets

Models: 2013-2014 Buick Encore
2014 Cadillac ELR
2011-2014 Chevrolet Cruze, Volt
2012-2014 Chevrolet Sonic
2013-2014 Chevrolet Trax
2012-2014 Opel Ampera
Equipped with 1.4L Engine (RPOs LUU, LUV or LUJ)

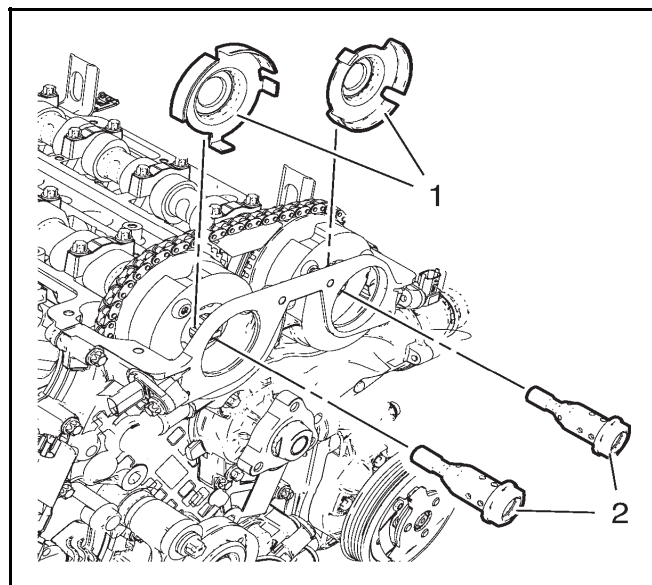
Exciter Wheel (1)

The exhaust and intake camshaft position exciter wheel must be installed properly with special tool EN-49977-100, fully seated on the cylinder head, before tightening the camshaft sprocket bolt. Refer to the pictures below for proper alignment installation and tool usage.

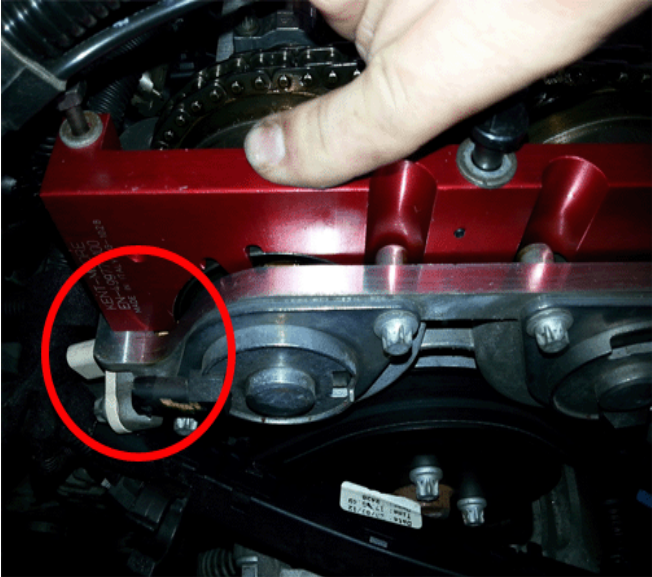
3819114

Rear Cylinder Head with Tool Showing Proper Exciter Wheel Alignment

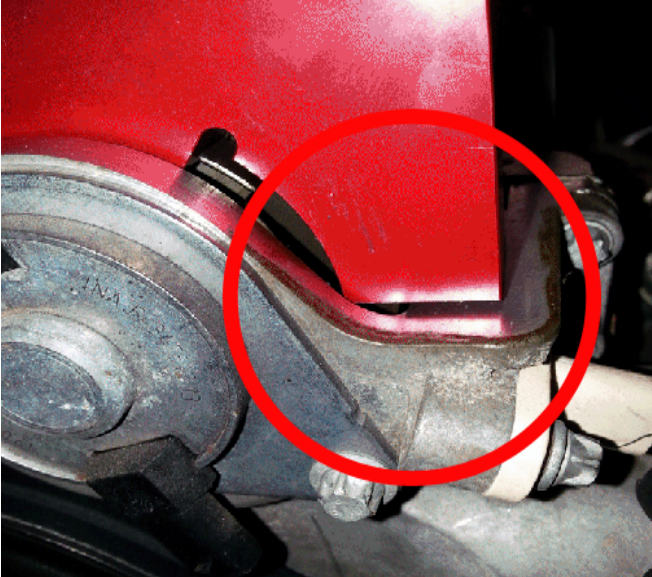
3819116

Some customers may comment on an intermittent crank/no start. After cycling the key, the vehicle will start. This may be caused after having the camshaft sprockets being removed for any type of engine service performed.

Front Cylinder Head with Tool Showing Exciter Wheel Misalignment

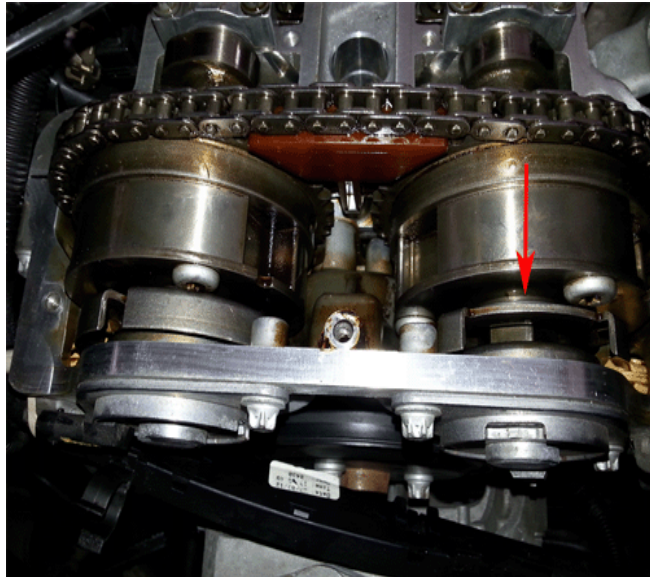
3819117

Exhaust Exciter Wheel Incorrect Alignment

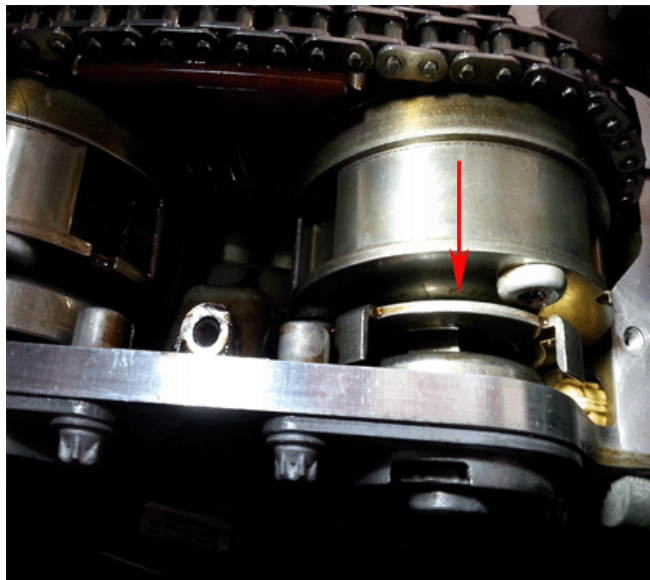
3819118

Exhaust Exciter Wheel Correct Alignment
