Service Bulletin

Bulletin No.: P11237A

Subject: Diagnostic Tip for Intermittent Crank/No Start After Removal of Cam Shaft Sprockets

Models: 2013-2014 Buick Encore
2014 Cadillac ELR
2011-2014 Chevrolet Cruze, Volt
2012-2014 Chevrolet Sonic
2013-2014 Chevrolet Trax
2012-2014 Opel Ampera
Equipped with 1.4L Engine (RPOs LUU, LUV or LUJ)

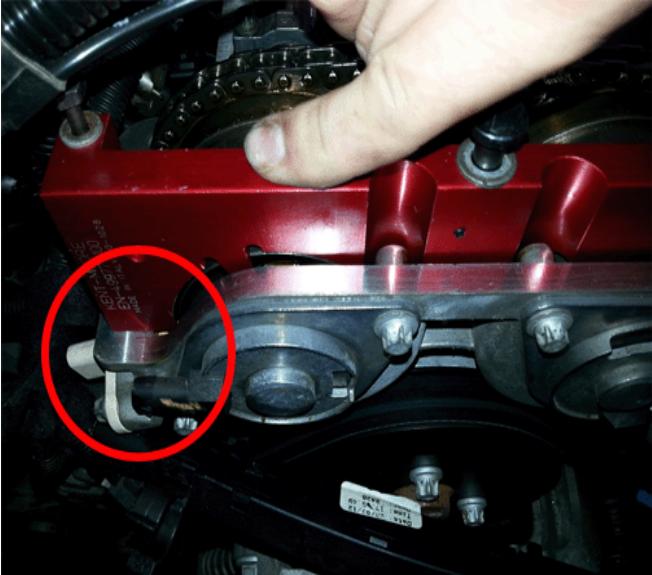
3819114

Rear Cylinder Head with Tool Showing Proper Exciter Wheel Alignment

The exhaust and intake camshaft position exciter wheel must be installed properly with special tool EN-49977-100, fully seated on the cylinder head, before tightening the camshaft sprocket bolt. Refer to the pictures below for proper alignment installation and tool usage.

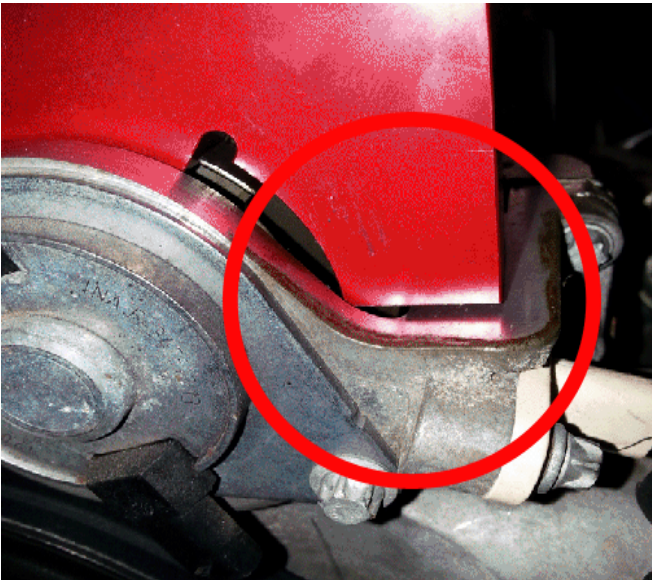
3819116

Some customers may comment on an intermittent crank/no start. After cycling the key, the vehicle will start. This may be caused after having the camshaft sprockets being removed for any type of engine service performed.

Front Cylinder Head with Tool Showing Exciter Wheel Misalignment

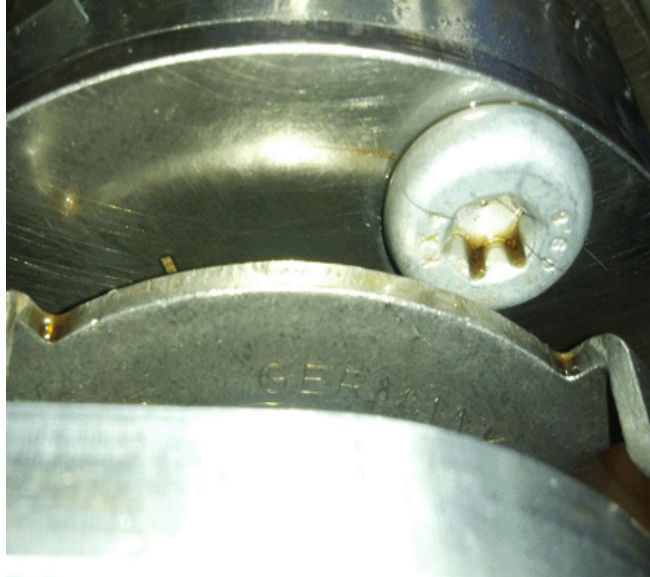
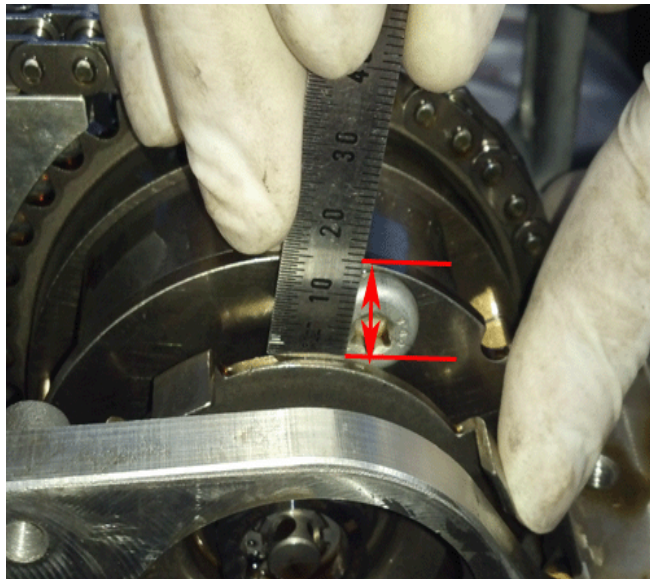
Exhaust Exciter Wheel Incorrect Alignment

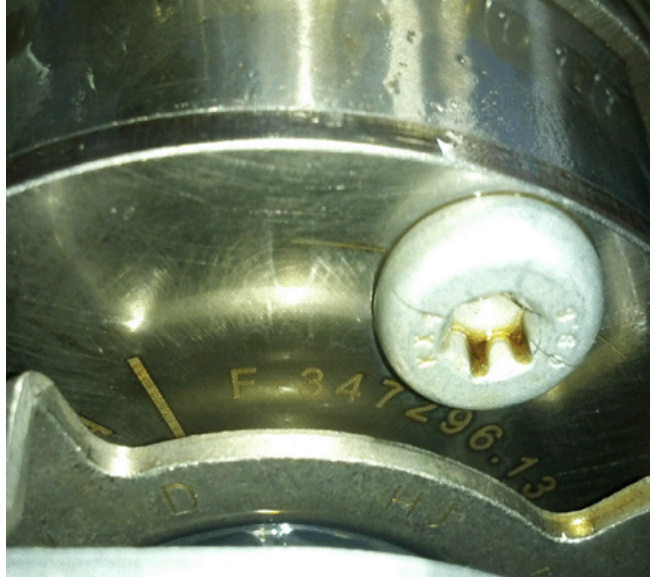
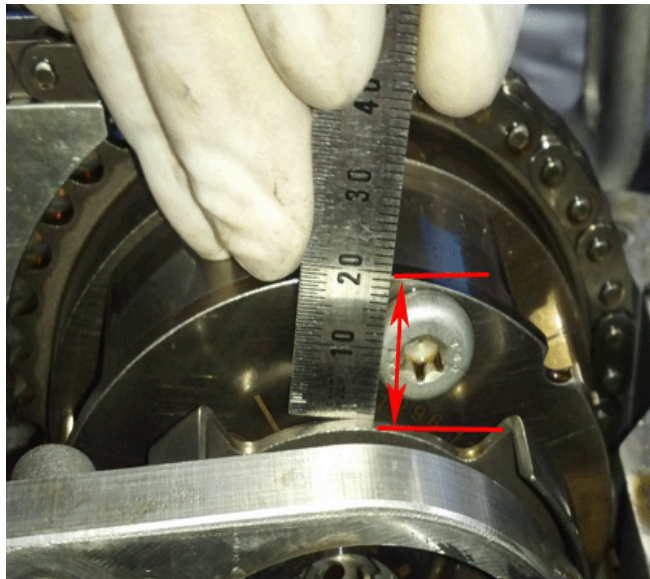
Exhaust Exciter Wheel Correct Alignment
