Service Bulletin

Bulletin No.: PIP5072

Date: November, 2012

Subject: Slip In Forward Ranges Immediately After Replacing The Input Housing - 621 - Check Input Housing - 621 - For Improperly Drilled Feed Holes

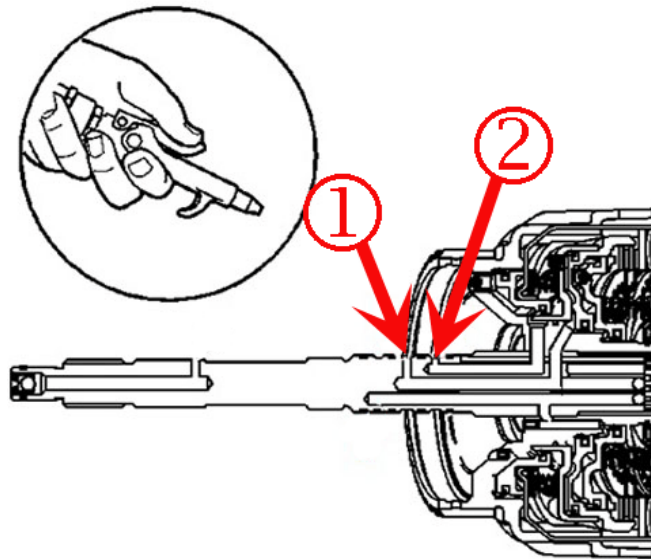
2966700

The Input Housing (621) from GM Service Parts may have an incorrectly drilled input shaft.

Air leaking from 3-4 apply hole may be noted when applying air pressure to the forward clutch apply hole during an air check with the Input Housing (621) fully assembled with seals and clutches.

Call out 1: Forward clutch feed hole.

Call out 2: 3-4 clutch feed hole.

Inspect the 3-4 clutch and the forward clutch oil feed passages for leakage between circuits. Apply regulated compressed air to the 3-4 clutch feed hole and the forward clutch feed hole one at a time with the Input Housing (621) completely assembled. See picture below.

Air should not leak out of the 3-4 clutch feed hole when applying air to the forward clutch feed hole and air should not leak out of the forward clutch feed hole when applying air to the 3-4 clutch feed hole. If air leakage is noted between the two feed holes the Input Housing (621) should be replaced with one from GM Service Parts. (Order new housing part number 19125752.)

Do not replace an Input Housing (621) assembly solely because of a small air leak between the shaft and housing. Re-use or replace the part based on results of inspection as described in Input Housing and Shaft Assembly Inspection above.
