Service Bulletin

Bulletin No.: PI0924

Subject: Intermittent Unwanted Trunk Opening While Vehicle is Parked

Models: 2010-2013 Buick LaCrosse
2011-2013 Buick Regal
2012-2013 Buick Verano
2011-2013 Chevrolet Cruze
2012-2013 Chevrolet Sonic (4 Door Sedan Only)
2013 Chevrolet Malibu

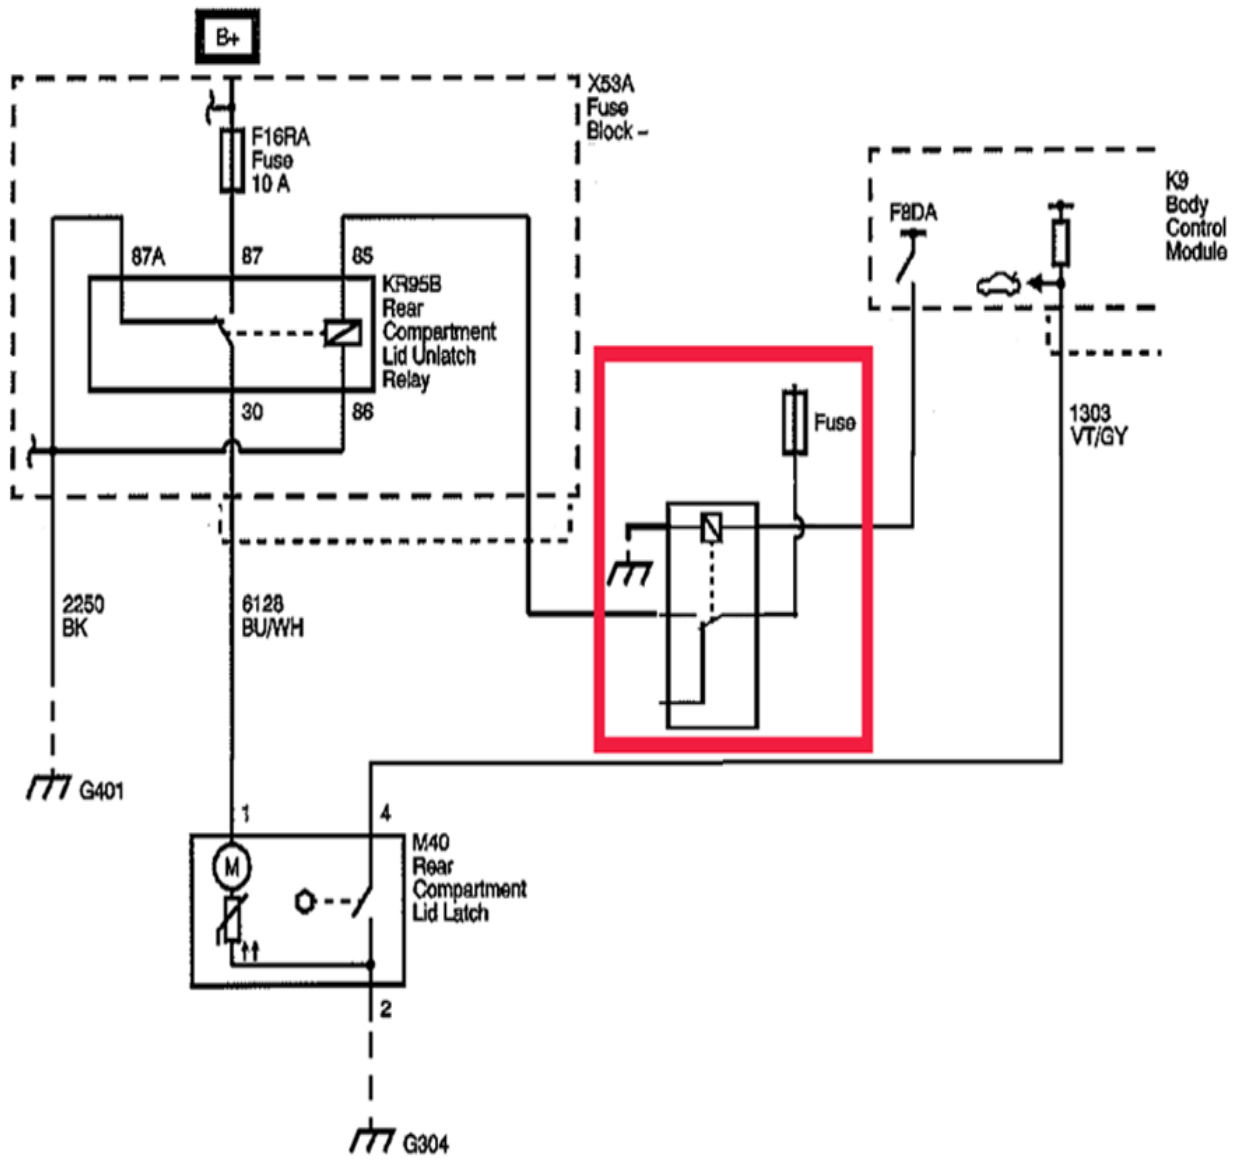
3329904

The rear compartment lid unlatch relay is part of the printed circuit board in the relay/fuse block and not serviceable separately. Installation of an external relay circuit to bypass the feed to the trunk release control will be required. Install the "Two Shot Relay" adjacent to the BCM and attach a tag to the relay and mark with "Two Shot Trunk Relay per Bulletin PI0924." For future diagnosis for an inoperative trunk release, this relay installation will be identified before a BCM is replaced.

1. Label the four leads of connector, P/N 12126045 as indicated below.
2. Connect the connector to the new relay, P/N 19119267.
3. Locate circuit 6188 (trunk release control) at the BCM following service information. Cut the wire and splice the BCM and relay side of the circuit as shown below.
4. Connect wire fused, unswitched power and ground as shown below.
