Service Bulletin

Bulletin No.: PI0984

Subject: Revised Liftgate Strut Replacement Procedure

Models: 2008-2012 Buick Enclave
2009-2012 Chevrolet Traverse
2007-2012 GMC Acadia
2007-2010 Saturn OUTLOOK

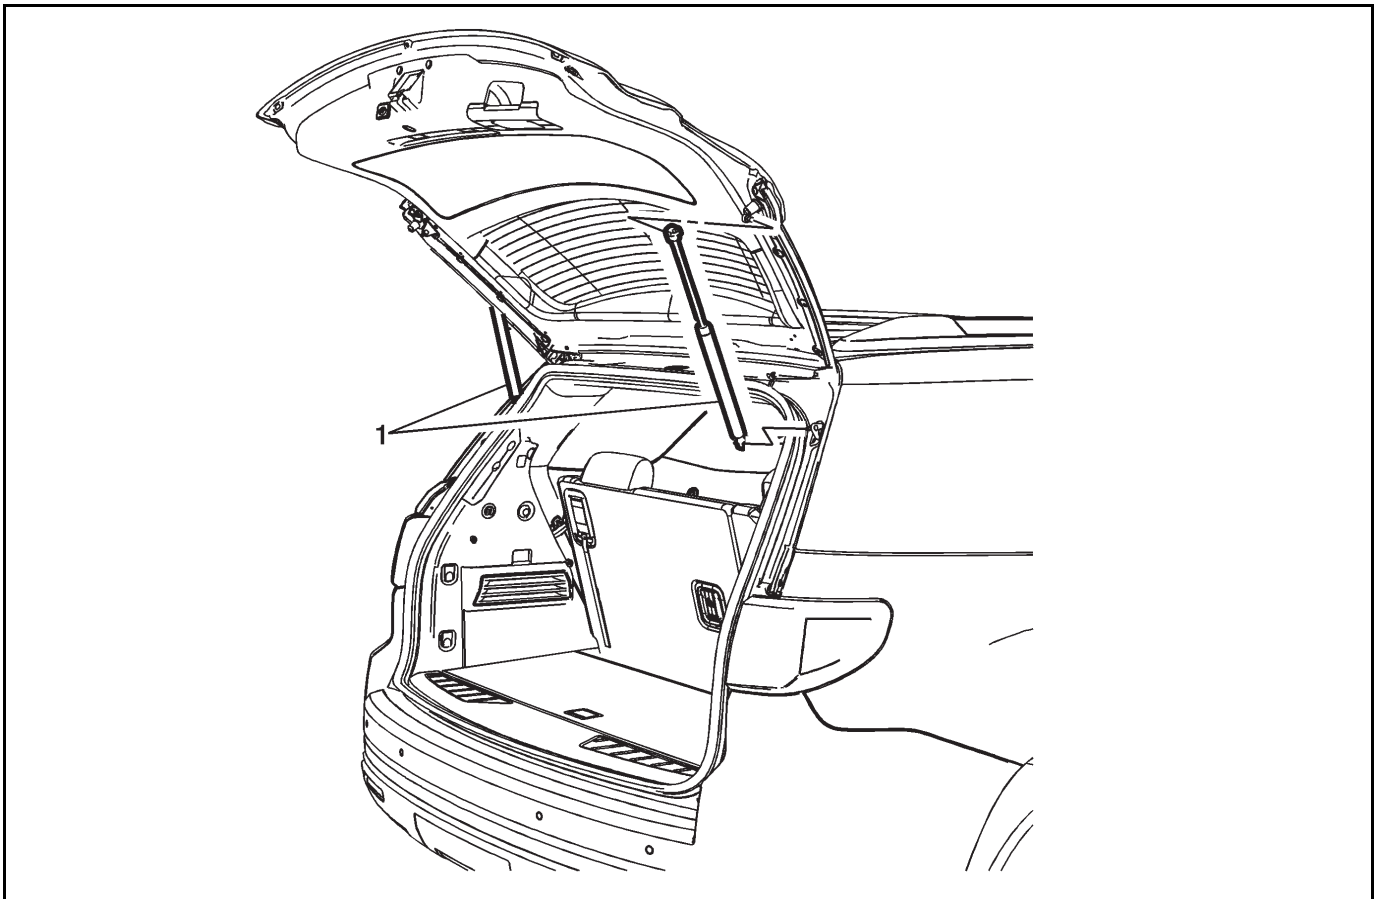
2878222

GM engineering has determined that improved durability of the liftgate strut can be realized by installing the strut assembly with the rod side down. In this orientation, dust and dirt does not collect on the strut housing to rod seal, which can cause wear on the seal.

When it is necessary to replace a liftgate strut, install the strut assembly with the strut body end attached to the body side of the vehicle and the rod side attached to the liftgate (1).

Important: This revised installation procedure applies to all vehicles even if the struts were installed in a different orientation from the factory.
