# Service Bulletin

Bulletin No.: PI0984A

**Subject:** Revised Liftgate Strut Replacement Procedure

**Models:** 2008-2012 Buick Enclave  
2009-2012 Chevrolet Traverse  
2007-2012 GMC Acadia  
2007-2010 Saturn OUTLOOK

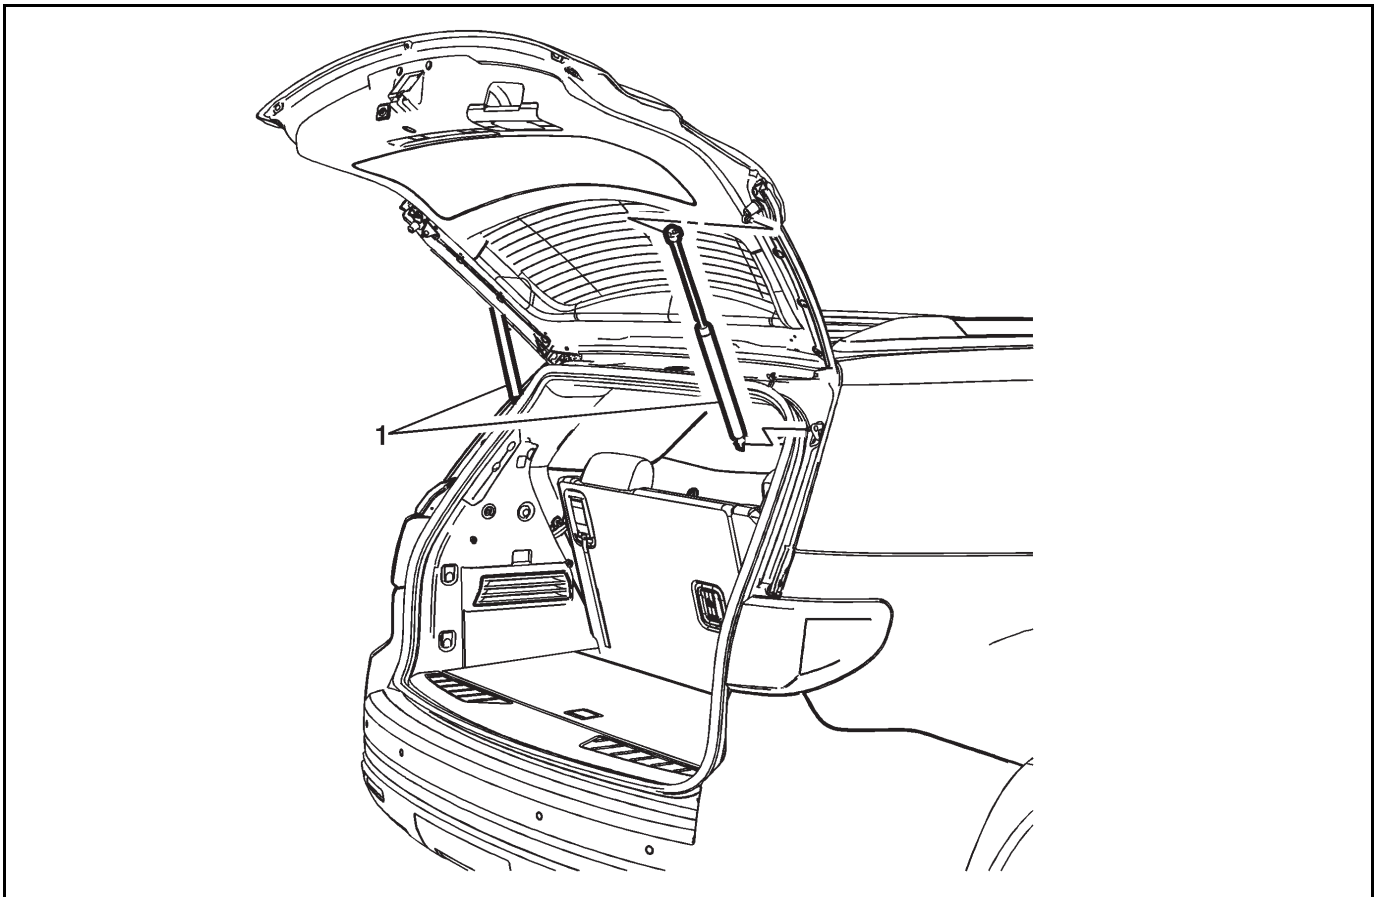
GM engineering has determined that improved durability of the liftgate strut can be realized by installing the strut assembly with the rod end facing downward (attached to the liftgate) when the liftgate is in the closed position. In this orientation, dust and dirt does not collect on the strut housing to rod seal, which can cause wear on the seal.

When it is necessary to replace a liftgate strut, install the strut assembly with the strut body end attached to the body side of the vehicle and the rod side attached to the liftgate (1).

**Important:** This revised installation procedure applies to all vehicles listed in the Models information even if the struts were installed in a different orientation from the factory.
