Service Bulletin

Bulletin No.: PI0987

Date: June, 2013

Subject: Passenger Side Defrost Air Flow/Performance and/or Temperature Less Warm Than Drivers Side in Defrost, IP Vent or Heat Modes

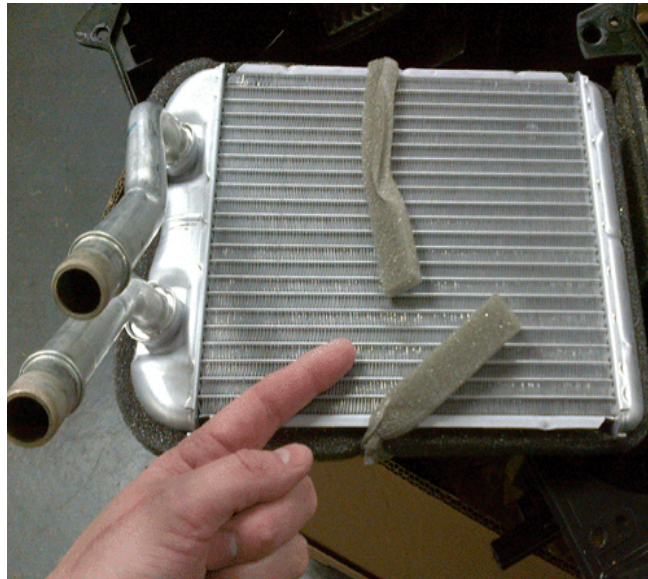
3459491

The cause of this condition may be that the belt seal (1) that goes around the heater core may have become mis-positioned. If this occurs, it can create a path for air to travel to the wrong side of the HVAC Module.
