Service Bulletin

Bulletin No.: PI0998

Subject: Accessory Tri-Fold Tonneau Cover Prevents Endgate/Tailgate from Closing

Models: 2014 Chevrolet Silverado Light Duty
2014 GMC Sierra Light Duty

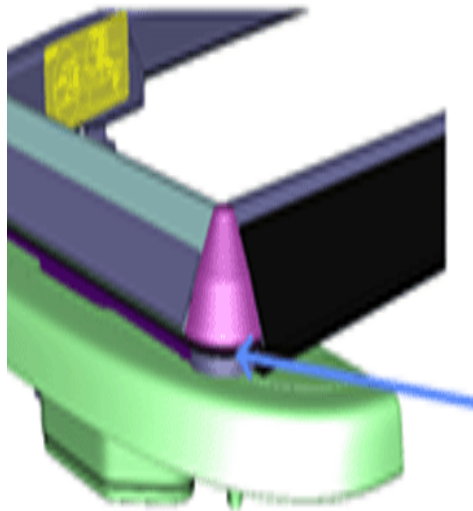
3461386

Some customers may comment that the tailgate will not close with the tri-fold tonneau cover in the closed position. This may be due to an early production condition caused by excessive twist in the rear rail of the tonneau cover, and the tailgate molding is not positioned flat on top of the tailgate.

2. Remove the adhesive liner from the pad and attach to the rear current corner pads on the right and left side as shown in the illustration above.

Note: If additional clearance is required, add a second layer of corner pads to each side.
