Service Bulletin

Bulletin No.: 15-05-25-001

Subject: Service Stabilitrak Message Displayed, DTC C0196-5A Set in Electronic Brake Control Module (EBCM)

Models: 2015-2016 Cadillac Escalade Models
2014 Chevrolet Silverado 1500
2015-2016 Chevrolet Silverado, Suburban, Tahoe
2014 GMC Sierra 1500
2015-2016 GMC Sierra, Yukon Models

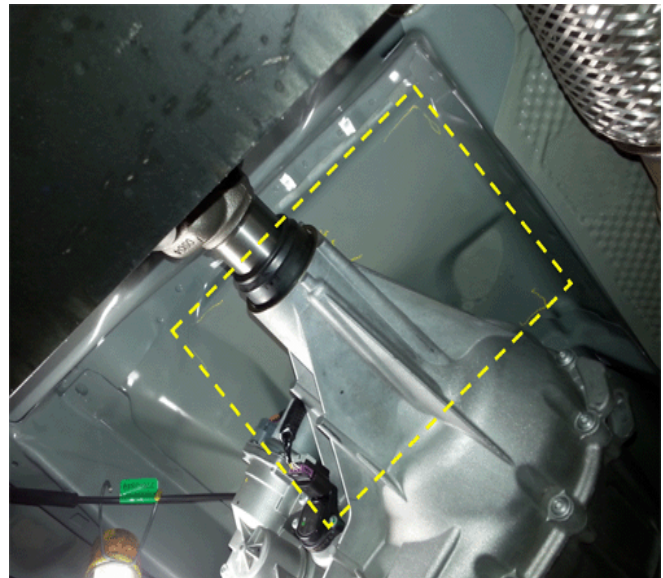
4250960

C0196-5A is related to YAW sensor plausibility. Engineering has determined that stone impacts to the underside of the transmission tunnel, right below the SDM, may cause the YAW/Lat sensor located in the SDM to send signal spikes related to the resonant frequencies of the sheet metal; 12-14 kHz range. If the YAW/Lat signals don't line up with vehicle speed and steering angle sensor data, the EBCM will set C0196-5A, plausibility fault. Sometimes the SDM will set C0196-00, invalid yaw rate data fault, if the stone impingement crosses the internal sensor fault threshold while will in turn cause the EBCM to set a C0452-71.

2. Locate area shown above transmission and transfer case, if equipped.
3. Ensure the area is free of any debris by cleaning the area with wax and grease remover or equivalent. Ensure area is dry.
4. Mark the transmission tunnel as noted.
