Special Service Message

SSM 71258 - Front Brake Calliper Appears To Leak Brake Fluid

Models : LA - Discovery 4 / LR4

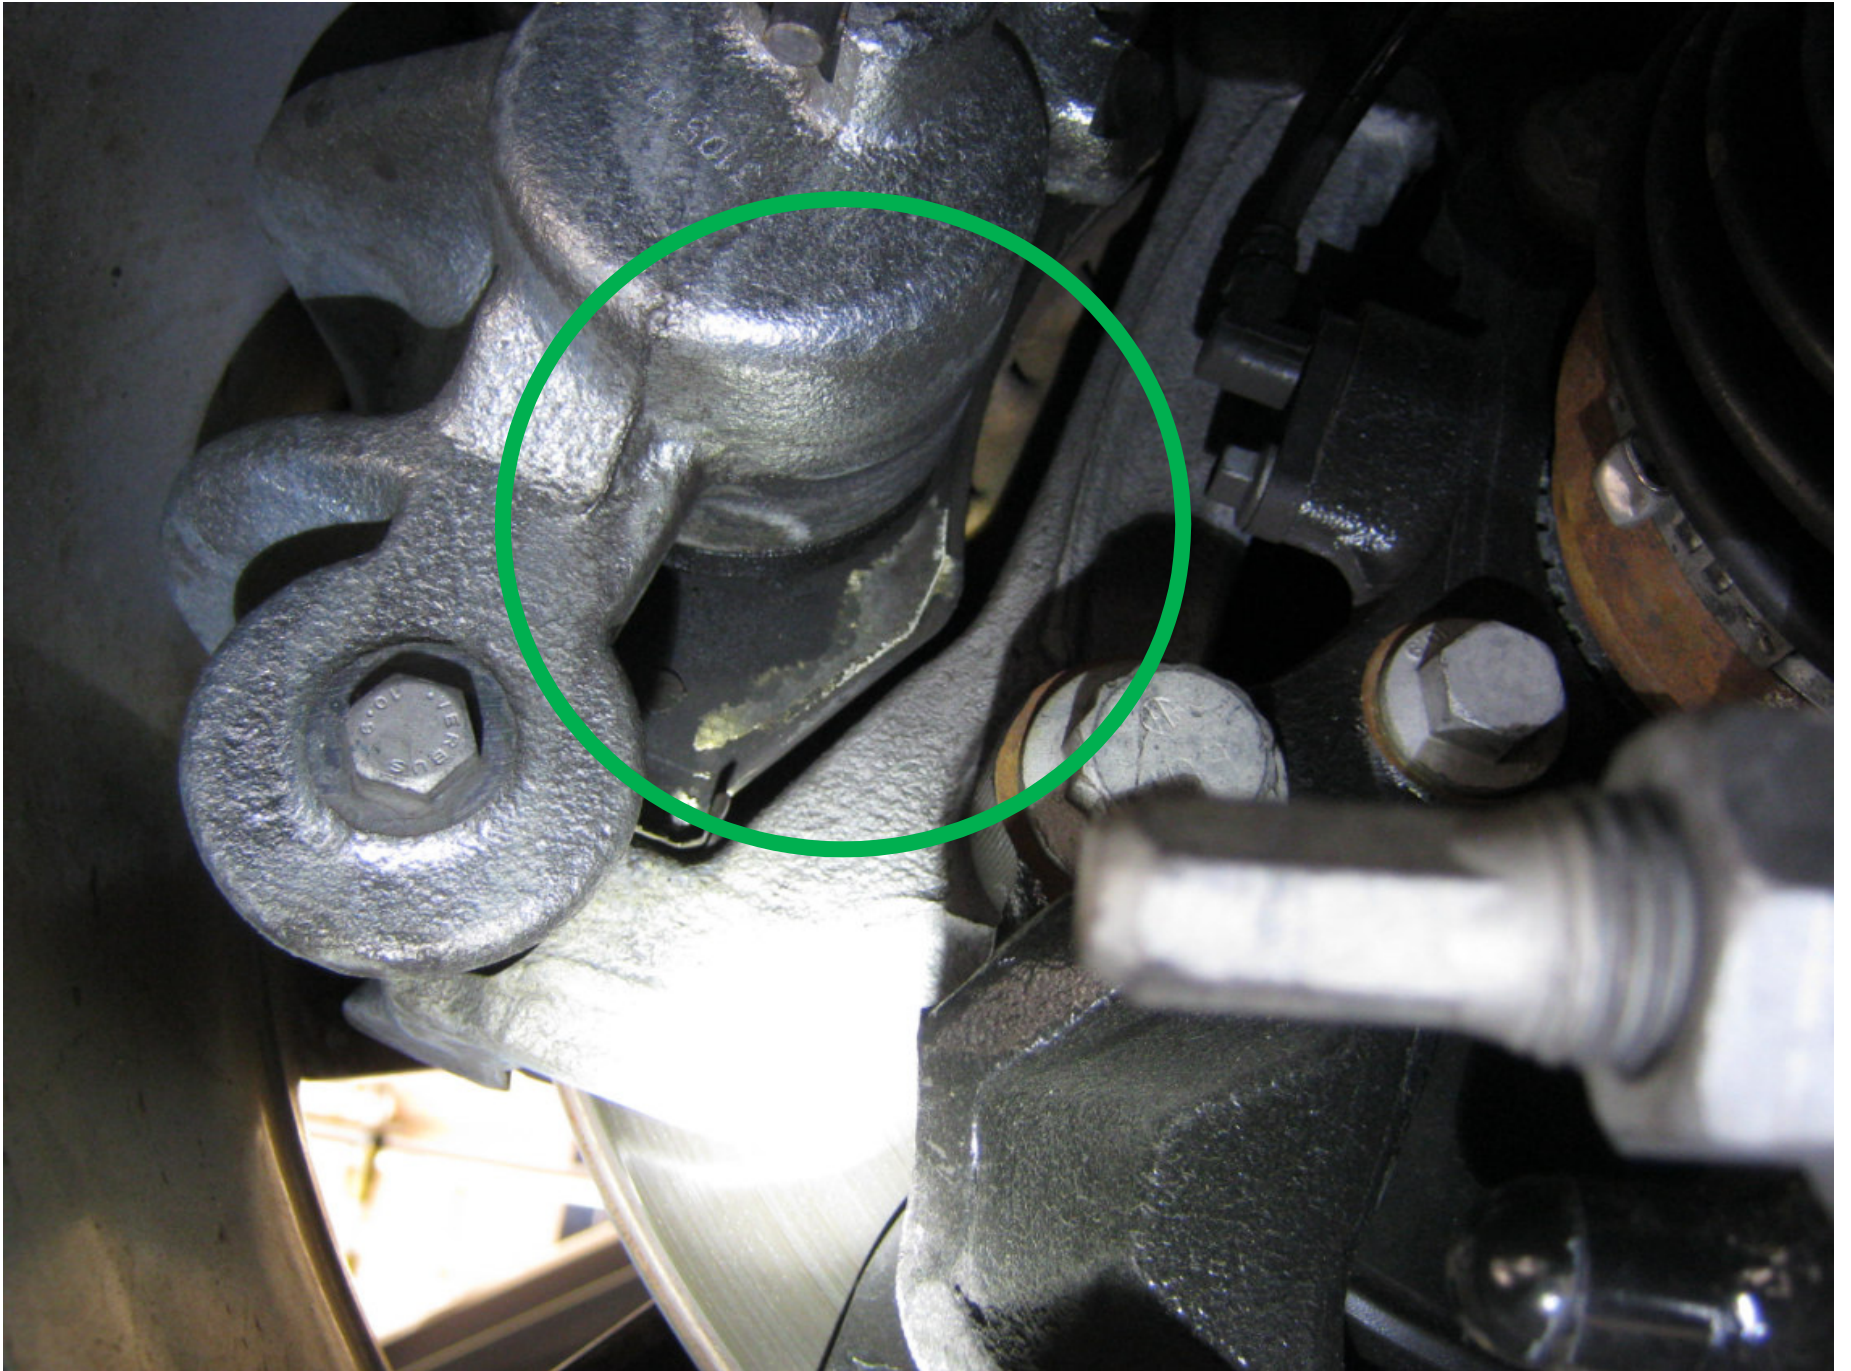
File : [OK Fluid or Grease on Caliper.pdf](#)

Content : **Issue:** Front brake callipers appear to be leaking brake fluid.

Cause: Assembly grease/fluid is present from the manufacturing process and gives a similar appearance to a brake fluid leak.

The attached photo shows typical grease/assembly fluid migration over time and is not a leak, this unit has been removed and confirmed as not leaking.

Action: When investigating any potential brake fluid leaks please first remove any traces of grease/fluid from the calliper area then firmly pump the brake pedal several times before re-inspecting to confirm if there is a genuine leak or not.
